Appendix A

Individual Summaries of all 2012 New Jersey Pedestrian Fatalities

New Jersey Bicycle and Pedestrian Resource Center

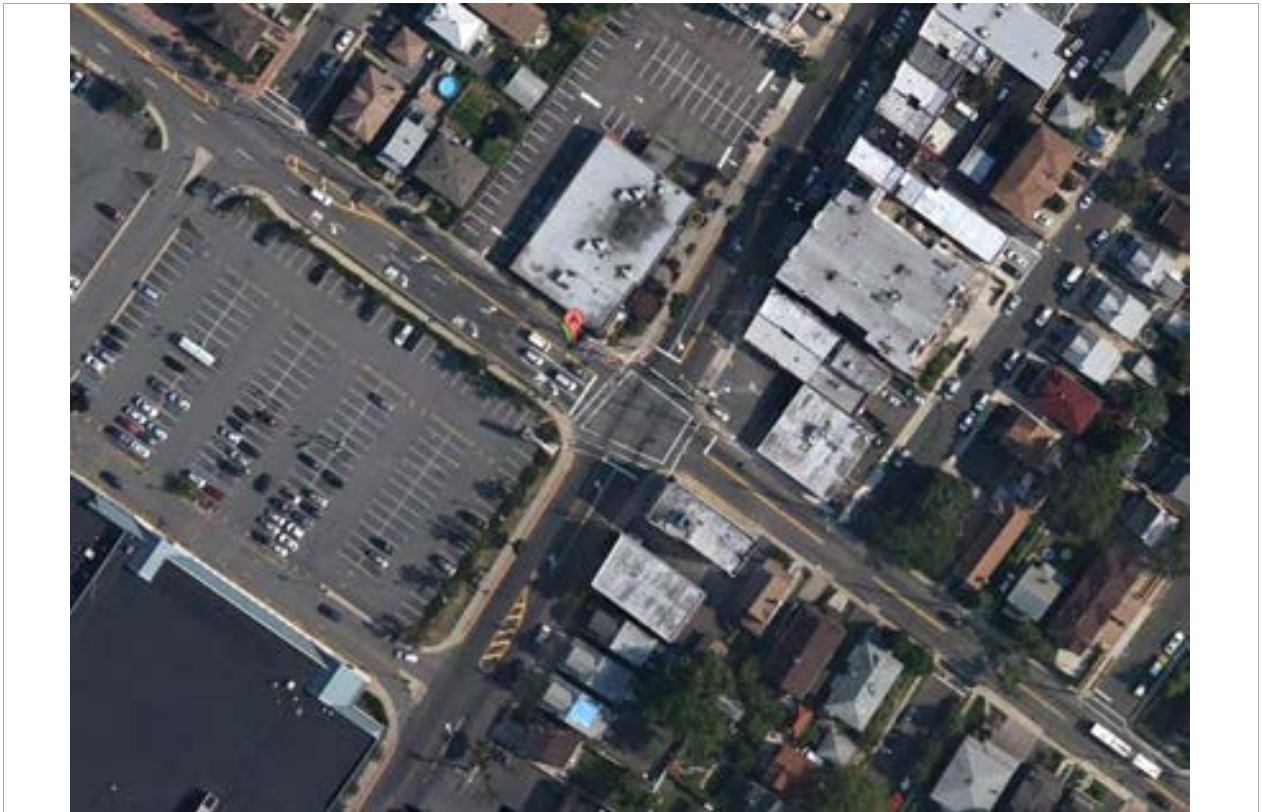
Figure 1. Overhead View of Site

Additional Infrastructure Dense urban area. A large A&P supermarket is on the southwest corner, with large surface parking. Multiple 3-4 story buildings in area, with residential on top. Residential neighborhoods in all directions.

Edgewater Road generally has one lane in each direction. At the intersection, it widens to three eastbound lanes to allow for turns. Anderson Avenue is also one lane in each direction, widening to two at the intersection to allow a left turn lane. Left turn arrow phasing in all directions. Marked transverse crosswalks in all directions.

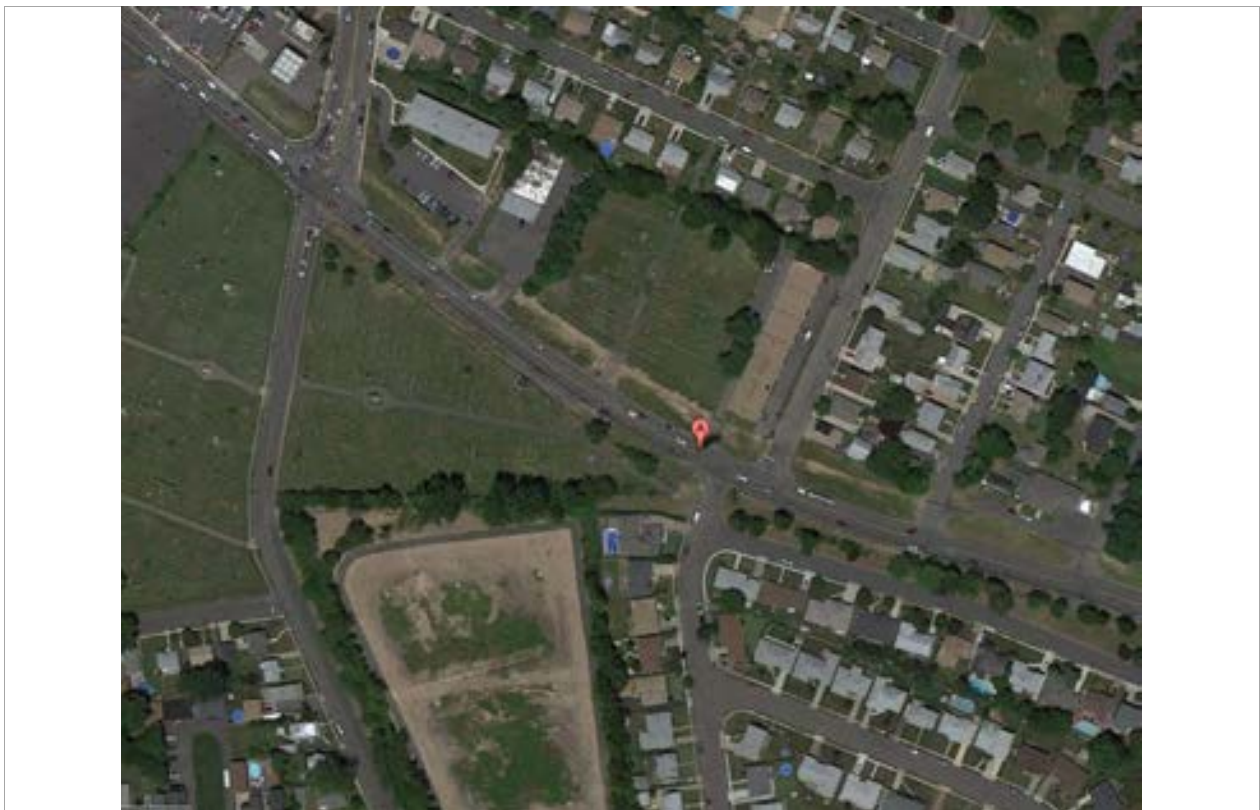
Figure 1. Overhead View of Site Map Link <http://goo.gl/maps/cE7on>

Additional Infrastructure Offset intersection with major 4 lane road and minor residential roads. Pfeiffer Blvd (NJ 184) is an east-west roadway with two lanes in each direction and a double-yellow line. In both directions it has highway characteristics as it passes over other routes, with on-ramps. At the crash site, there is an at-grade off-set intersection with a very minor residential road. Pfeiffer has the right of way.

In September 2012, a transverse crosswalk is shown across the minor residential road, with none across arterial. That crosswalk did not exist in 2009. There is a sidewalk only on one corner. One street light at intersection

Infrastructure contribute?	<input type="text" value="Yes: Street lights were off at 9:16 PM, no crosswalks, high speed (45mph), no sidewalks"/>								
Questions	<ol style="list-style-type: none"> 1. What is average speed of drivers? 2. Are pedestrians walking to nearby business area? 3. Was pedestrian intoxicated? 4. Are lights adequate? 5. Why is there no crosswalk across Pfeiffer Blvd (184)? 6. Is a road diet justified?

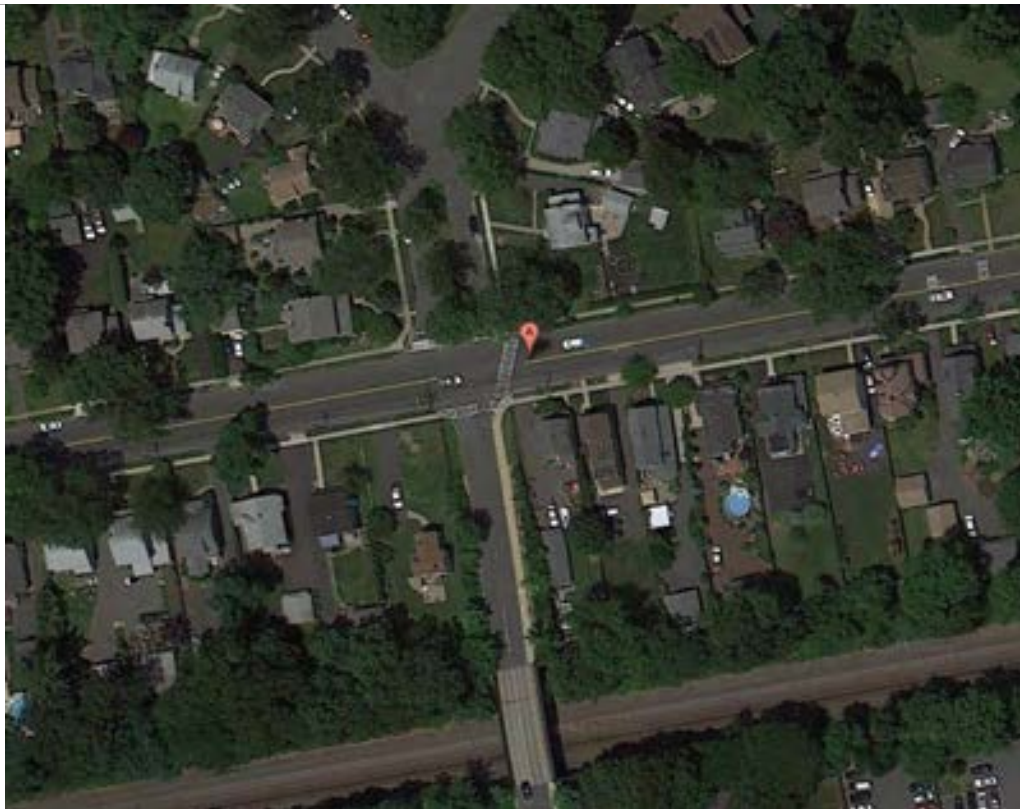
Figure 1. Overhead View of Site

At the intersection, there is a well marked ladder crosswalk across North, on the east side, and crosswalks over Tuttle. Tuttle is stop controlled while North has the right of way Streetview indicates the crosswalk, with signs, existed as early as 2007.

The surrounding area is suburban residential. Downtown Westfield, with a train station and many businesses, is about half a mile east.

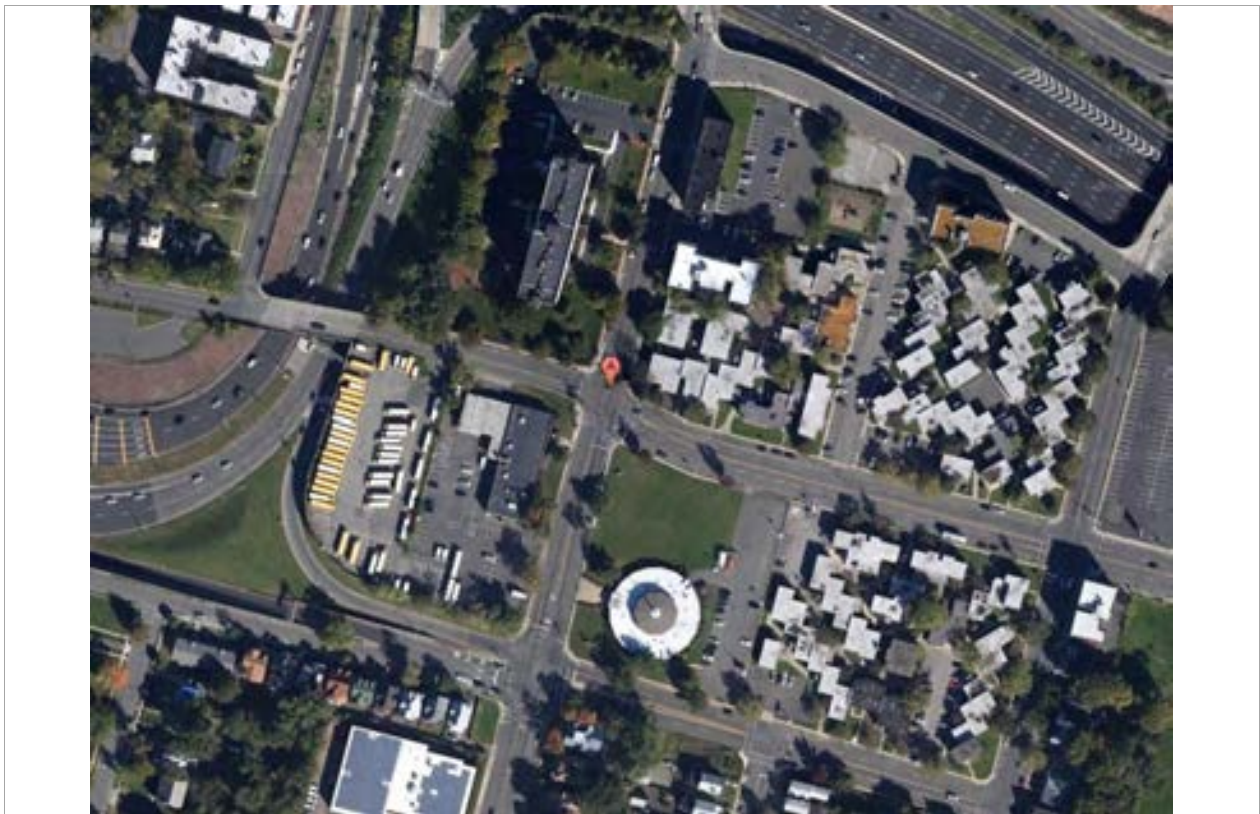
Figure 1. Overhead View of Site

A bus stop with shelter is at the intersection. Multiple streetlights observed in area. Intersection is near highways, possibly causing drivers to speed. There are very faded transverse crosswalks at the intersection.

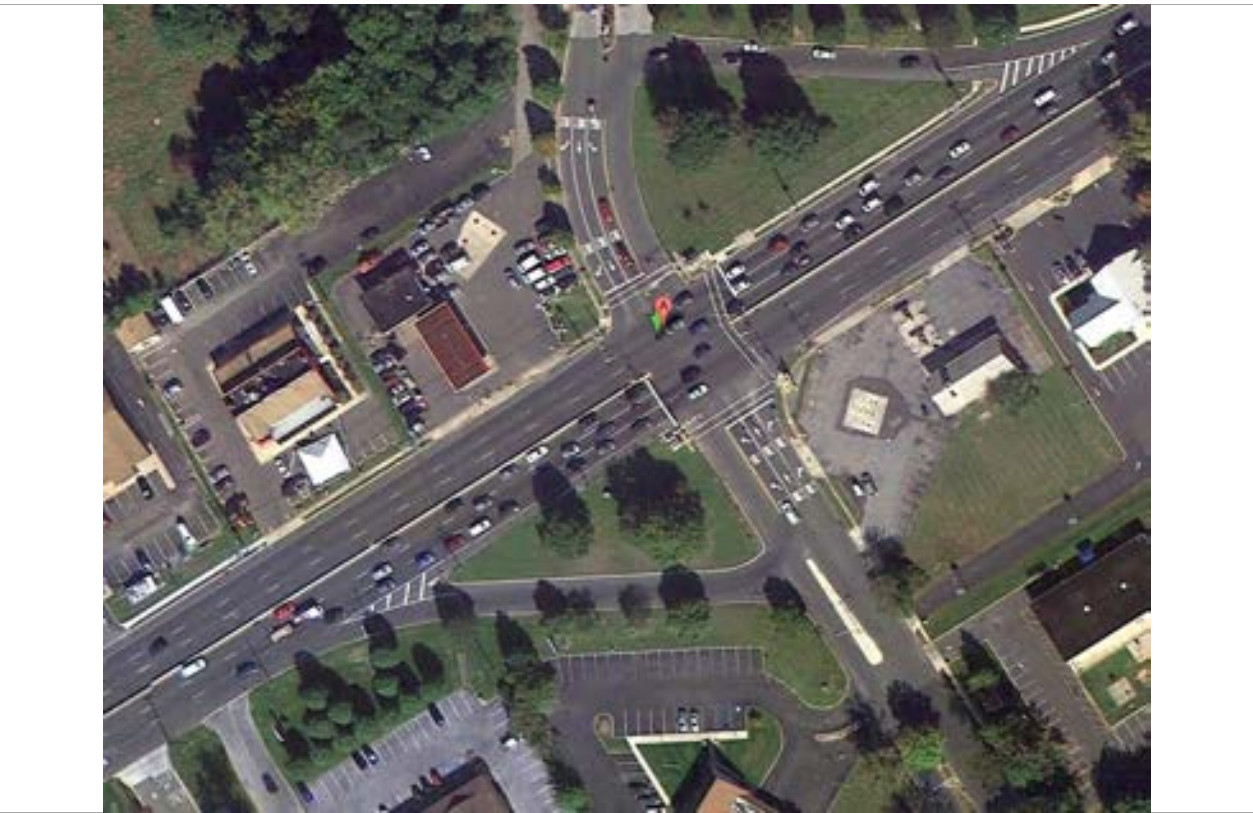
Figure 1. Overhead View of Site Map Link <http://goo.gl/maps/KsO1e>

Small streetlights appear to be attached to every signal pole.

Area is surrounded by suburban residential and commercial uses.

Interpretation Report notes that "all witnesses" stated that pedestrian crossed against light, but witnesses not listed.
Bus stop is present with no pedestrian infrastructure. Missing crosswalk means pedestrian must cross three roads to get to the other corner. Lights exist at each corner but they appear small and not well positioned over the roadway. Speed limit is high.
Pedestrian blamed for crossing where prohibited but it is unclear if crossing is actually prohibited or if crossing functions as unmarked crosswalk.

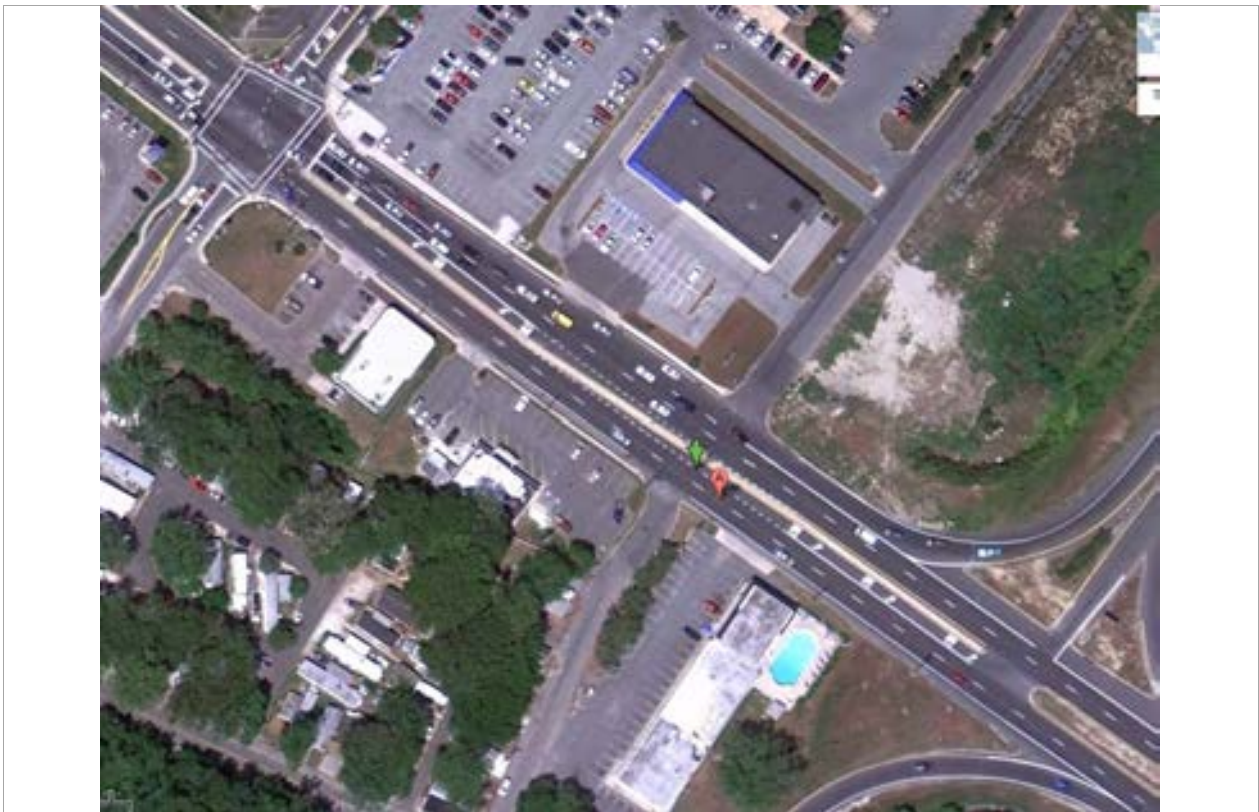
Figure 1. Overhead View of Site

The closest building to the collision is a motel, on the southeast corner of 47 and 6th. On the north side there is a commercial center with a ShopRite and RiteAid. There is a small trailer park behind the motel.

There are no street lights on 47, except for one oriented diagonally into the intersection from S. 6th.

<input type="text" value="Pedestrian is listed as living in a motel .3 miles away. If she was coming from there, she would have had to cross 5th."/>								
Infrastructure contribute?	<input type="text" value="Yes: No street lights, no crosswalk at 6th Street"/>								
Questions	<input type="text" value="1. Was the pedestrian crossing legally in an unmarked crosswalk?

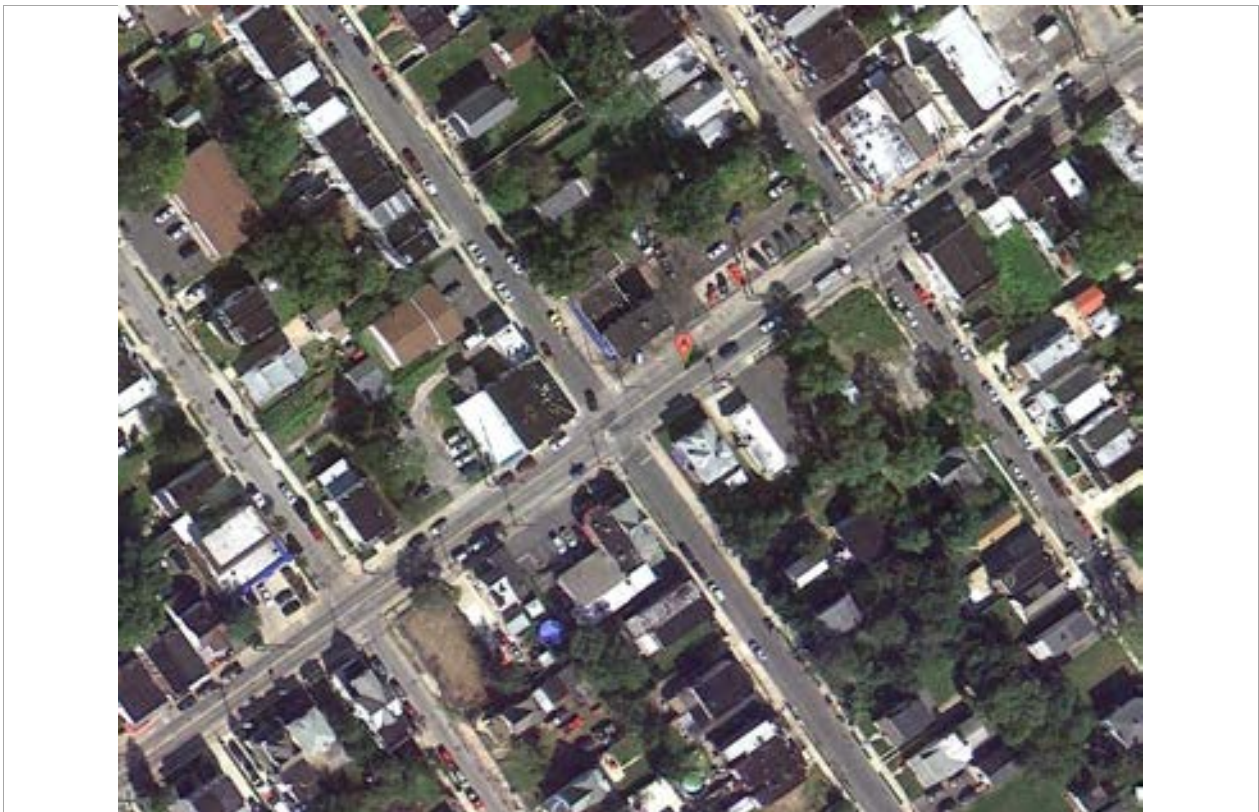
Figure 1. Overhead View of Site

Road has frequent street lighting, but CAIT database describes them as not functional. Intersections are frequent, with the intersection to the east having a traffic signal. A light rail stop is within walking distance.

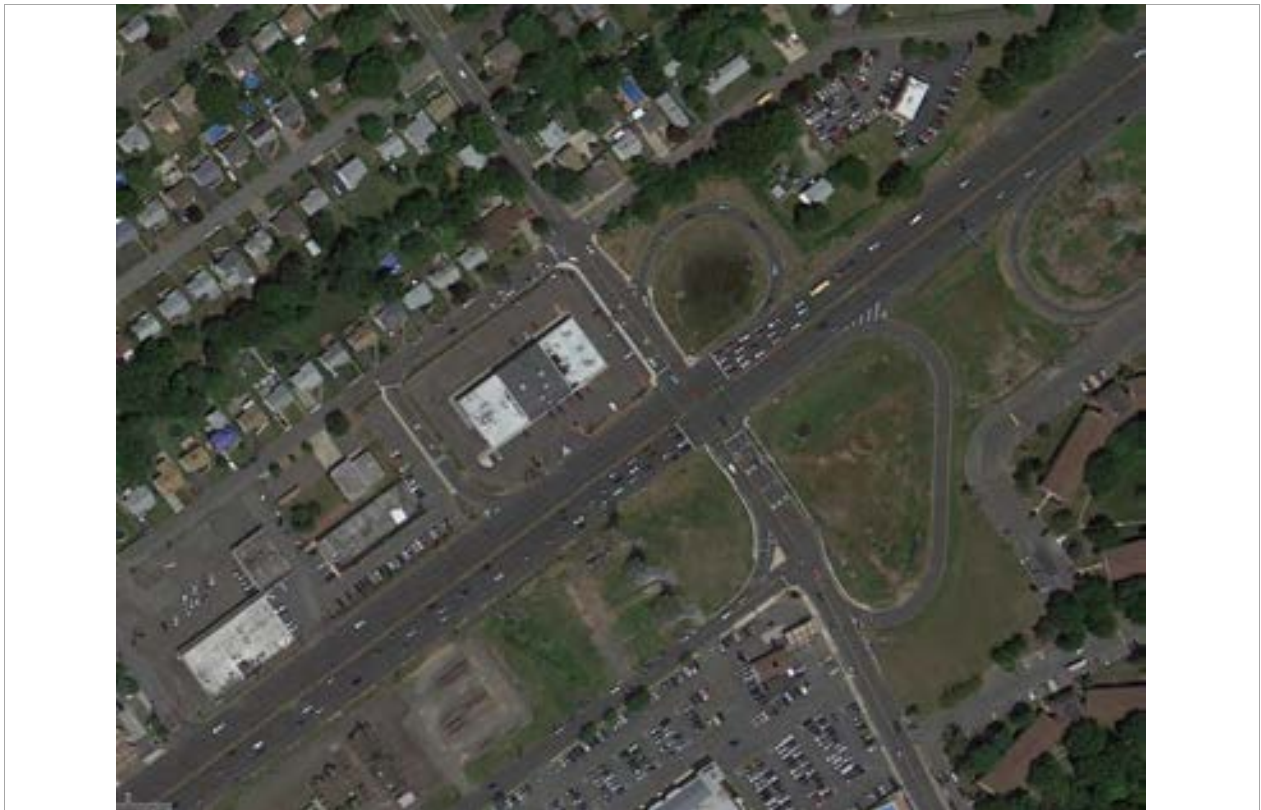
Figure 1. Overhead View of Site Map Link <http://goo.gl/maps/MnVrA>

Ford Avenue is 2 lanes wide, but widens to 4 or 5 at the intersection with Route 1. It has sidewalks in all directions.

Street lights exist at the intersection, but do not look long enough to provide complete coverage of crosswalk. There is no pedestrian refuge.

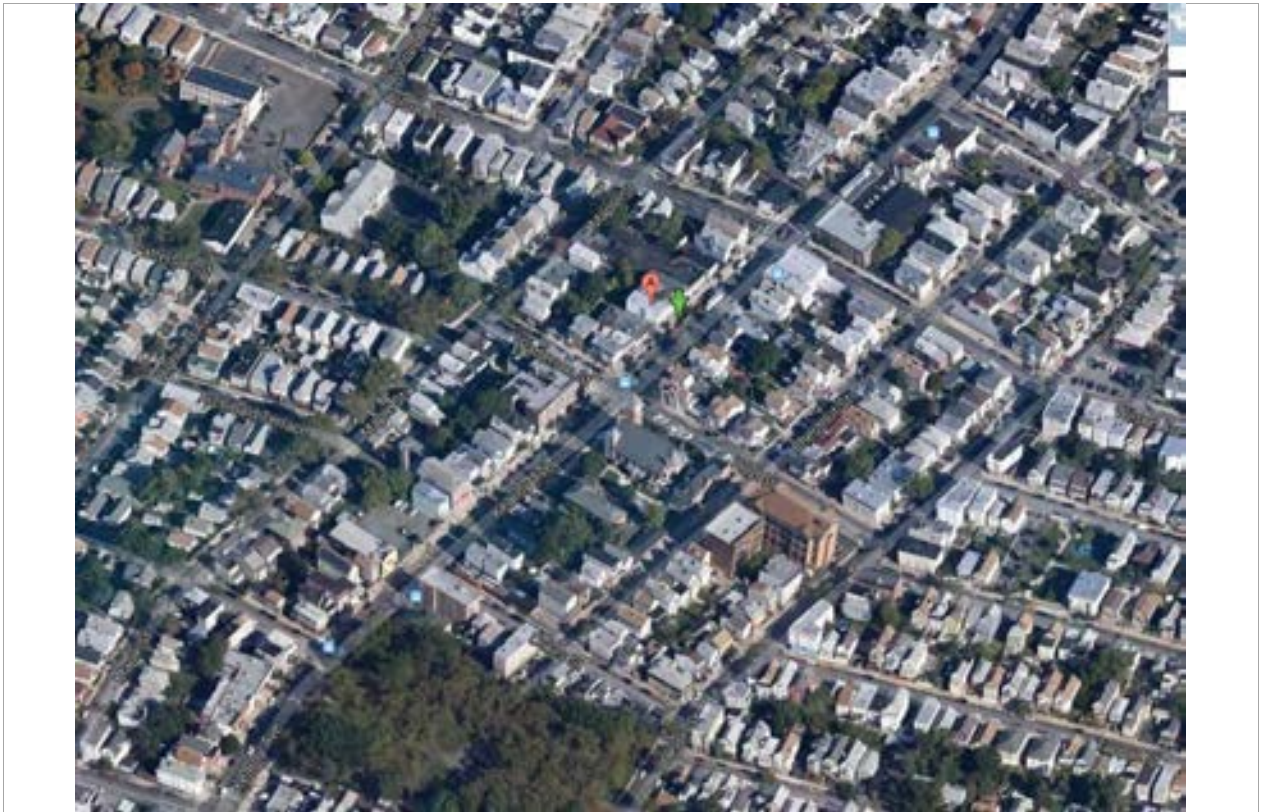
Figure 1. Overhead View of Site

Incident took place in a parallel parking spot, as the driver reversed into it.

Driver did not see pedestrian when backing up, which is a failure to exercise caution. Pedestrian might have been in a blind spot, which is where technology like rear-view cameras could help. Light posts are frequent on the street, but perhaps a more directional type of lighting could have helped to illuminate the pedestrian, especially if there was glare from other vehicle headlights.

Road appears to be very wide for 2 lanes with parking. This might cause speeding, which could be why driver was more worried about approaching vehicles than looking for the pedestrian.

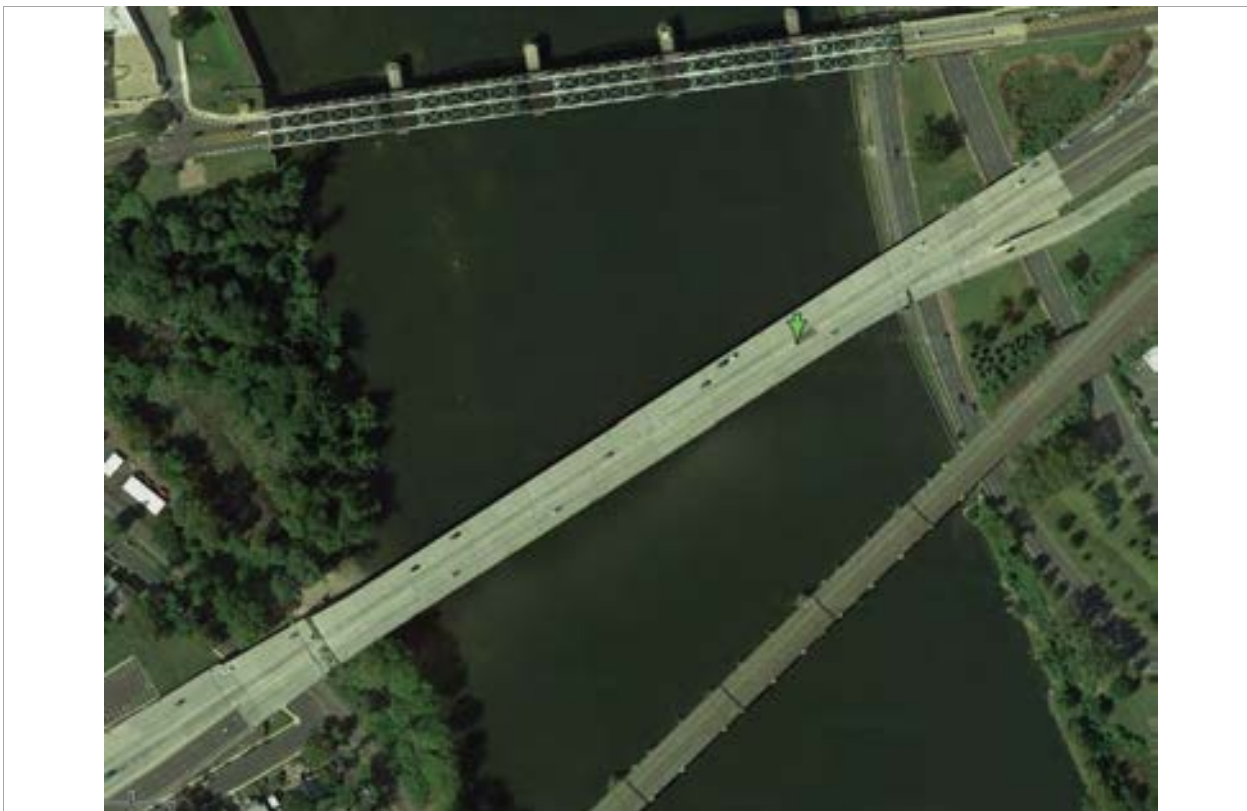
Figure 1. Overhead View of Site

The roadway consists of 3 southbound lanes and 3 northbound lanes separated by a concrete barrier. All lanes are concrete, approx. 12 ft wide and in good condition. The roadway is clearly marked through the area with painted lanes and the speed limit posted is 50 mph.

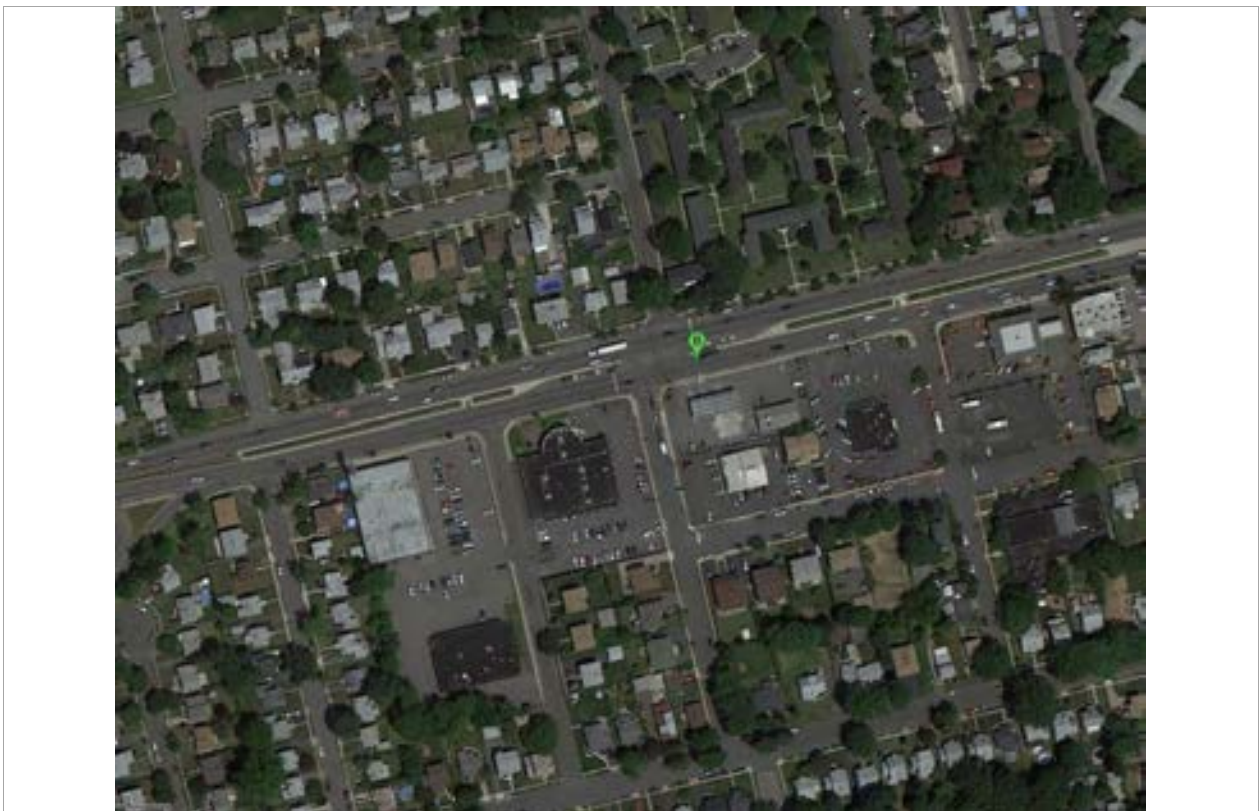
Figure 1. Overhead View of Site Map Link <http://goo.gl/maps/wrBpb>

Transverse crosswalks are painted across 7th on both sides and across 46 only on the western leg of the intersection. While the east side is lacking crosswalk paint, pedestrian signals, and ramps, there don't appear to be any signs banning crossings. On the south side, the location of the missing crosswalk is a gas station curb cut.

There is a single street light for the entire intersection.

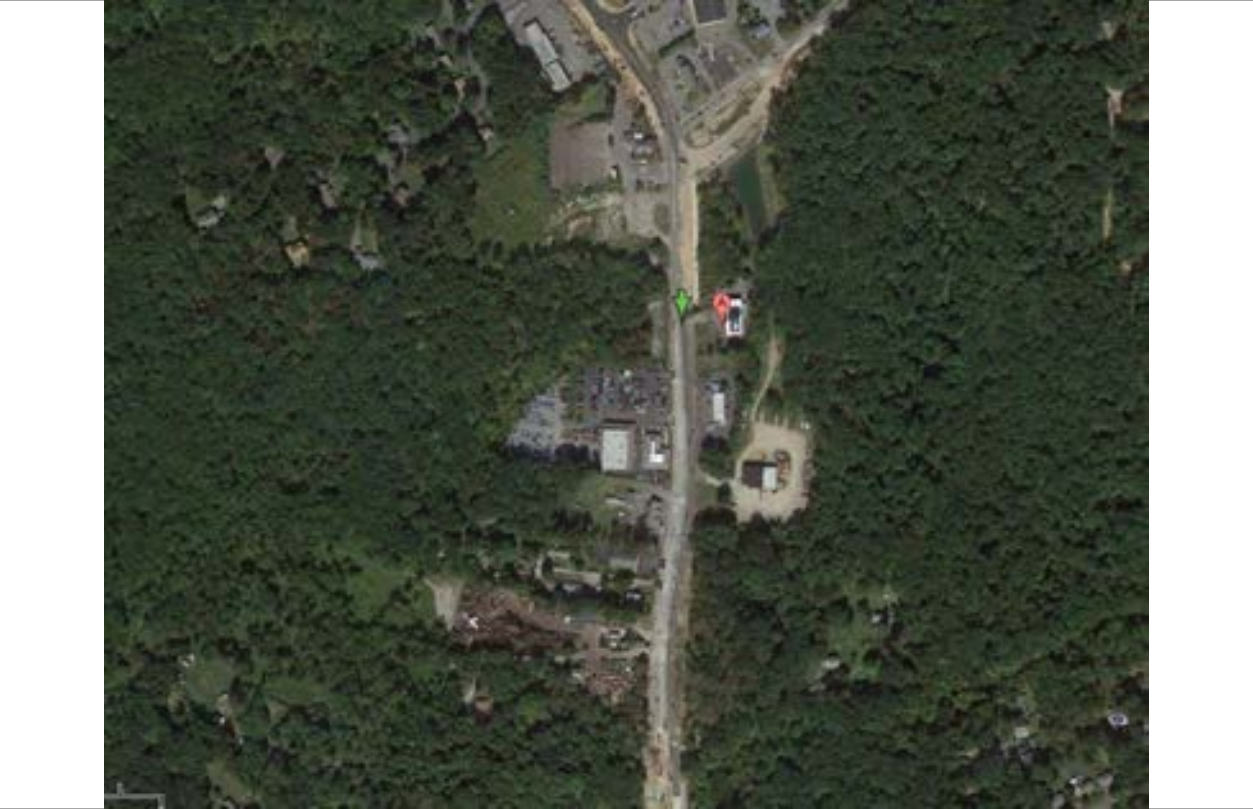
Figure 1. Overhead View of Site Map Link <http://goo.gl/maps/Q1ehD>

Area is very rural (forested). South of crash site are the ends of suburban residential neighborhoods. To the west is the Allamuchy Mountain Park, and to the east mostly forest.

The crash itself happened directly outside of STS Tire and Auto Center. A car wash and a Nissan dealership are further south. To the north of the crash site, there is a shopping center with a ShopRite, bank, McDonalds, and liquor store.

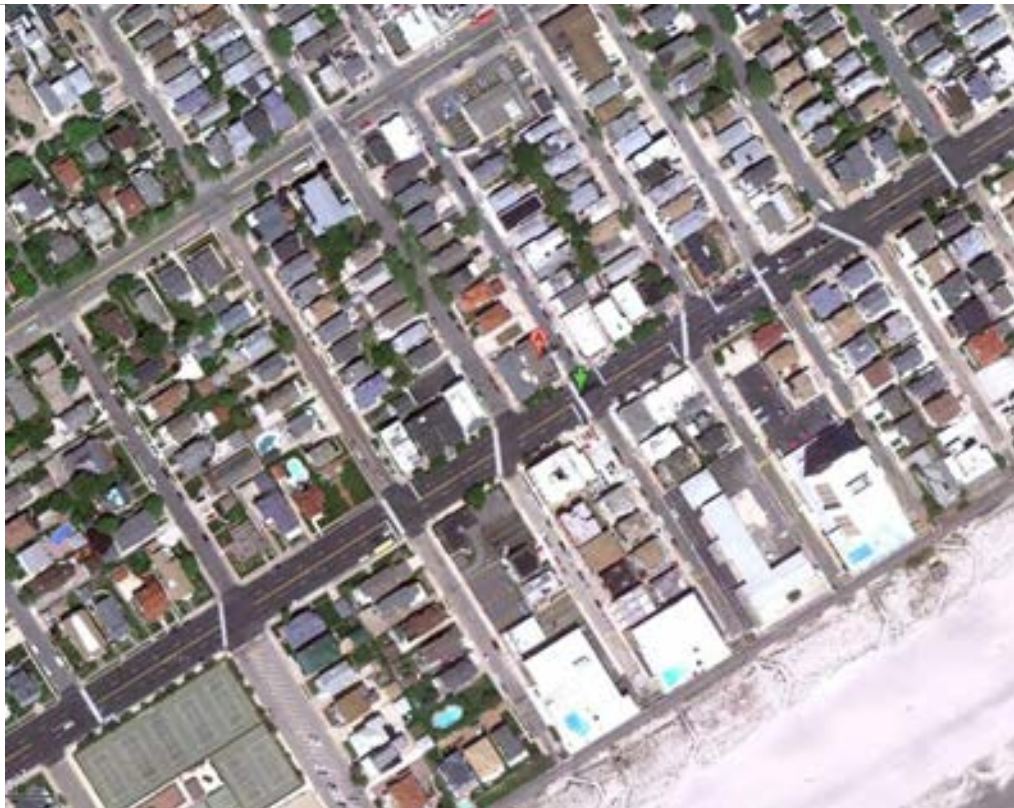
Figure 1. Overhead View of Site

Atlantic Avenue is a block from beach, with typical shore-style residential in area. Atlantic is mixed use, with retail on bottom.

CAIT database indicates no streetlights, but streetview shows some, including one at intersection.

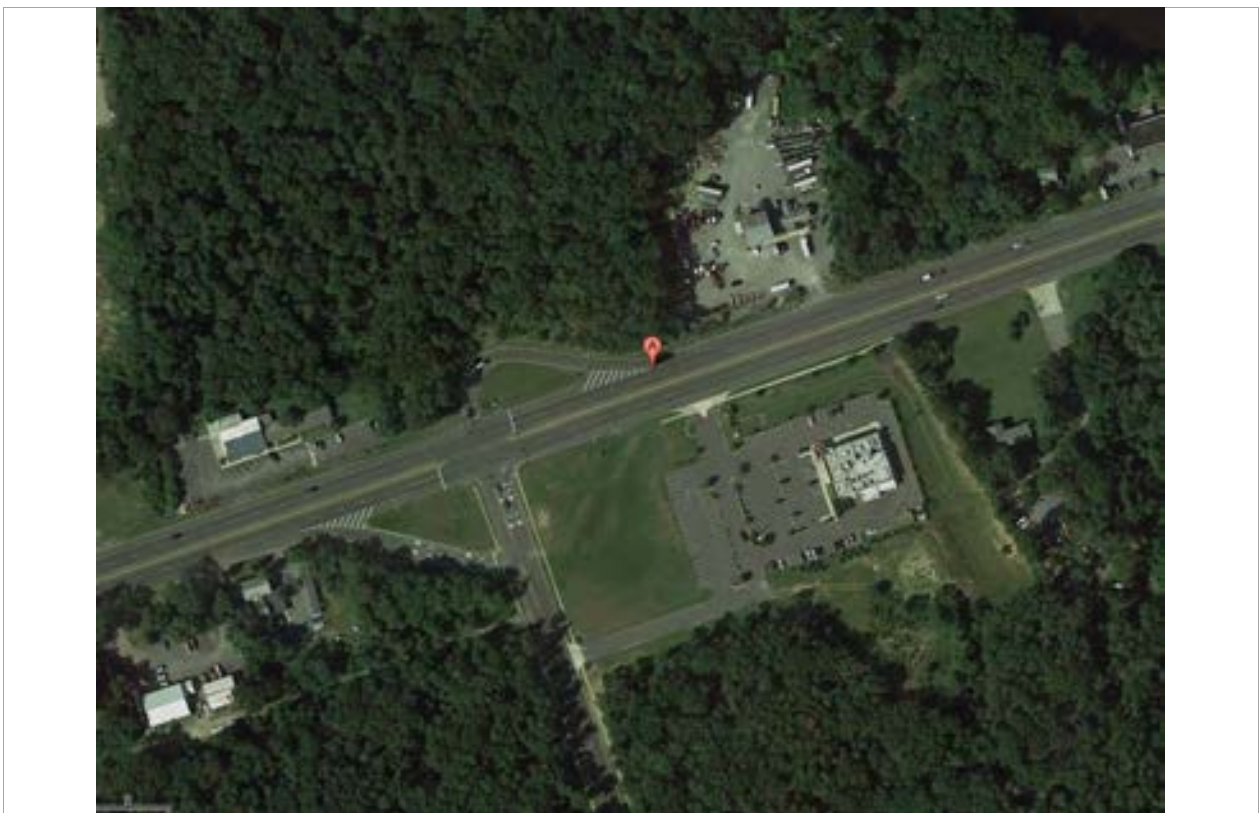
Figure 1. Overhead View of Site Map Link <http://goo.gl/maps/Ta73F>

Approaching the jughandle, the shoulder for the westbound lane becomes a traffic lane into the jughandle. The pedestrian was walking in the shoulder, which became a lane.

There are unevenly spaced streetlights over the roadway.

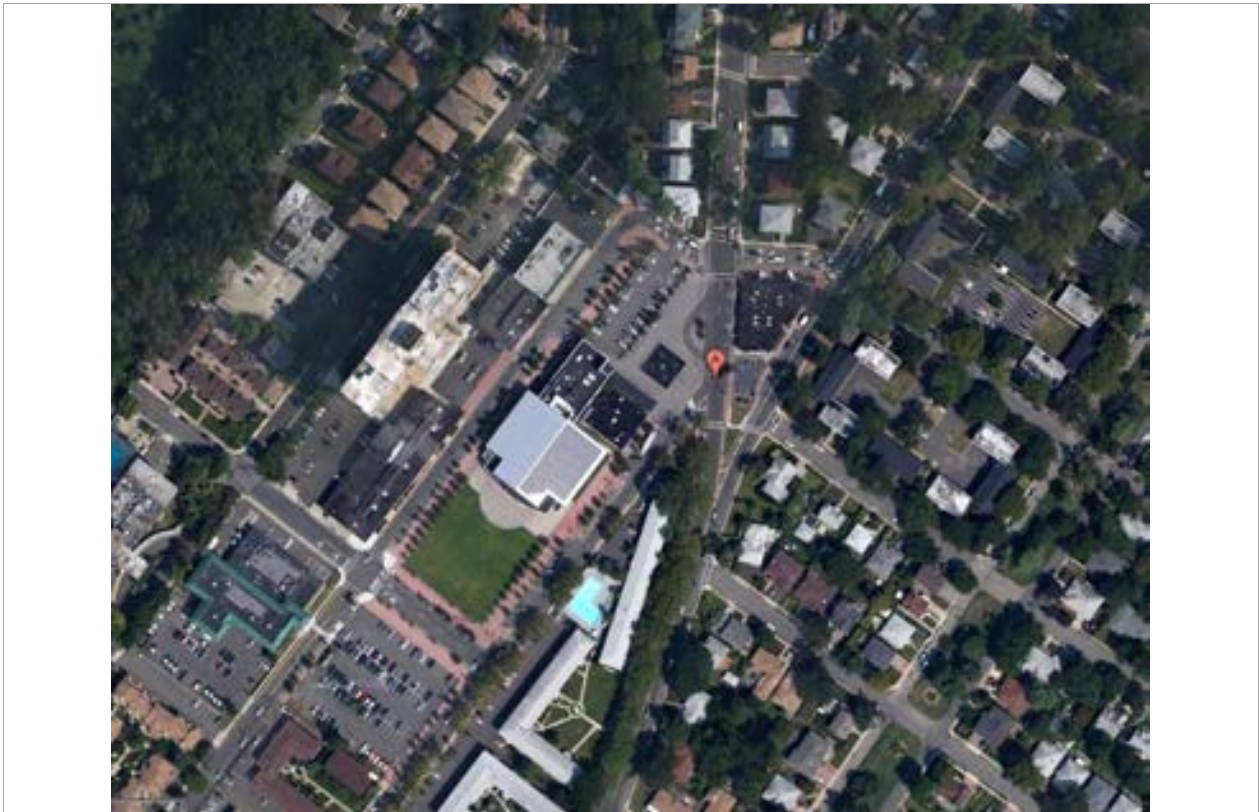
Figure 1. Overhead View of Site Map Link <http://goo.gl/maps/ufE5W>

Anderson Avenue is a 2-lane, one way street, south direction. Right lane breaks off to form Inwood Terrace, a one-way, one-lane street. Directly west of crash site is the Fort Lee Community Center. Directly east is a small one-story retail center with parking for 9 cars.

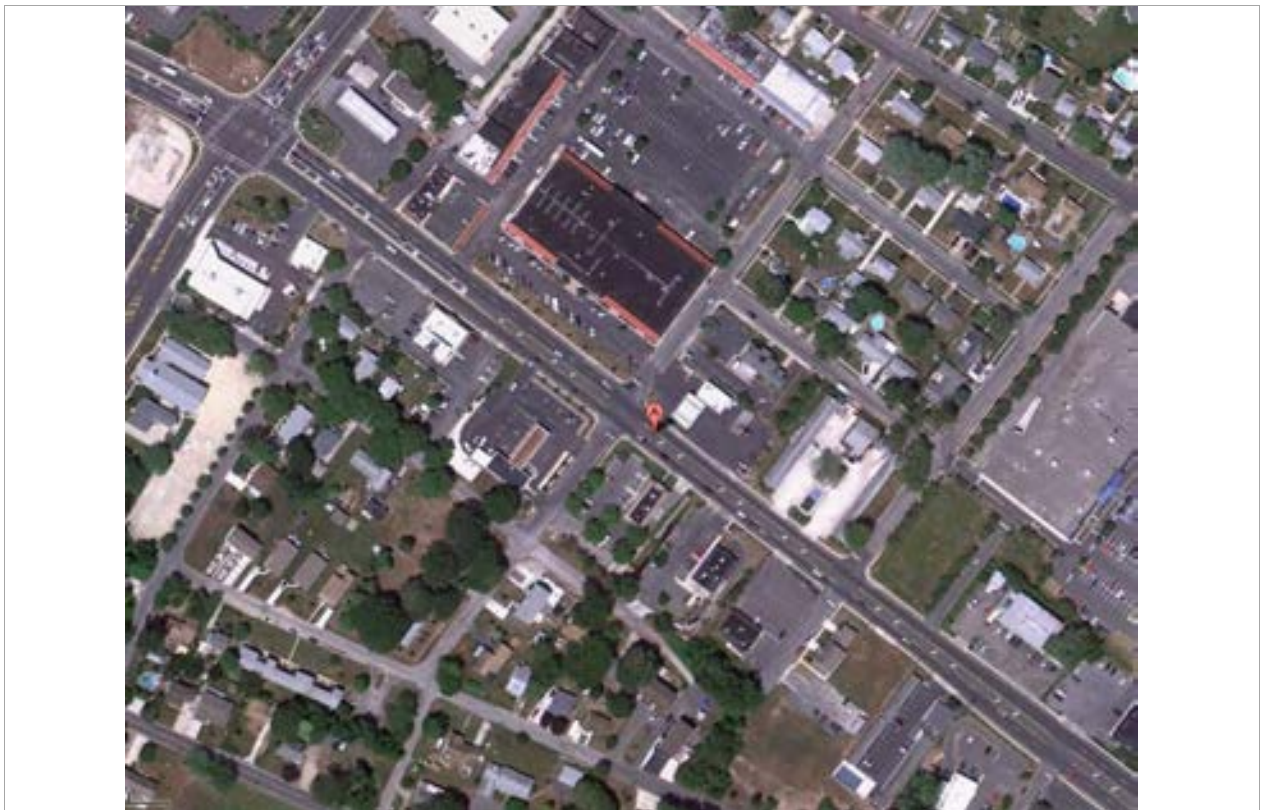
Figure 1. Overhead View of Site

There are no painted crosswalks at the intersection in any direction, and there is a single streetlight over the intersection.

Further west, 47 expands to two southbound lanes, a concrete median, and 3 northbound lanes at the intersection with Shore Road, which is signal controlled.

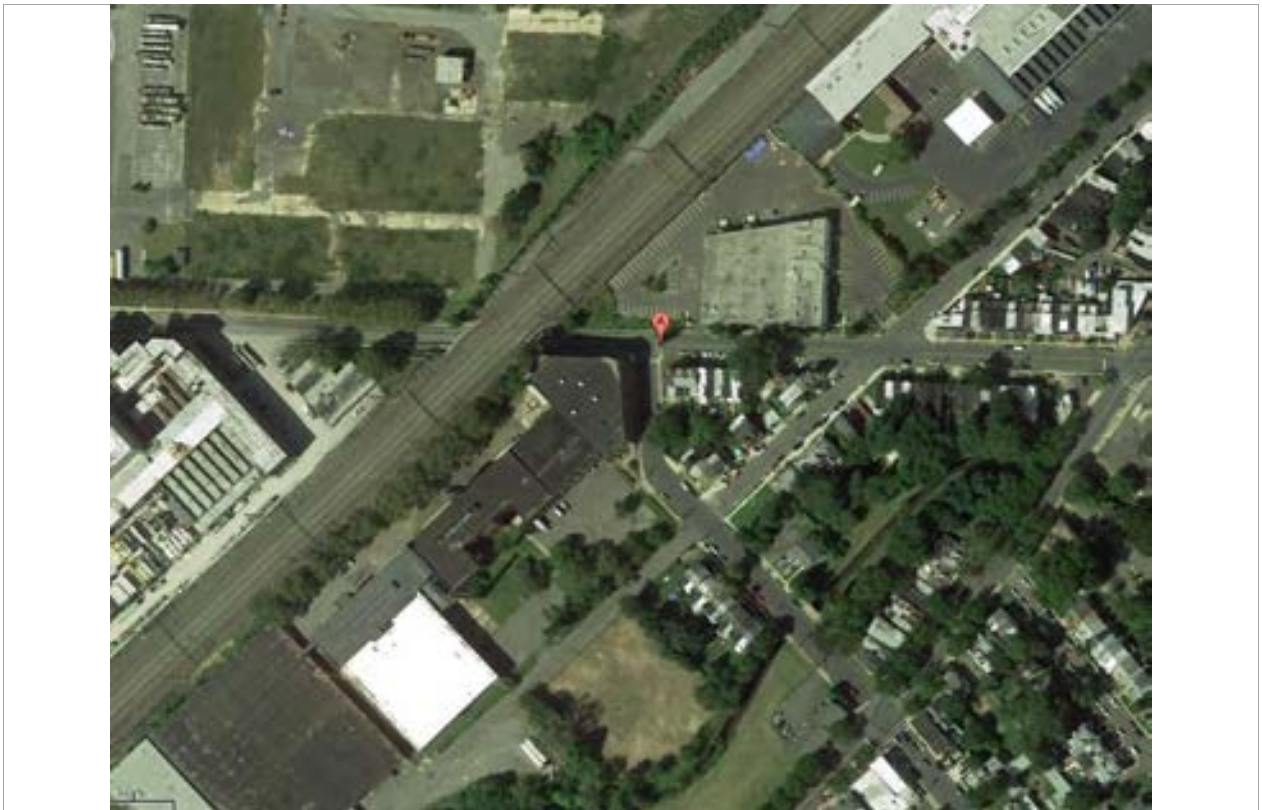
Figure 1. Overhead View of Site Map Link <http://goo.gl/maps/kWUsO>

There is a single street light over the intersection. From the report, the street light was on at the time and provided good light.

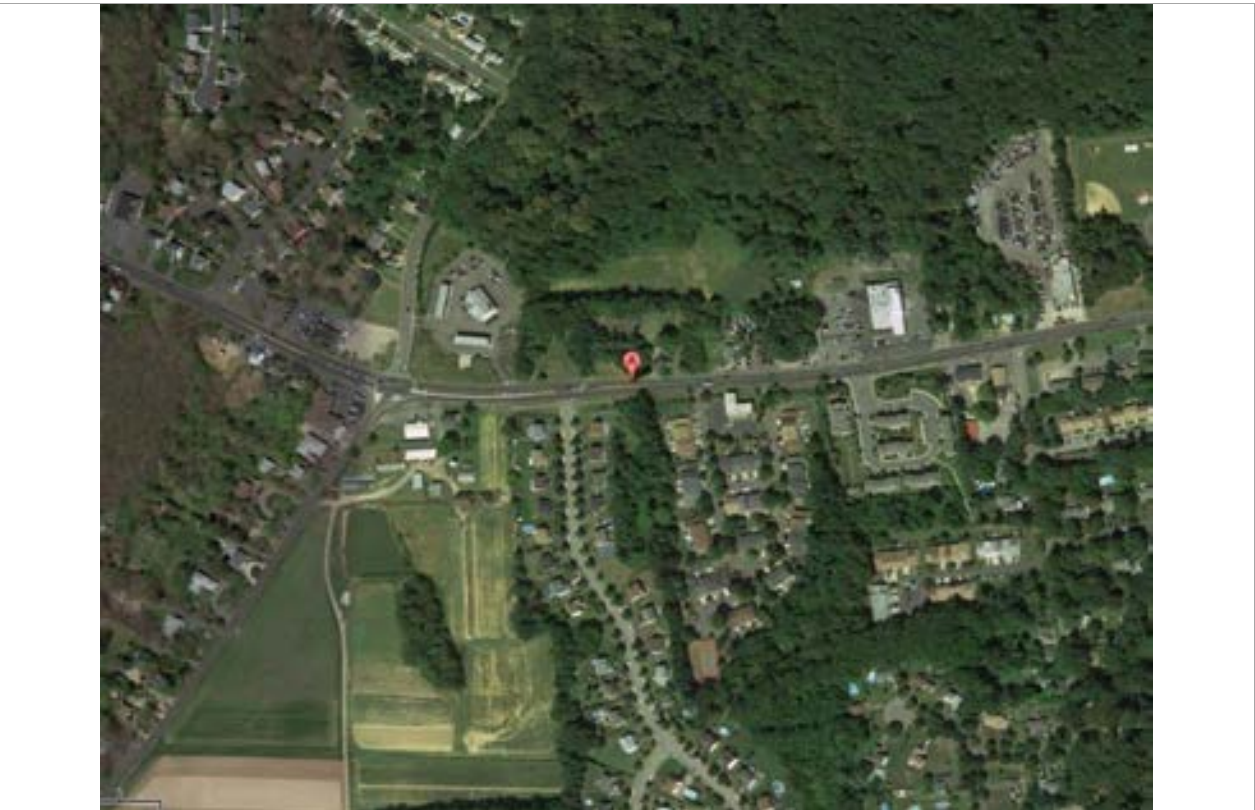
Figure 1. Overhead View of Site Map Link <http://goo.gl/maps/i7NqJ>

Additional Infrastructure Highway 34 is an east-west route with one lane in each direction, divided by a double yellow line. There are no sidewalks in either direction, but there is a shoulder on each side, with a variable width.
 Incident occurred near intersection with Annie Drive, a minor residential street. Route 34 widens slightly to add a left turn lane from the westbound direction onto Annie. Annie is stop controlled, and Highway 34 has the right of way. .1 mile west, there is a signalized intersection.
 Area is sparsely populated, with suburban developments and forests.
 Incident occurred about 350 feet from the driveway of WaWa - the destination of the pedestrian.
 There are no streetlights.

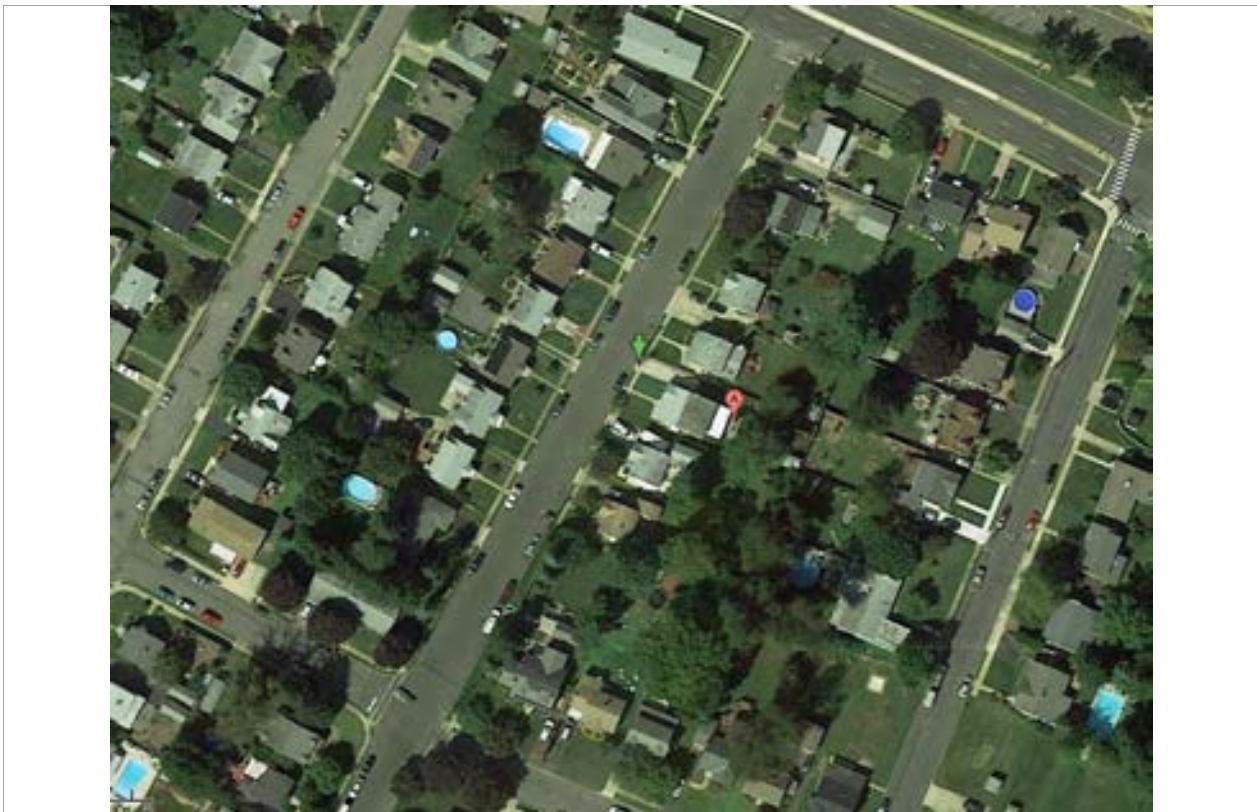
Figure 1. Overhead View of Site

Incident occurred on sidewalk, as vehicle was backing out of driveway into roadway. Driver was resident of home, victim was neighbor.

Land use is suburban residential, with detached homes, almost all with driveways.

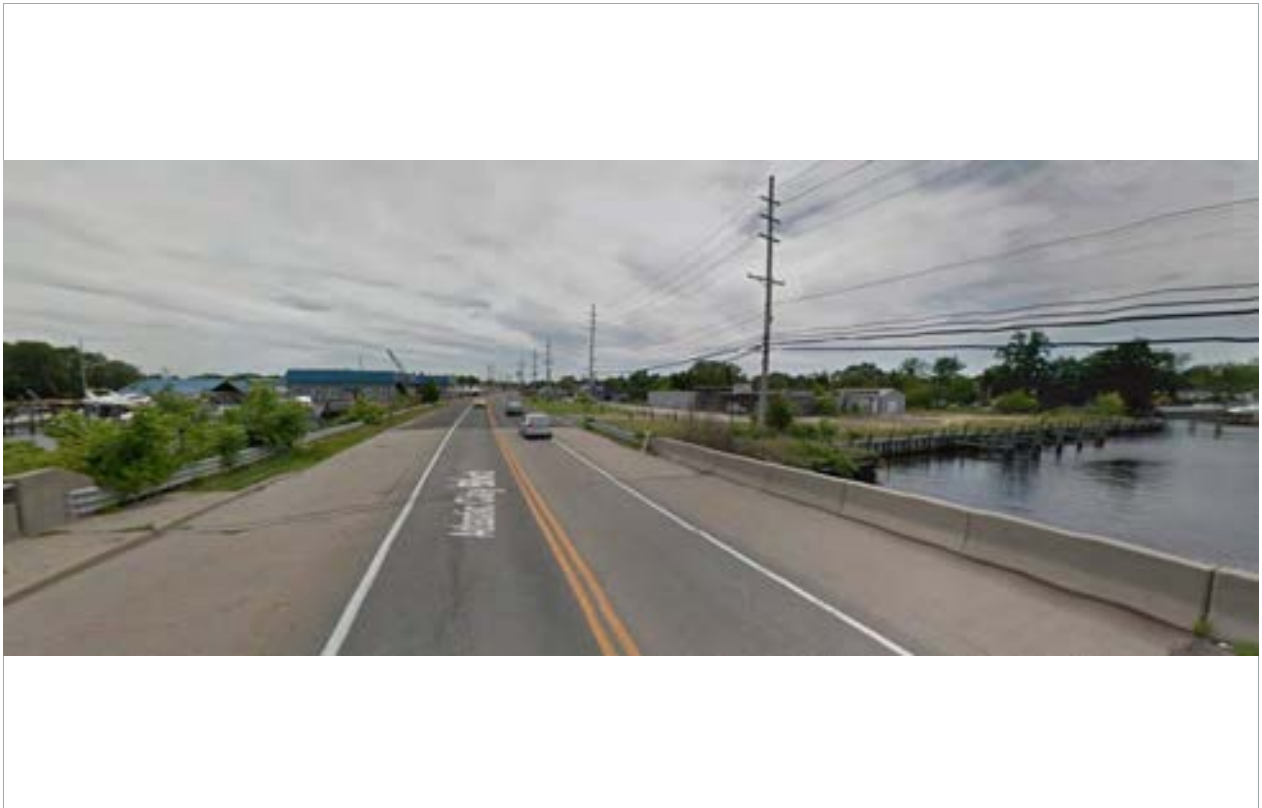
Figure 1. Overhead View of Site Map Link <http://goo.gl/maps/ul8TZ>

There are no sidewalks on either side of Rt. 166 on this side of the bridge. However, there is one sidewalk to the north of the bridge on Rt 166. There are also no sidewalks on Crabbe Road.

There are no traffic lights on the road near the incident.
