Appendix A

Individual Summaries of all 2012 New Jersey Pedestrian Fatalities

New Jersey Bicycle and Pedestrian Resource Center

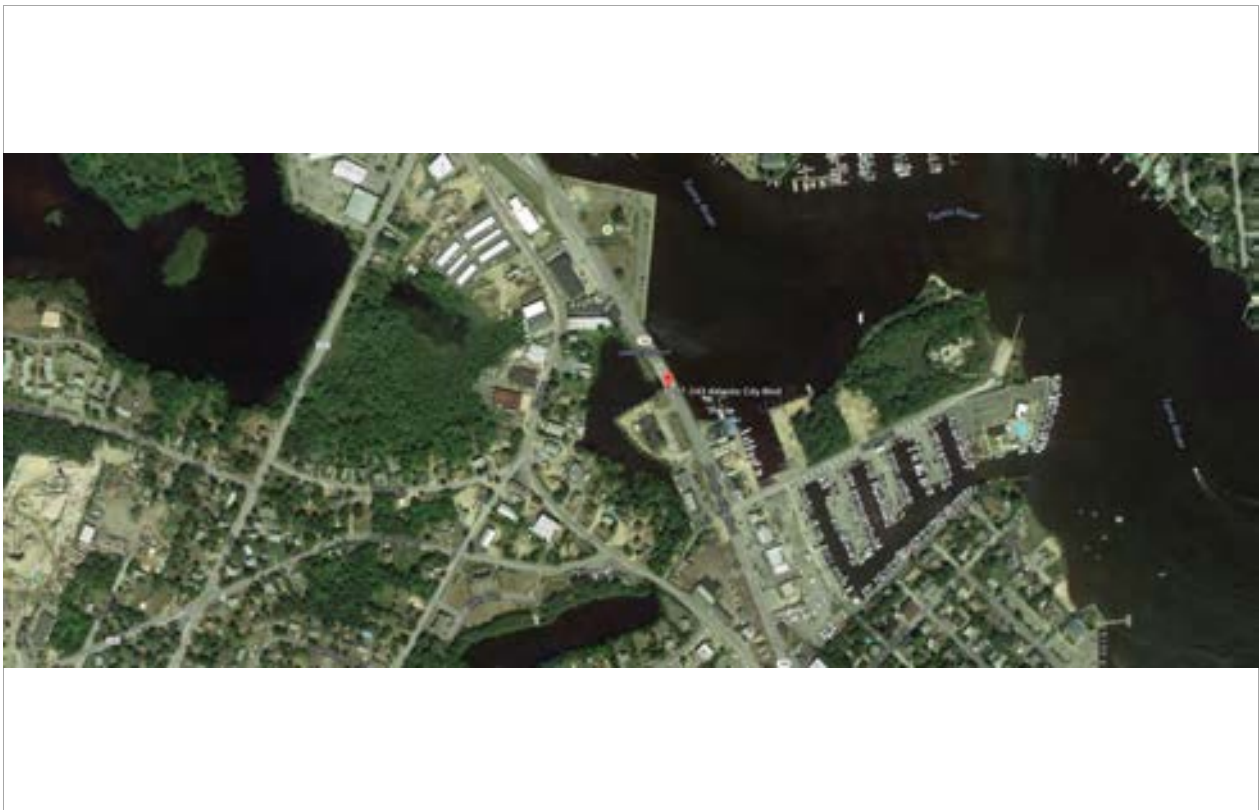
Figure 1. Overhead View of Site Map Link <http://goo.gl/maps/ul8TZ>

Additional Infrastructure
 Route 166 is a two lane roadway with double yellow striping. There is no street parking.
 At the intersection of Crabbe Road, there is no crosswalk or traffic light. Crabbe Road has no lines on the road at all and looks poorly maintained. Crabbe Road has a stop sign where it intersects with Rt 166.
 There is a small bridge on Rt 166 north of where the incident occurred. There is a small body of water or a bay on either side of the small bridge.
 There are no sidewalks on either side of Rt. 166 on this side of the bridge. However, there is one sidewalk to the north of the bridge on Rt 166. There are also no sidewalks on Crabbe Road.
 There are no traffic lights on the road near the incident.

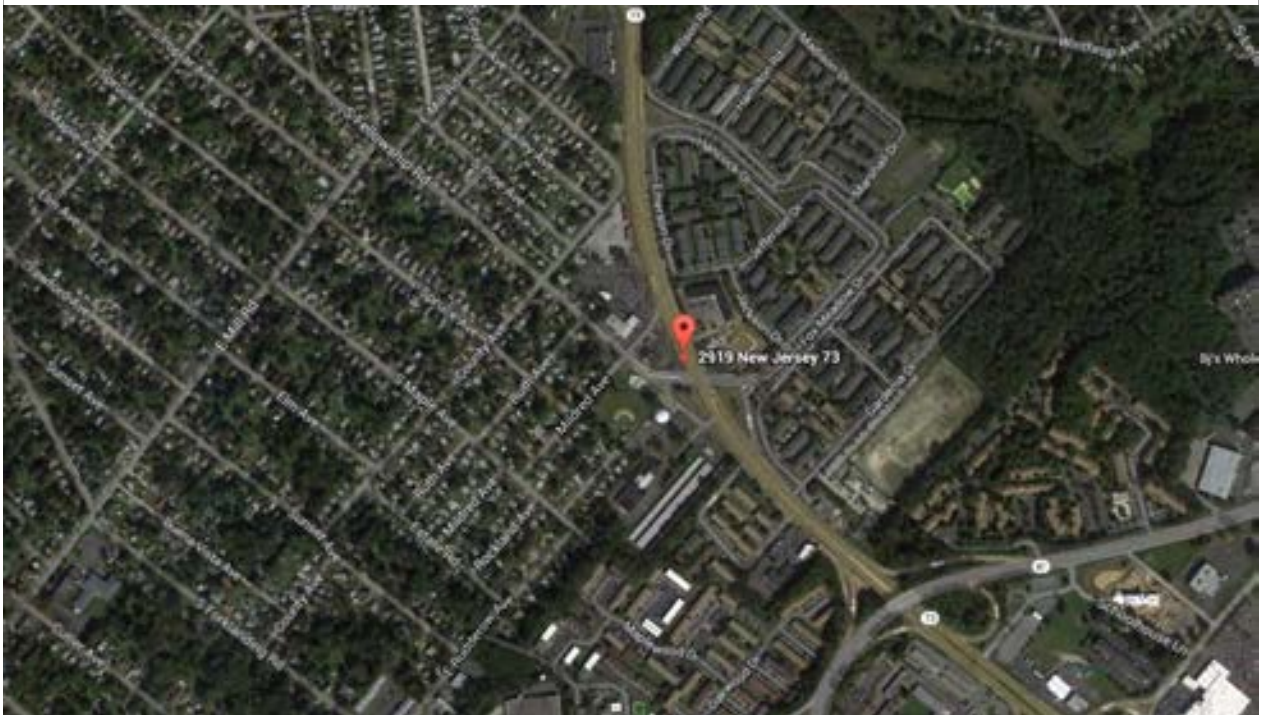
Figure 1. Overhead View of Site

Land use is very suburban.

There are pedestrian lights, signaling when the pedestrian should cross at this intersection.

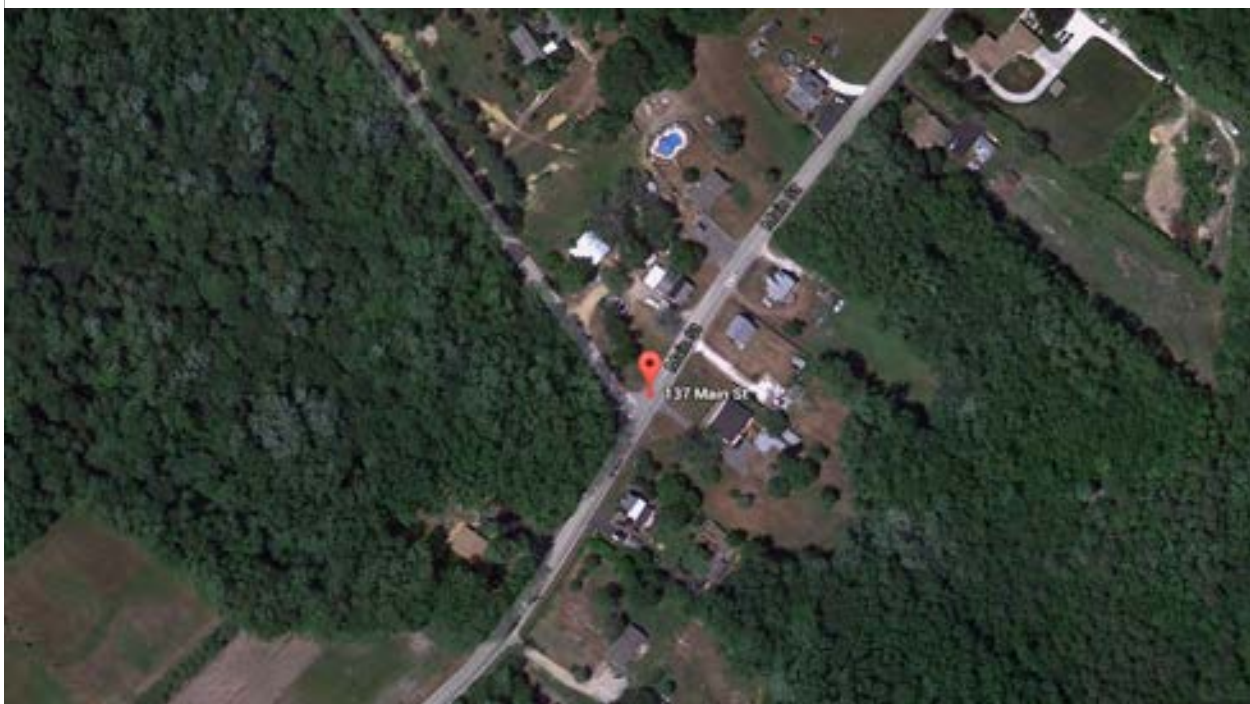
Figure 1. Overhead View of Site

There are no sidewalks. Rt 616 is a two lane roadway. There is one northbound and one southbound lane. The lanes are bordered by a white fog line and are divided by a yellow center line. Approximately 389 feet north of the point of impact there is a "Handicapped Children in Area" sign and approximately 598 feet north of the point of impact there is a sign indicating a curve with a cautionary speed of 45 mph.

Incident occurred just north of a T intersection with a minor road. There are no crosswalks at the intersection.

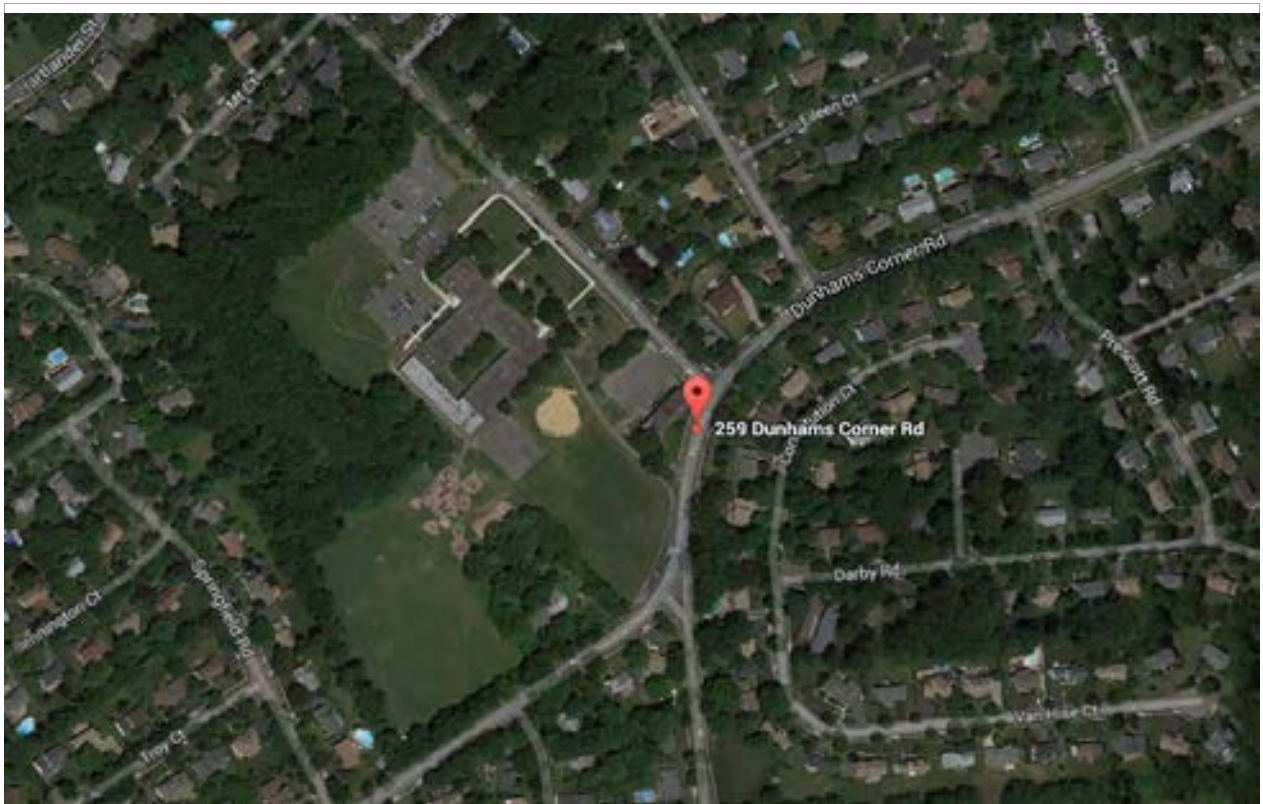
Figure 1. Overhead View of Site Map Link <https://goo.gl/maps/hac2a>

There are sidewalks on both sides of the road. They look poorly maintained. There are also poles every 20-30 feet on the side of the road for electrical wires and also overhead street lights. Only a couple feet west from where the incident occurred there is a pedestrian crossing sign. There is also a speed limit sign of "30". It is noted here in the CAIT data that the driver was going 40.

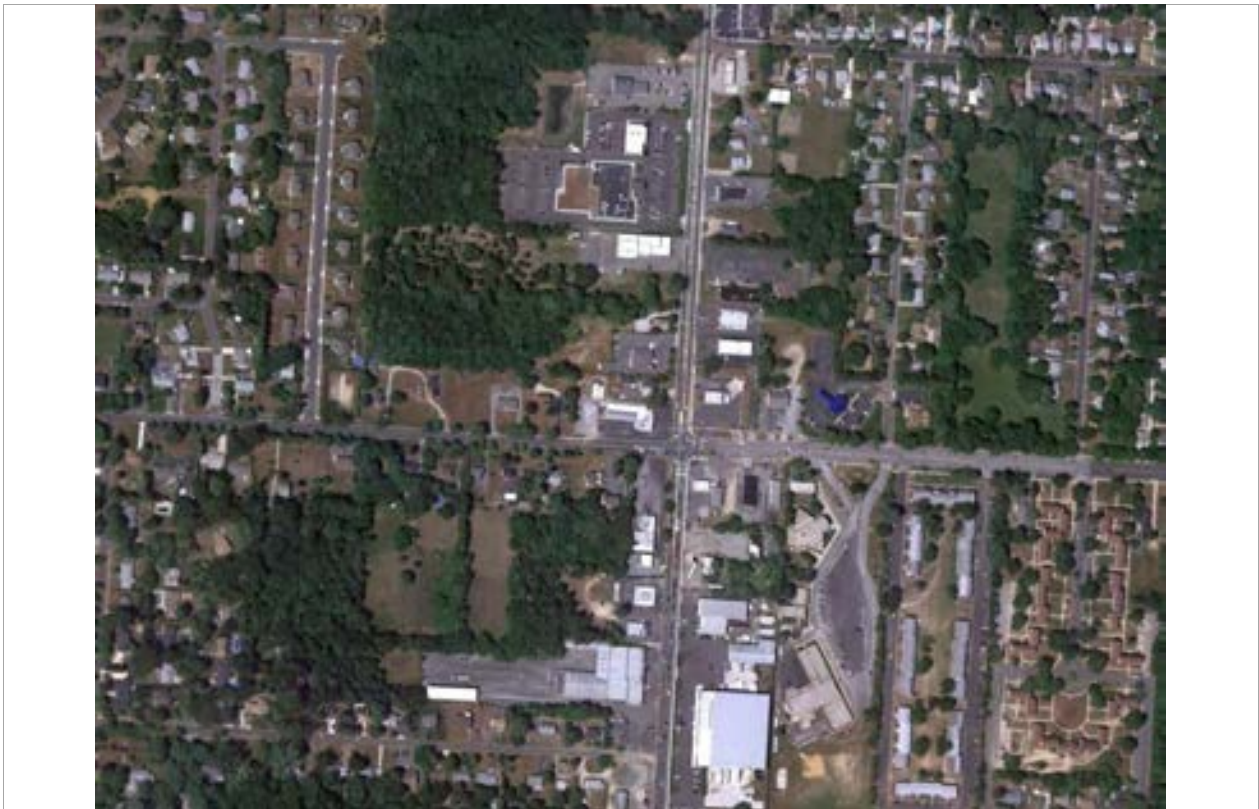
Figure 1. Overhead View of Site [Map Link https://goo.gl/maps/7wlj8](https://goo.gl/maps/7wlj8)

There appear to be overhead lights.

Along Delsea Drive there seems to be mostly commercial buildings. According to the X,Y coordinates reported by CAIT there is a liquor store where the pedestrian was struck. There is also a gas station at the intersection and a fast food drive in restaurant.

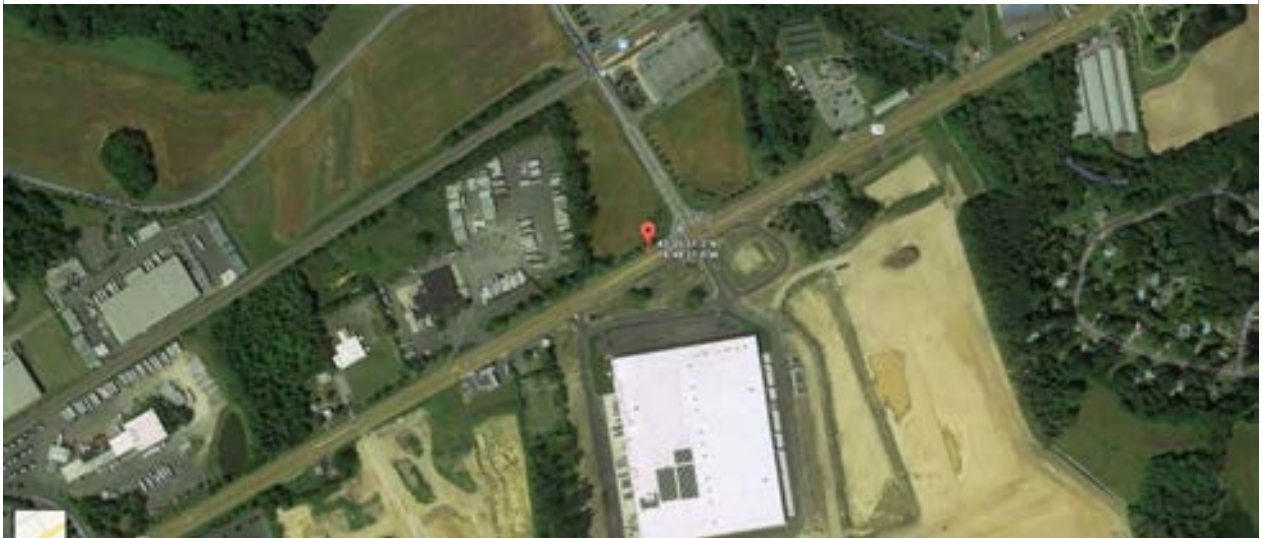
Figure 1. Overhead View of Site

There is a large intersection east of the collision that the vehicle just went through. It is a four-way intersection with sidewalks on the corners and pedestrian crossing signs, along with crosswalks. John Galt Way is a 4 lane roadway that has a protected right turn lane onto US-130. John Galt Way goes right into a Subaru parking lot to the south of US-130. On Google Street View, there are many truck trucks on the roadway.

There is a train station nearby on John Galt Way.

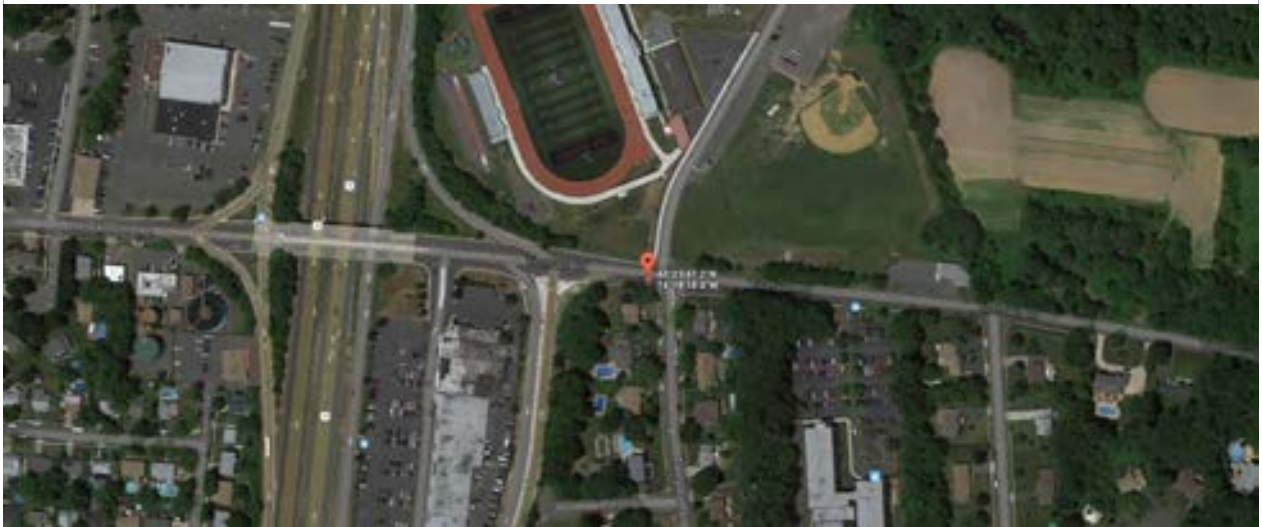
Figure 1. Overhead View of Site Map Link <https://goo.gl/maps/rkVTf>

On the westbound lane of Ticetown Road there is a 25mph speed limit painted onto the roadway, and a yield to pedestrians in crosswalk sign. Right at the intersection, there is a stop for pedestrians in crosswalk sign. It is unknown if this existed prior to the crash. On the eastbound lane of Ticetown Road there is also a pedestrian crossing sign at the crosswalks.

To the north of the intersection there is a school. To the south of the intersection is a residential area. To the west of the intersection are on and off ramps to Route 9. Route 9 has 4 lanes only on the bridge over that Route. There is a bus station to the east of the intersection.

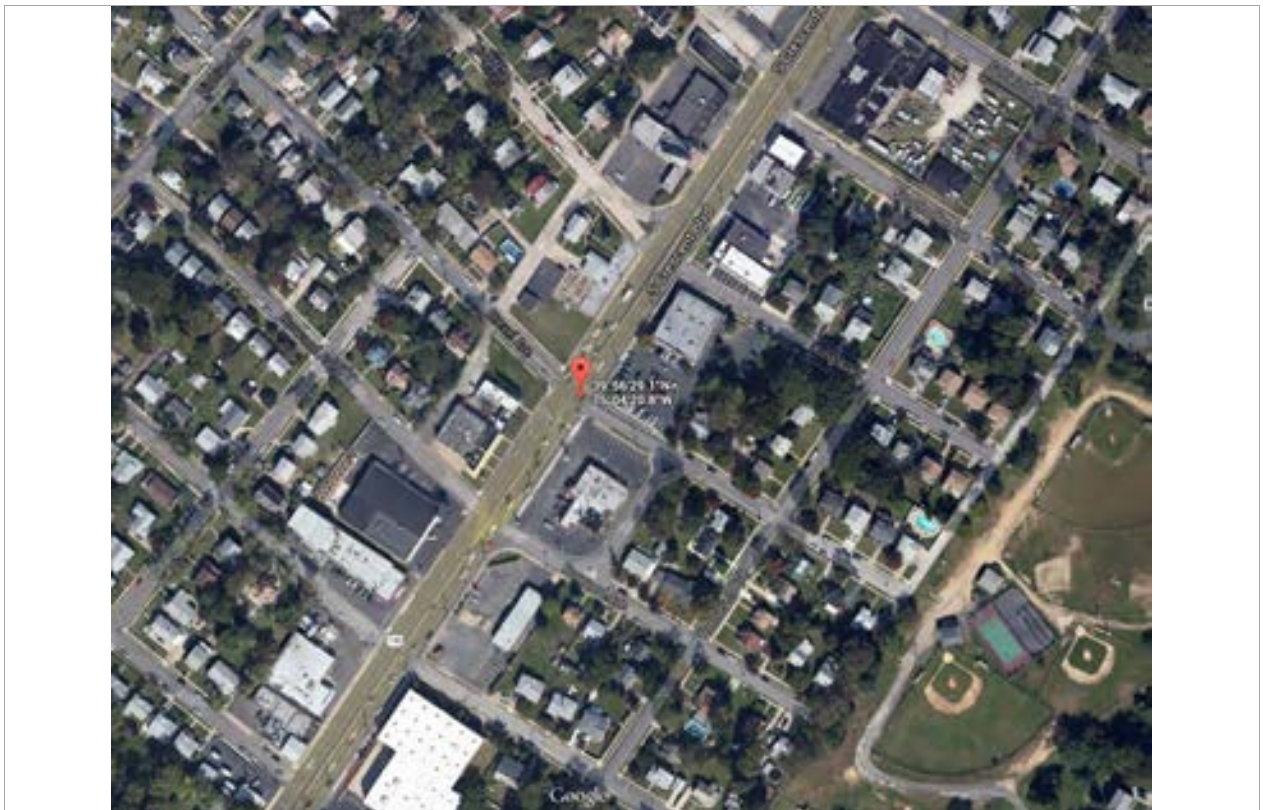
Figure 1. Overhead View of Site

This neighborhood looks suburban with mostly residential outside of the intersection. Along US-130 and at the intersection there are other commercial buildings.

At the intersection there is a bar on the southeast corner and there is an autoshop at the northeast corner. On the northwest corner there is a vacant lot. On the southwest corner there is a pool maintenance store

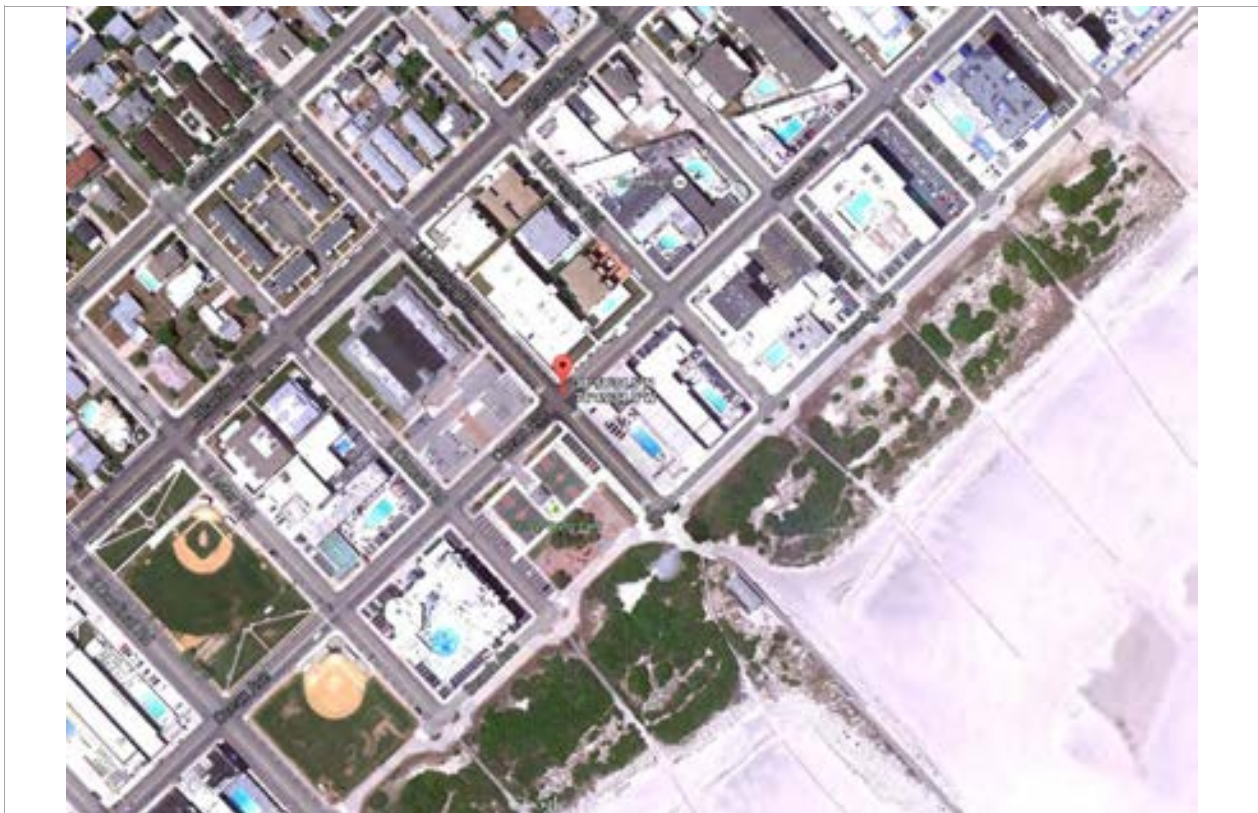
Figure 1. Overhead View of Site

On the northeast corner there is a hotel and on the northwest corner there is an apartment building. On the southwest corner there is a rec center, which has a large parking lot in front of it. On the southeast corner there is parking and basketball courts.

There are sidewalks on all corners and on both roads of the intersection. There are overhead streetlamps. There are no marked crosswalks but there are pedestrian crossing signs further down the road that go from the park to the rec center. There is street parking.

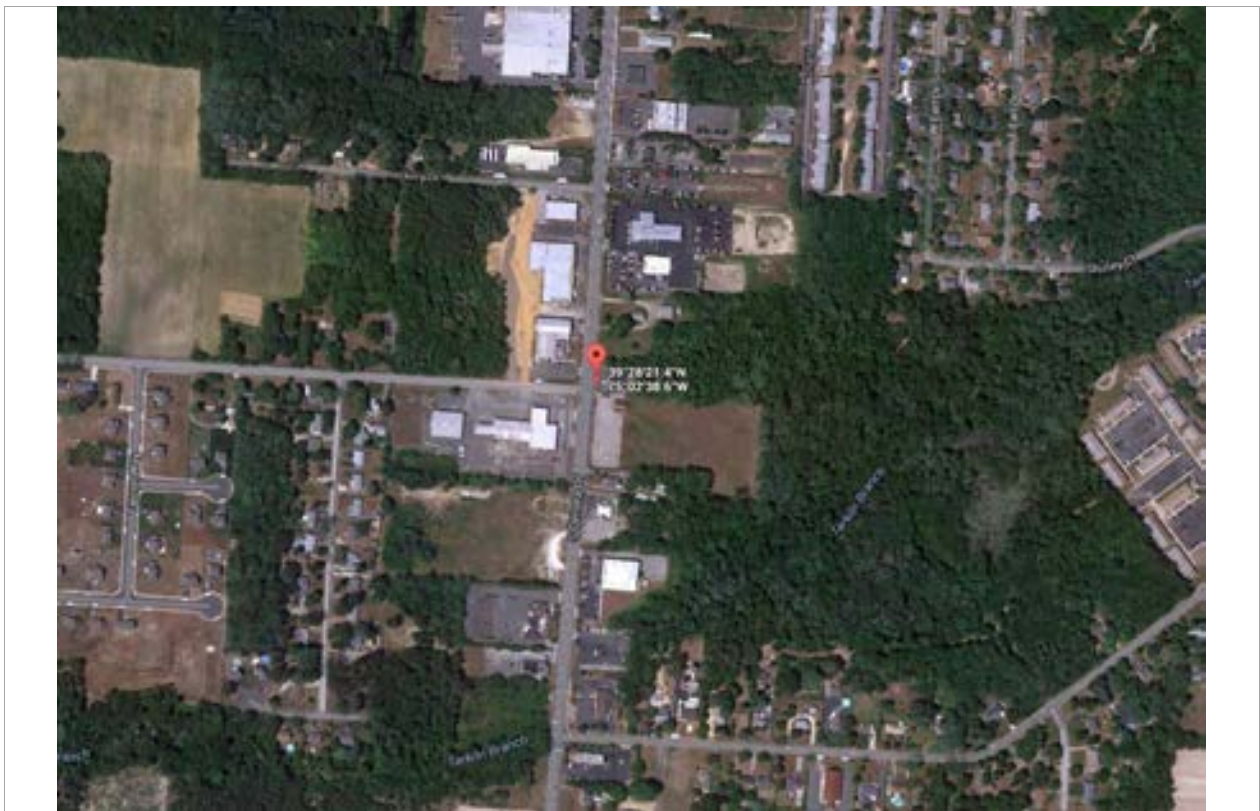
Figure 1. Overhead View of Site

Additional Infrastructure S Delsea Drive is a two lane roadway, which one southbound lane and one northbound lane. There are shoulders on either side of the road. The two lanes are separated by a dashed yellow line. There are no sidewalks. At the nearest intersection, there are no crosswalks or a traffic light.

The area seems to be suburban. There are some residential and cul-de-sac neighborhoods in the surrounding area. There is a heavily wooded area to the east of the accident. Delsea Drive seems to be an arterial road and there are commercial buildings along Delsea Drive.

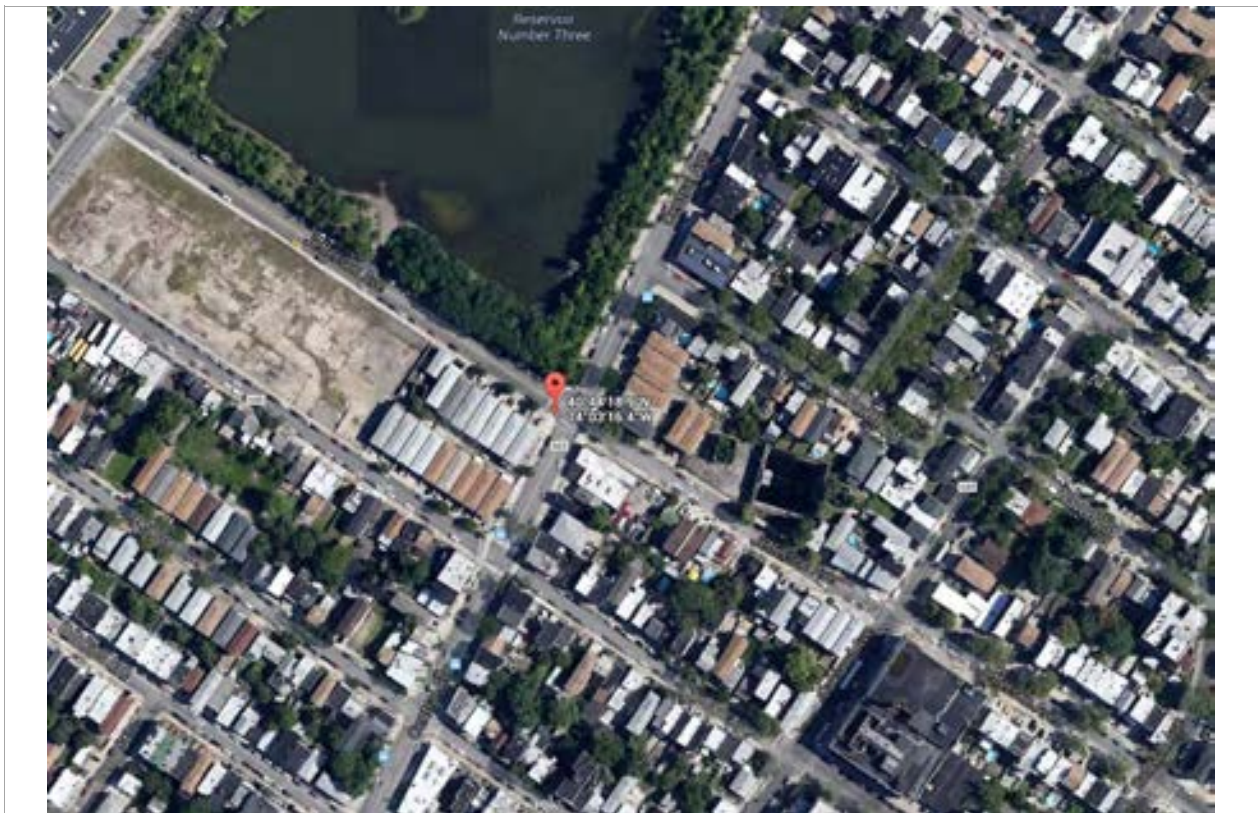
Figure 1. Overhead View of Site

The intersection is controlled with a traffic signal that did exist in 2012, but did not exist in 2007, according to streetview.

This area is urban, there is mixed residential and commercial use. There is a large reservoir on the northwest corner of the intersection.

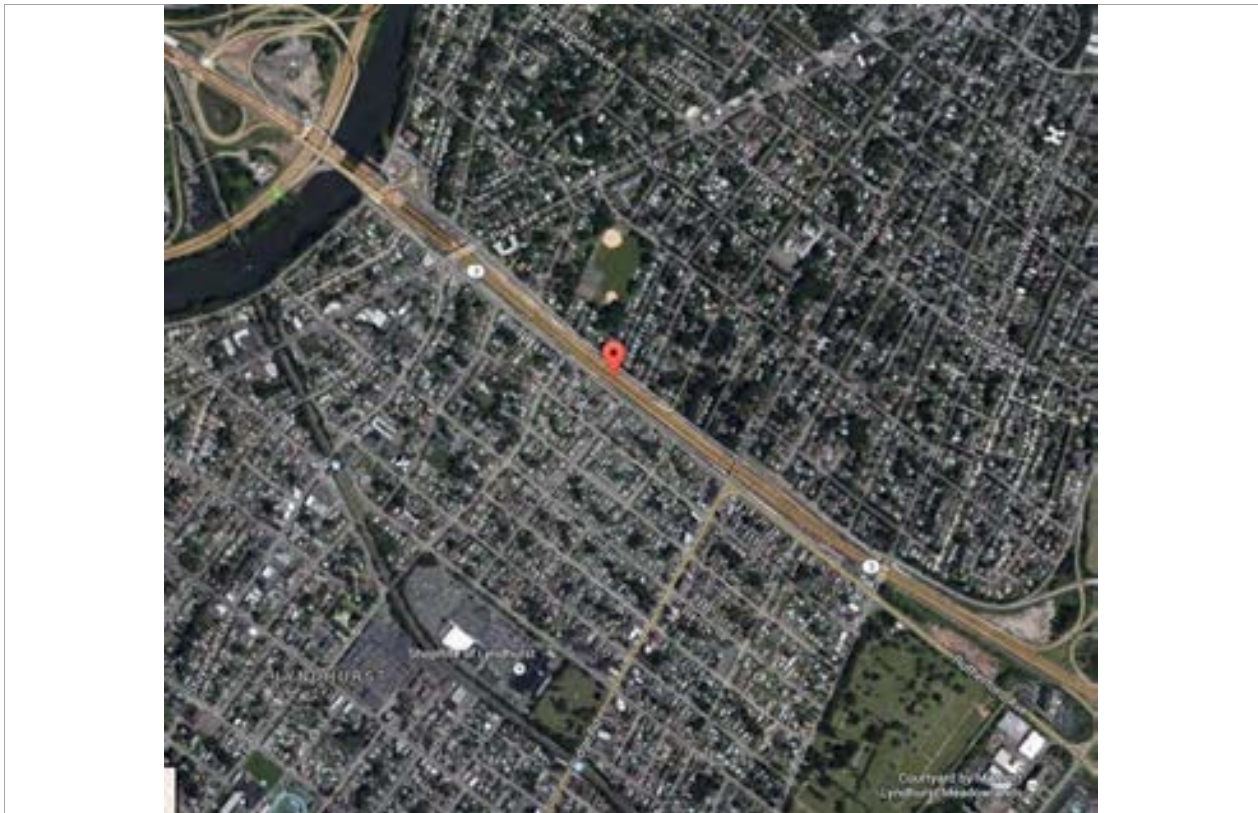
Figure 1. Overhead View of Site Map Link <https://goo.gl/maps/OjT8t>

Additional Infrastructure
 There is no detail of where the accident occurred on Highway 3.
 Highway 3 is a 6 lane highway, with 3 lanes traveling eastbound and 3 lanes traveling westbound. There is a cement barrier separating the lanes.
 The area surrounding the highway is very suburban and residential. Streetview shows construction in February 2013, unknown if there was construction at the time.

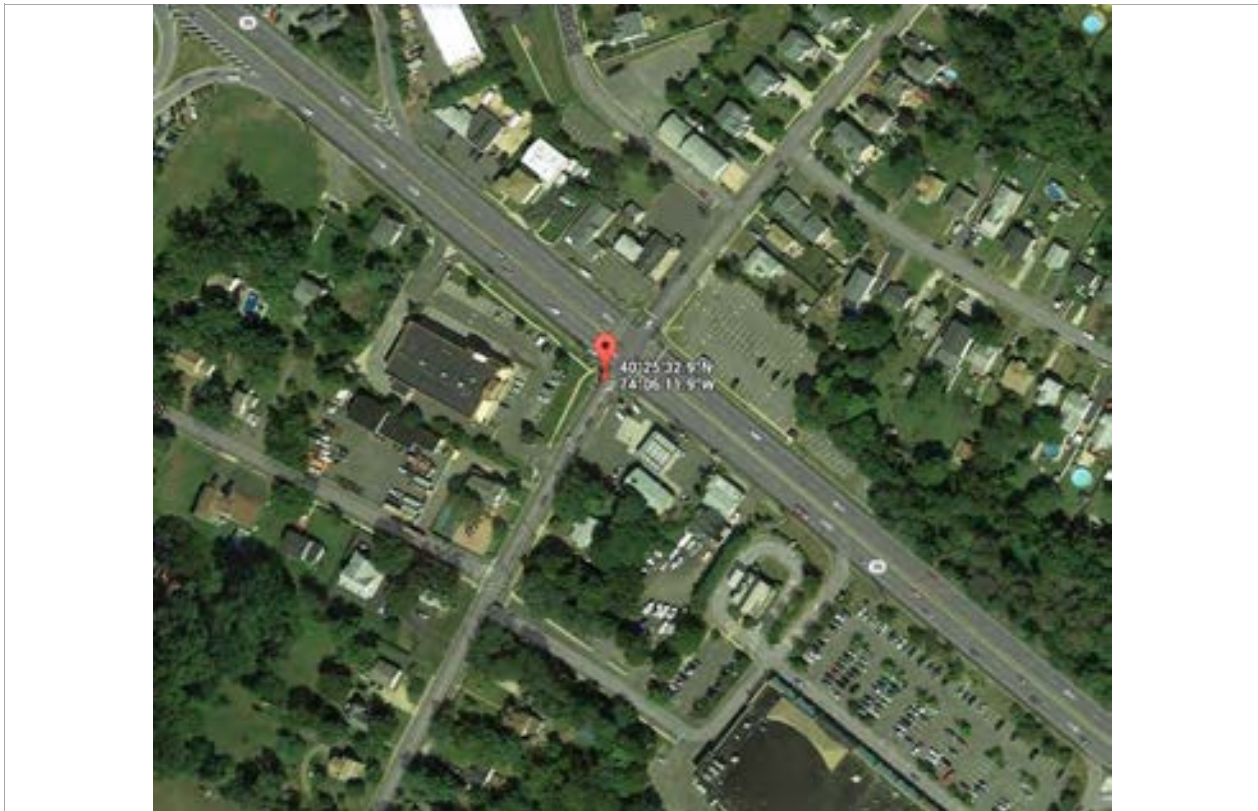
Figure 1. Overhead View of Site

There are overhead streetlamps on NJ highway 36.

In the surrounding area, it seems to be suburban residential. Along NJ highway 36, there are more commercial buildings.

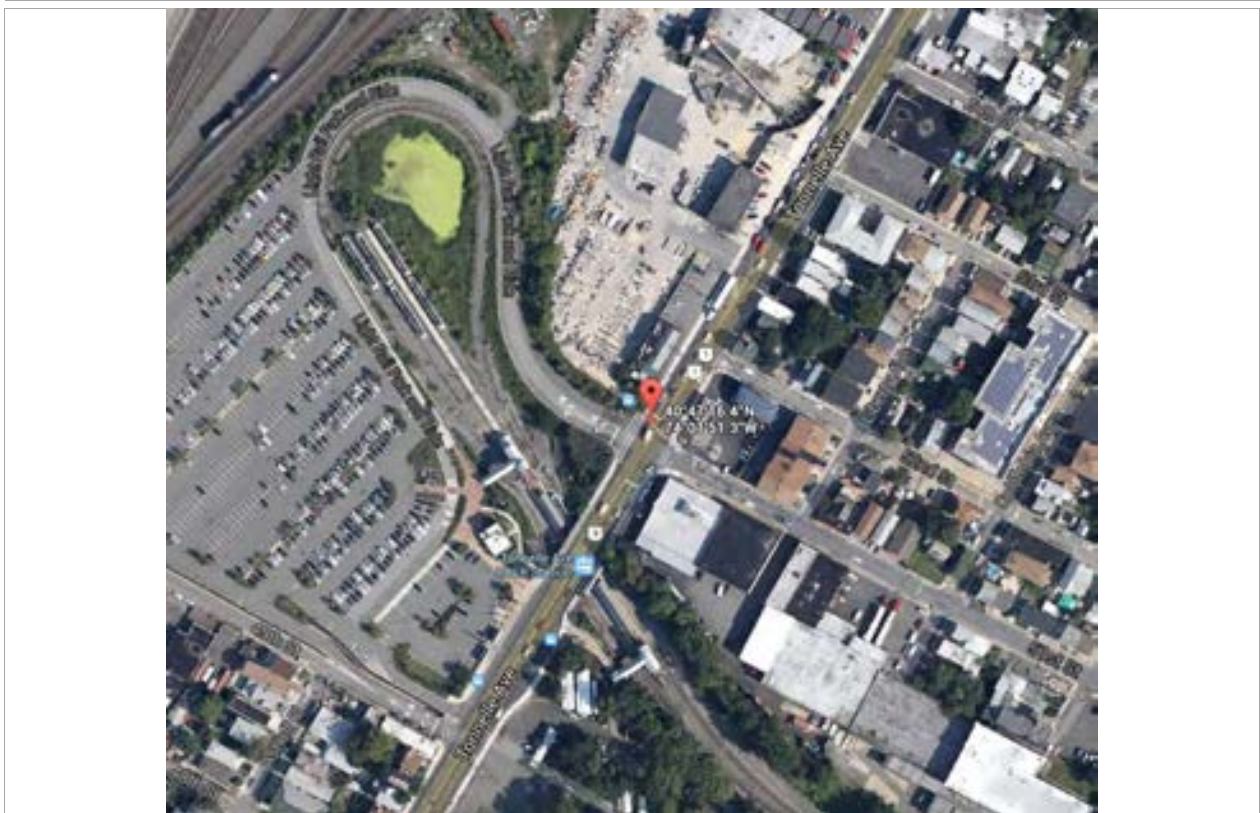
Figure 1. Overhead View of Site

There are traffic lights at all sides of the intersection. There are crosswalks and pedestrian signals on all sides of the intersection except for the south side of the intersection on US Highway 1. There are overhead streetlights.

The surrounding area seems to be a fairly dense residential area. The Tonnelle Ave Light Rail Park and Ride Station is to the west. There is a gas station on the northeast corner. There is a bar/restaurant on the northwest corner.

Infrastructure contribute?	<input type="text" value="Yes - High speed roadway (40mph) when there is a Park and Ride/ Light Rail and also high density residential area."/>								
Questions	<input type="text" value="Was the light actually green?"/>								
Supplemental	<input type="text" value="The report lacks detail, a diagram and any witnesses."/>

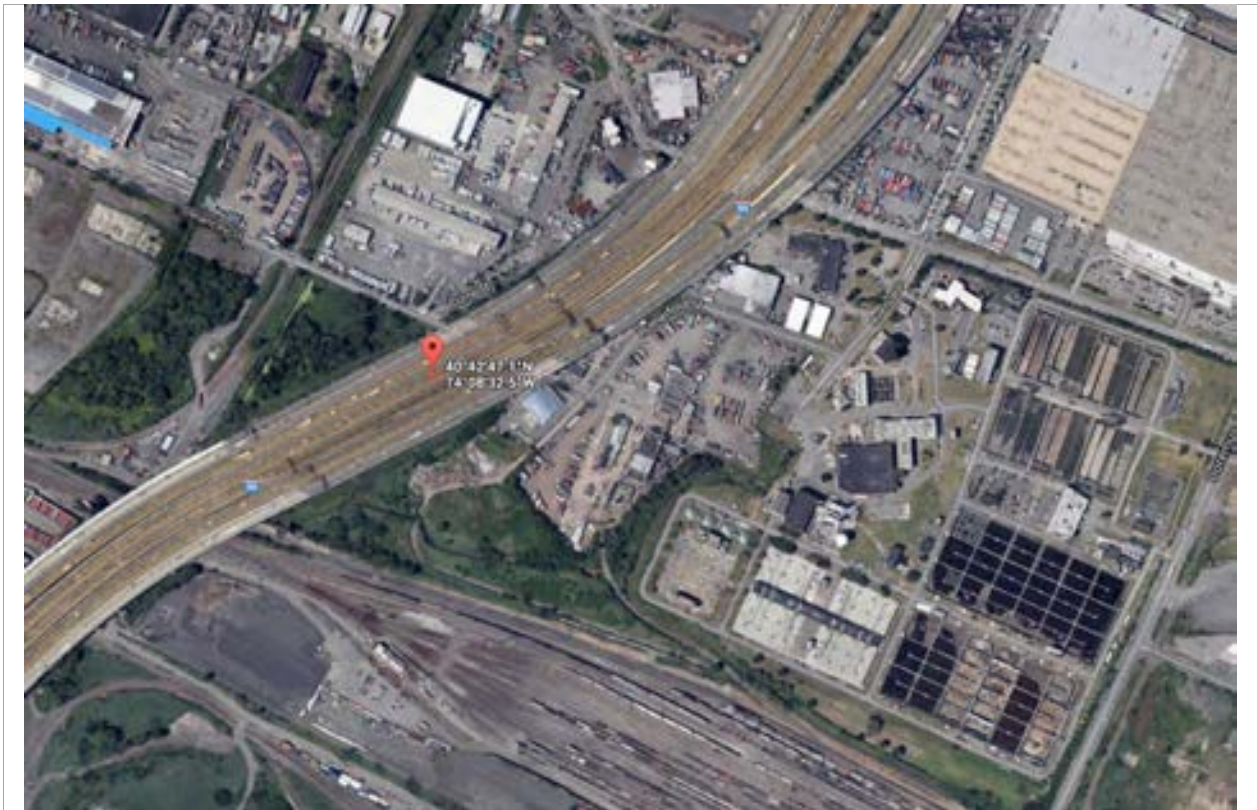
Figure 1. Overhead View of Site Map Link <http://goo.gl/maps/1bcp3>

There are overhead street lights on the street. There are shoulders on both sides of each roadway. There are no sidewalks.

The surrounding area is mostly industrial and warehouses/ storage facilities. To the west and east of where the incident occurred, there are small wooded areas

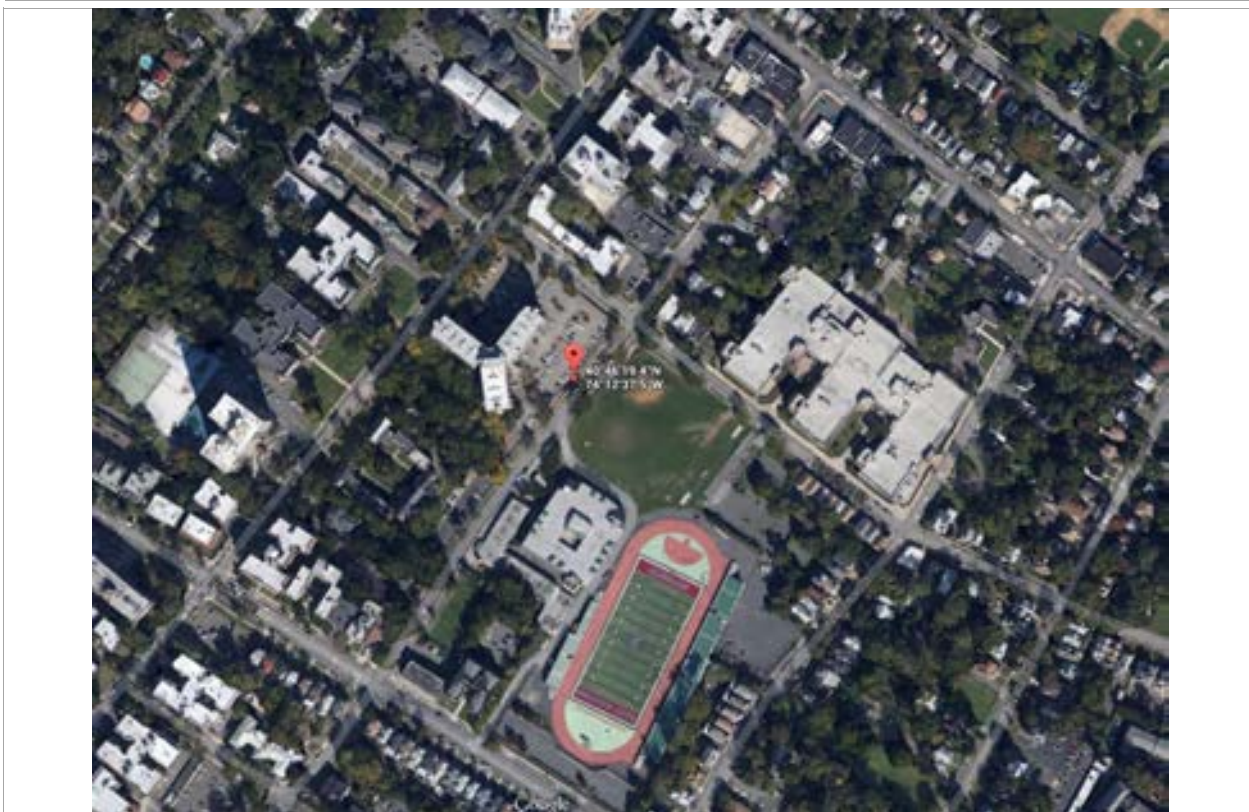
Figure 1. Overhead View of Site

On the road, it says "School" in white paint. There are also dashed white lines going across southbound lane. These are either rumble strips or just to denote that the speed should decrease.

The area surrounding the incident seems to be fairly dense. There looks to be residential neighborhoods to the east and more commercial buildings to the west

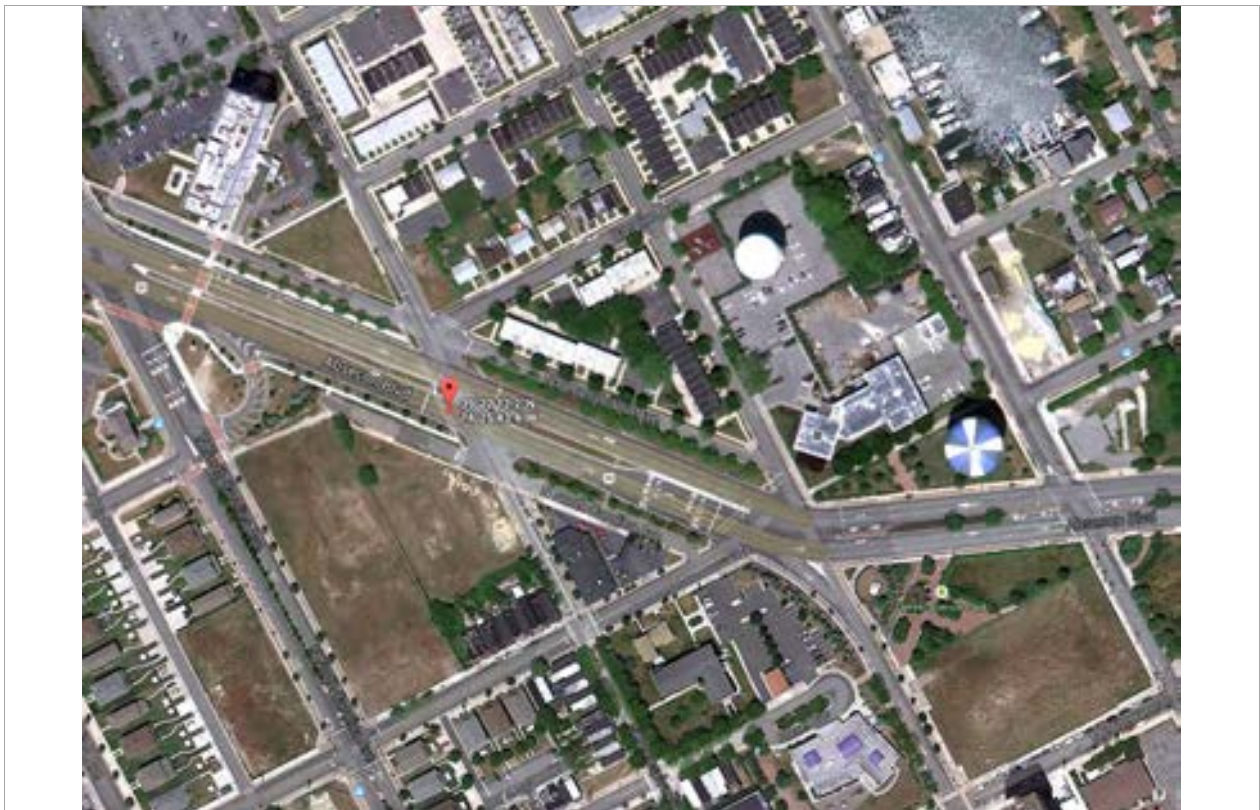
Figure 1. Overhead View of Site Map Link <https://goo.gl/maps/2f3wf>

There are crosswalks across all 8 lanes of traffic on the west side of the intersection. There are traffic lights on all 4 sides of the intersection. There are pedestrian crosswalk buttons at every median.

The area surrounding the accident looks residential. There is an apartment building to the north, where the video footage was taken from. There is a grassy field south of the intersection. There also looks to be more commercial areas to the east of the intersection

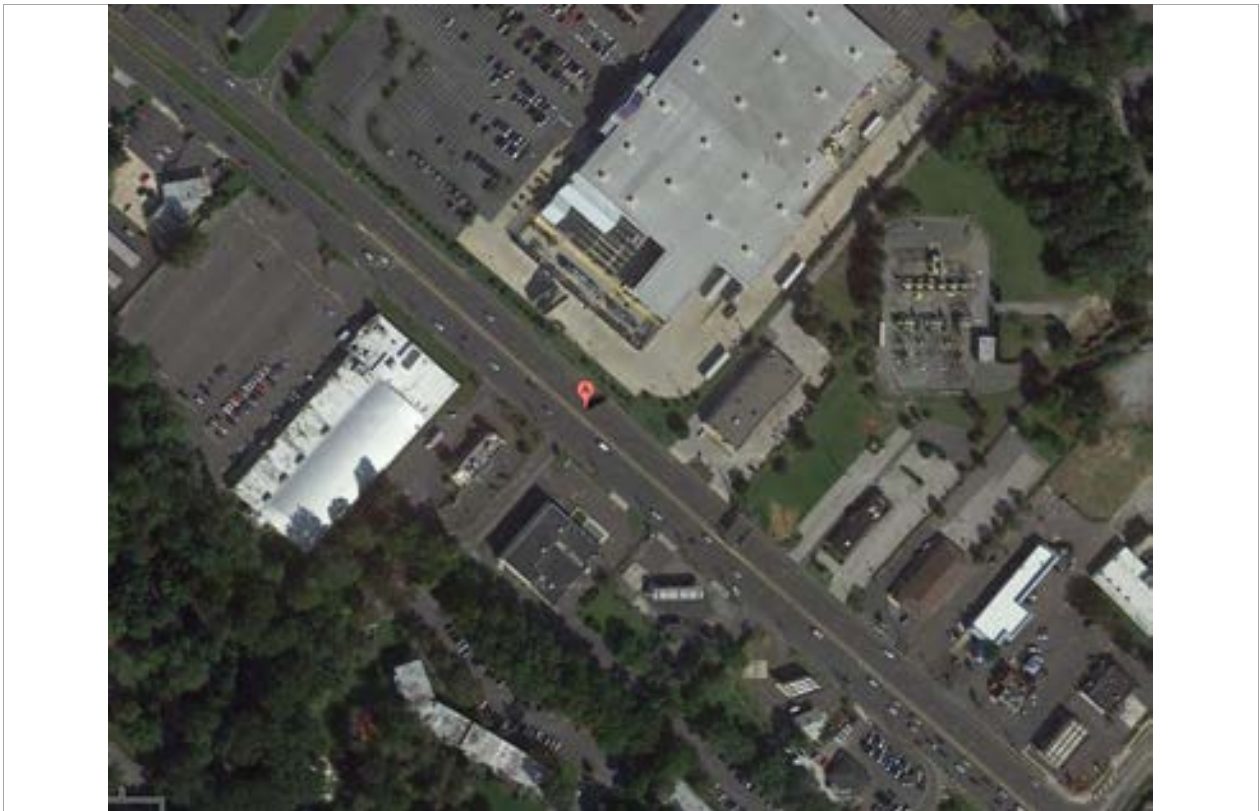
Figure 1. Overhead View of Site Map Link <http://goo.gl/maps/LOIM2>

The highway is strip commercial, with a mix of businesses such as Lowes, a bowling alley, gas stations, etc. There are nearby motels that were been used as housing for Sandy victims.

Roadway is designed for high speeds, and there are no streetlights

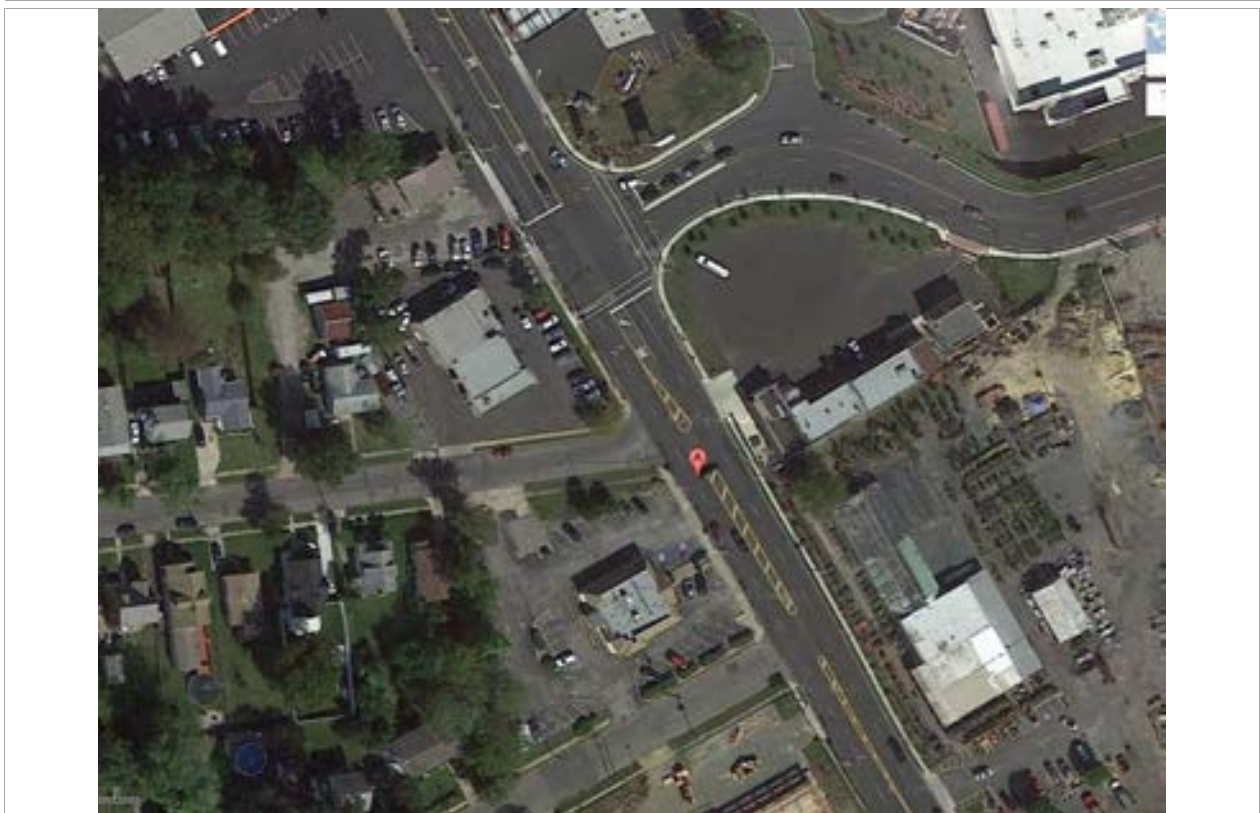
Figure 1. Overhead View of Site

The closest streetlight, 97 feet away, was not working. The nearby businesses did not add lighting to the roadway.

East Washington Avenue terminates at South White Horse Pike with a stop sign. There is a gap in the painted median for turning traffic but not crosswalk. The nearest crosswalk was 160 feet north at a signalized T intersection.

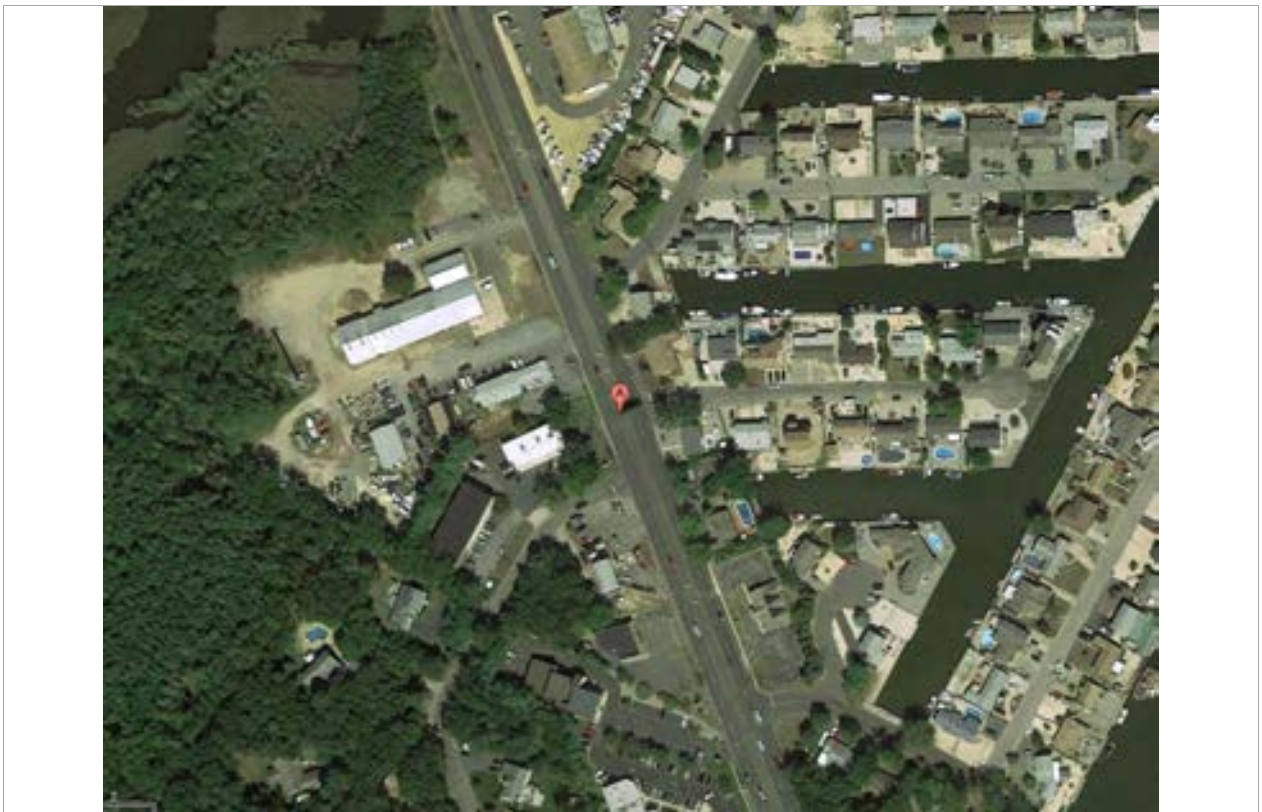
Figure 1. Overhead View of Site

Additional Infrastructure Flischer Boulevard is 2 lanes in either direction with a turning lane in the center. There are no crosswalks crossing this road and there are no sidewalks on the sides of this road. There are also very few street light. The area is mostly residential, aside from a nursery school.

Capstan Driver terminates on Flischer with a stop sign. It is a very minor residential cul-de-sac.
