Appendix A

Individual Summaries of all 2012 New Jersey Pedestrian Fatalities

New Jersey Bicycle and Pedestrian Resource Center

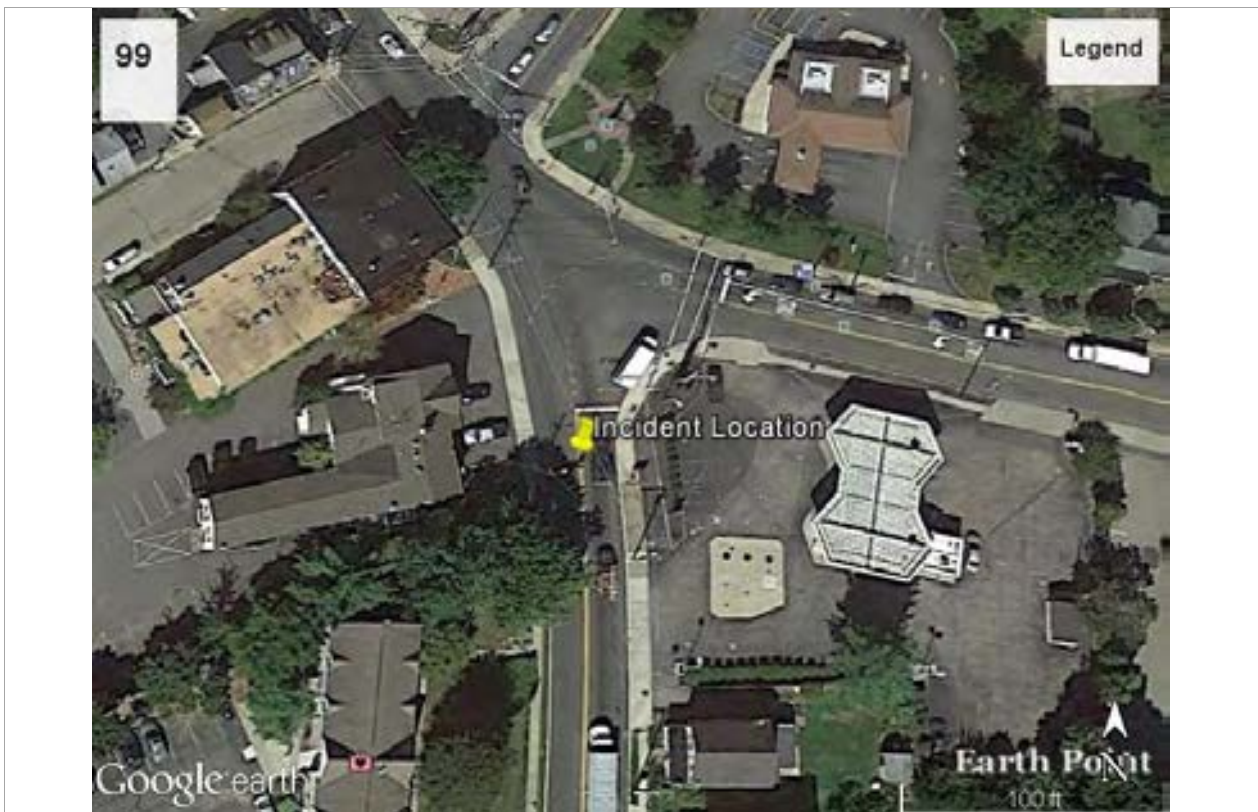
Figure 1. Overhead View of Site Map Link <https://goo.gl/maps/3s3CJ>

Additional Infrastructure Collision occurred on Mountain Avenue (Nj Highway 182) which is a roadway divided by a double yellow line. Incident occurred 100 feet south of a complicated 5-road intersection. Although that intersection is signal controlled, there is no marked crosswalk across Mountain, and location of signals appears to be confusing. The intersection has various auto-oriented businesses, including gas station and drive-thru bank. Surrounding area is suburban residential.

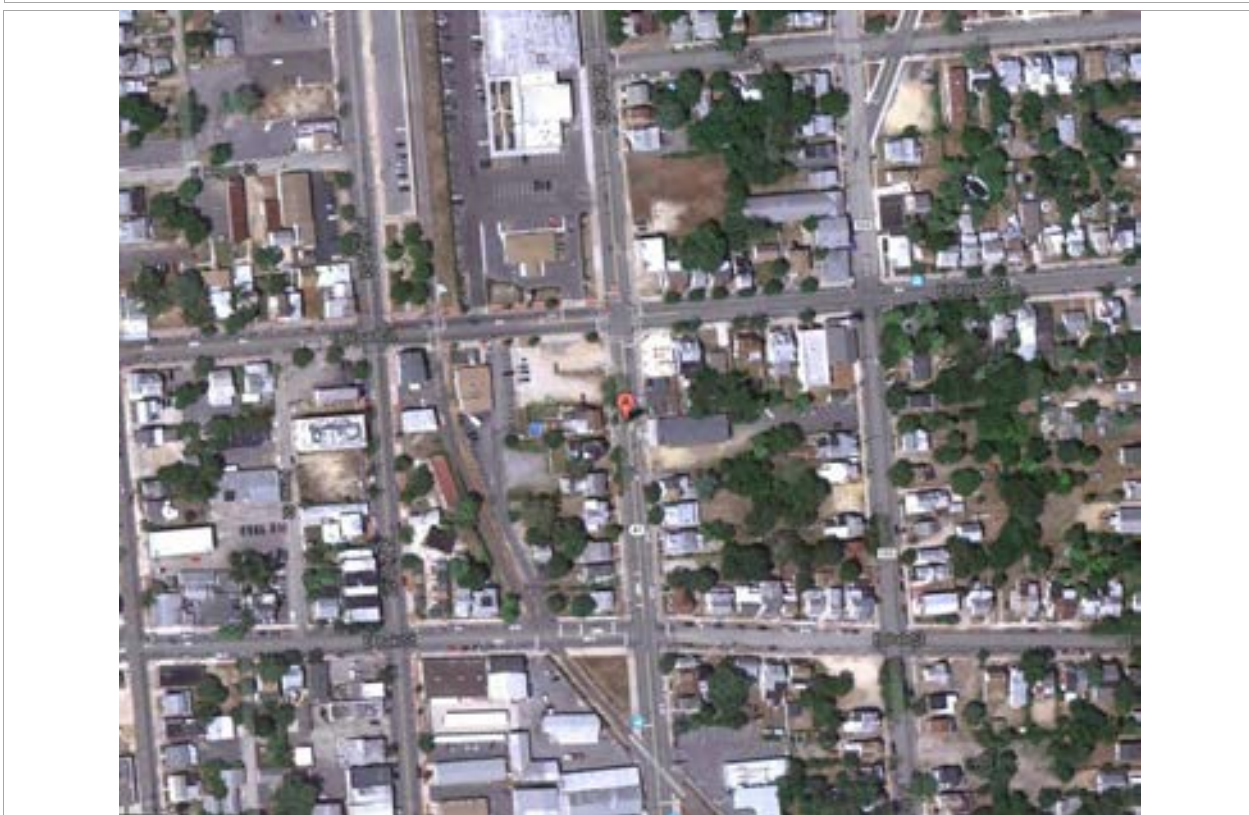
Figure 1. Overhead View of Site Map Link <https://goo.gl/maps/AX8MV>

Adjacent land use is multi- family detached residential, which appears to be low-income in nature. There is also a Dollar Plus Food Mart immediately adjacent to crash location, and a custard shop next to it.

There are streetlights on some utility poles but report says it was very dark and unlit. Closest light was 100 feet south.

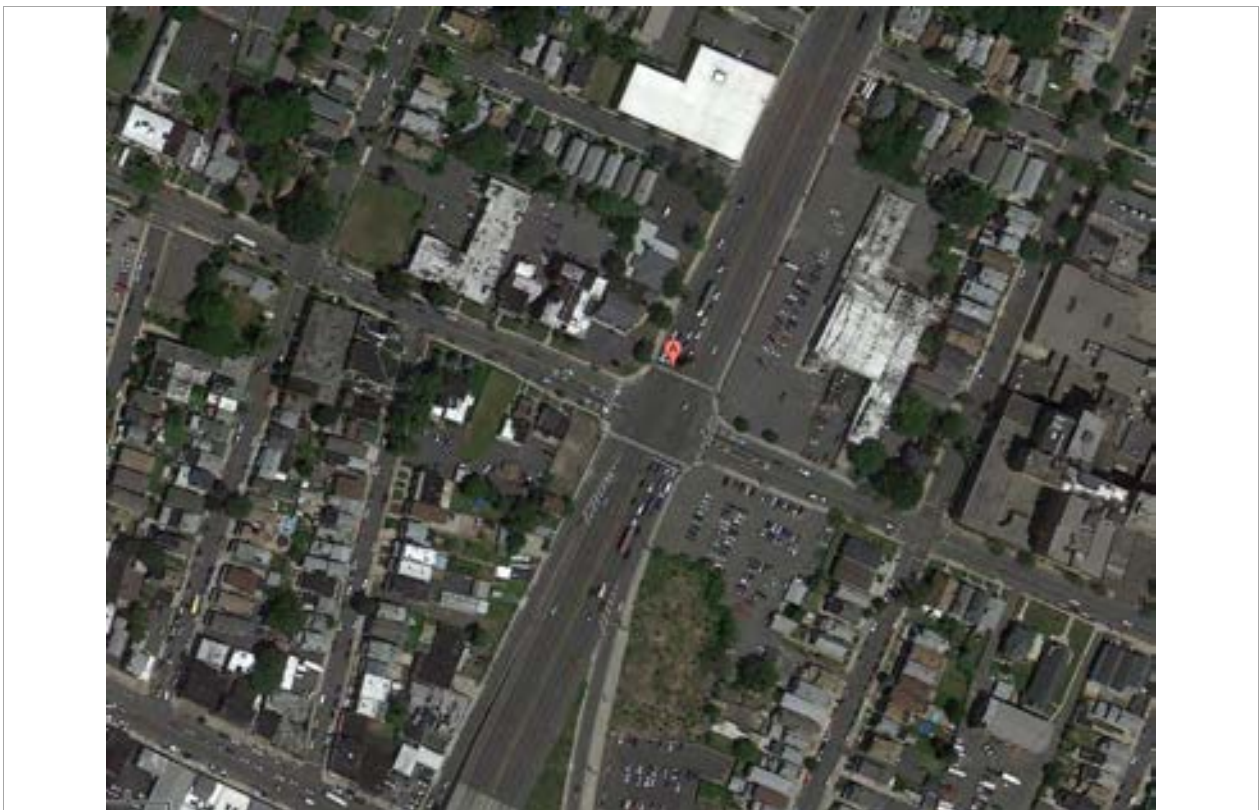
Figure 1. Overhead View of Site

There are sidewalks in all directions, and ladder-style crosswalks on all legs. There are four streetlights at the intersection.

Land use is a mix of strip commercial and residential, with surface parking lots on 3 of the corners of the intersection, and a vacant parcel on the fourth.

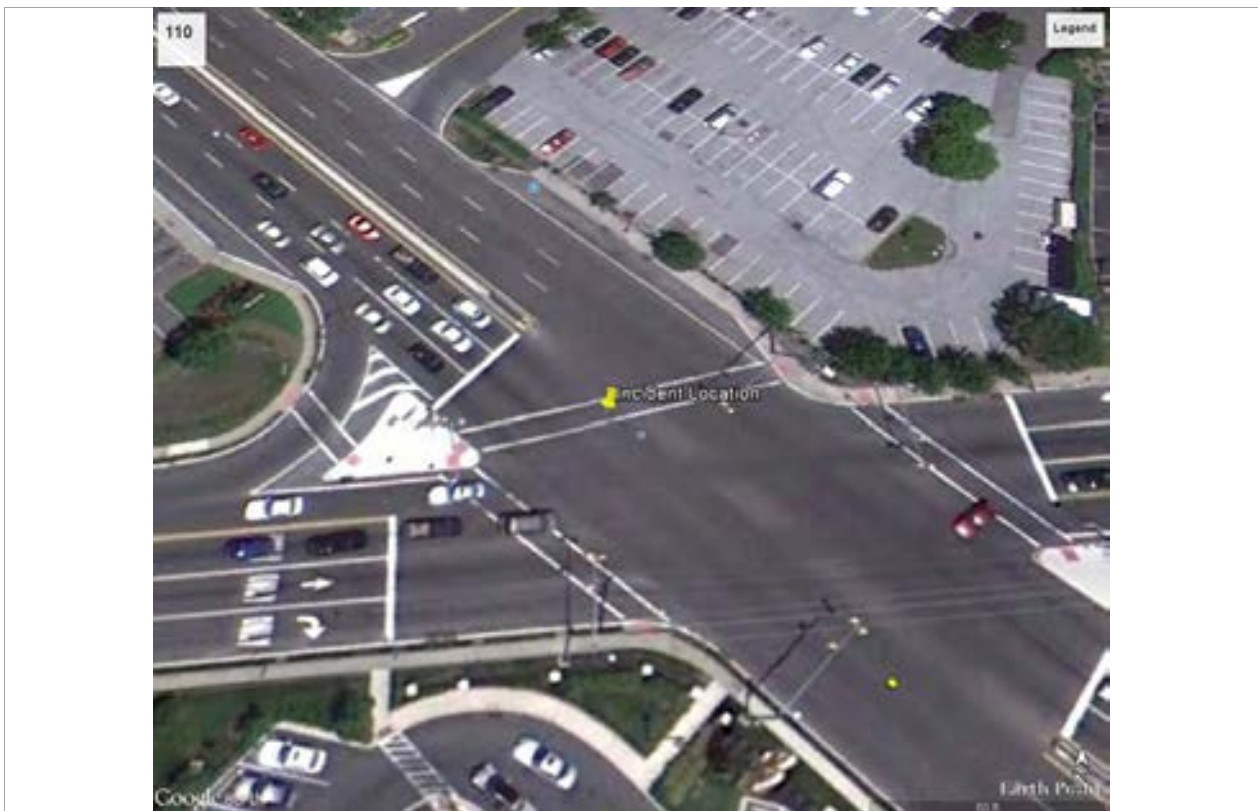
Figure 1. Overhead View of Site Map Link <https://goo.gl/maps/jUMA7>

There are two pedestrian islands in this intersection on opposite corners from each other. These islands are created by right turn slip lanes off Route 30 and onto Mill Road.

On this roadway are many commercial strip malls. At this intersection there is a McDonald's, a supermarket and a bank. There is a small grassy area at the southeast corner of the intersection

Fault Details	<p>The pedestrian was crossing the street against the "Don't Walk" sign and should have waited until the sign changed in his favor. The driver entered the intersection on a green light and had the right of way.</p>								
Interpretation	<p>The pedestrian elected to walk against the light. There are 6 lanes of traffic, the crosswalk is angled, and there is no median refuge, making it difficult to walk across. The driver stated he never saw the pedestrian, and the two witnesses stated that they thought the vehicle had hit a garbage bag. This indicates that lighting is very poor.</p>								
Infrastructure contribute?	<p>Yes - Very wide intersection with angled crosswalk and no median refuge. Poor lighting.</p>								
Questions	<p>Is the lighting sufficient? Do the ped signals work? Are the ped signals automatic?</p>								
Supplemental

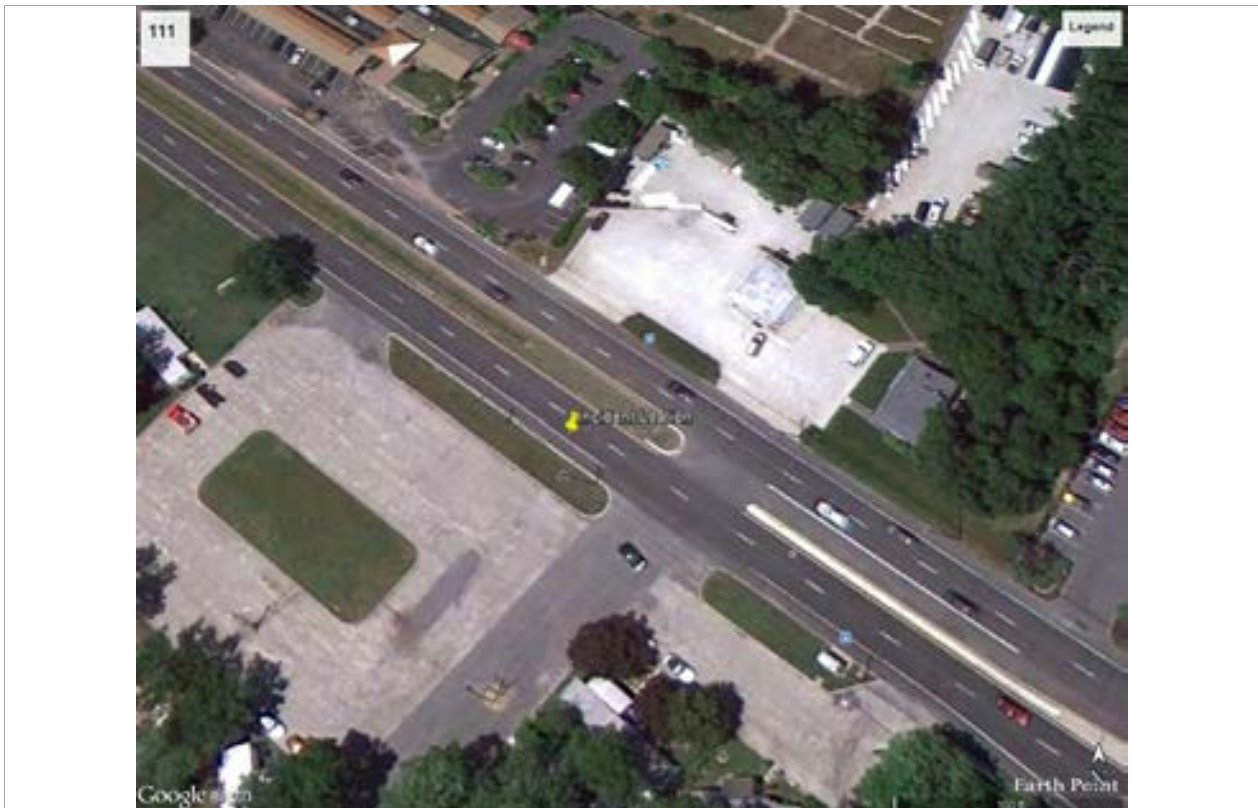
Figure 1. Overhead View of Site

The properties on the south side of the roadway consist of a trailer park. The turning lane leads to their driveway.

There are no sidewalks or crosswalks in the area. There is an NJ Transit bus stop with shelter in a grassy area.

Interpretation The pedestrian must have been either intoxicated, drugged or had a mental condition that would lead to this accident. If the area had been better lit the driver could have seen the pedestrian sooner and avoided this accident. It is doubtful that sidewalks would have prevented this death, although some are certainly needed to access the bus stop.

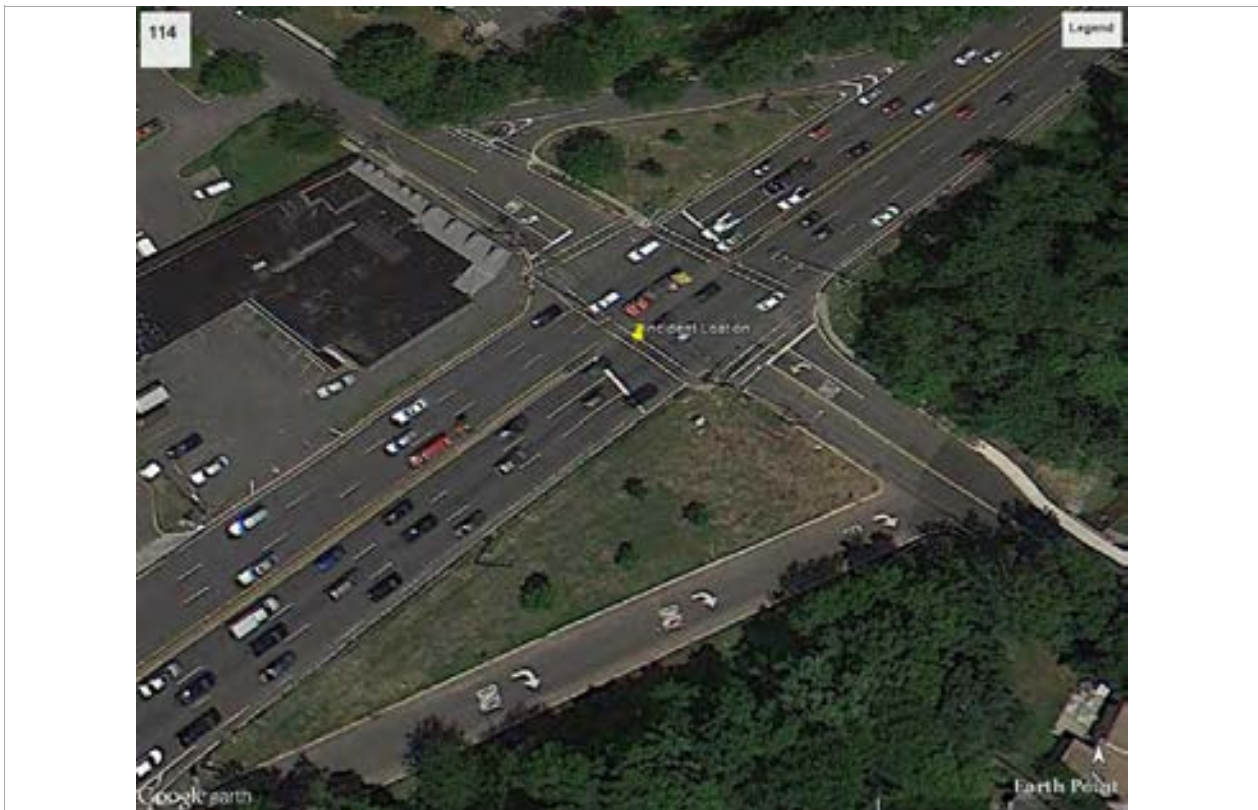
Figure 1. Overhead View of Site Map Link <https://goo.gl/maps/OXYx6>

On either side of Rt 22 continuing northeast, there is a wooded area which acts as a buffer to the residential neighborhoods. The north side has multiple garden-style apartment complexes, while the south side is mostly made up of detached homes. To the south, there is strip commercial on the north side of Route 22.

There is a single streetlight at the intersection. CAIT data reports that it was not on at the time of the incident.

Police Reported Fault	<input type="text"/>	Hit and Run	<input type="checkbox"/>	Ped Clothes	<input type="text"/>	Ped Out of Nowhere	<input type="checkbox"/>	Did Not See Ped	<input type="checkbox"/>
Police Findings	Vehicle was traveling East on Route 22 in the left lane. The pedestrians were travelling south to north in the crosswalk. No other details in report.								
Fault Details	There were no charges made against the driver. Plan4Safety says "dark clothing, failed to obey traffic control device, and crossing at marked crosswalk"								
Interpretation	It is unclear whether the pedestrian had a crossing signal. The report code indicates that the pedestrian failed to obey traffic control device, but we are missing two pages and any narrative.								
Infrastructure contribute?	Yes - Wide intersection, pedestrians have to cross 6 lanes of traffic with no center median to wait in. Speed limit is 50 mph, only two corners have sidewalks

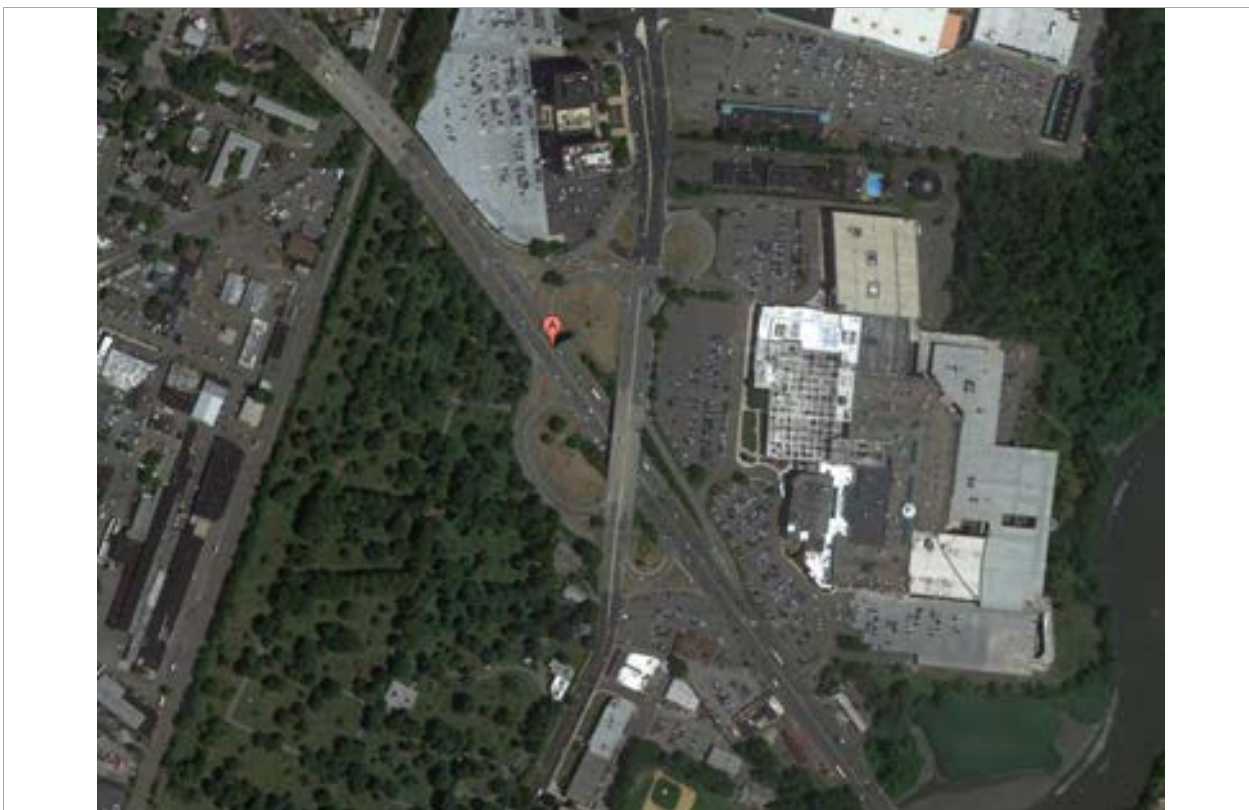
Figure 1. Overhead View of Site

There are overhead streetlights along the side of the highway.

There is a cemetery to the west of the highway. To the east of the highway on the north are three 10-story office towers surrounded by extensive parking. To the east on the south there is a mall – The Shops at Riverside.

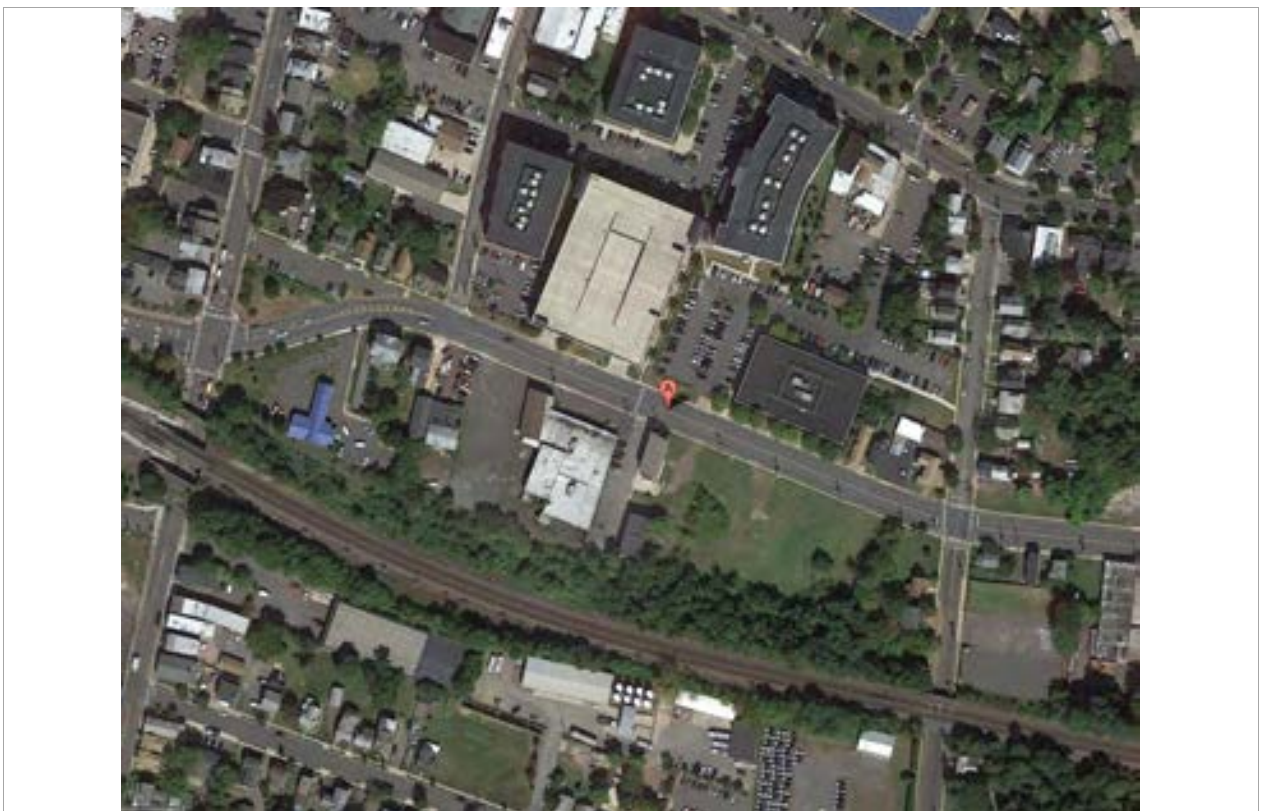
Figure 1. Overhead View of Site

There is one residence in the area and is on one corner of the intersection. The opposing corner has commercial buildings and across the highway is a large parking garage and what seems to be an office building.

There are a few street lights on the telephone polls over the highway for light. The incident occurred around 6:30 pm in the rain.

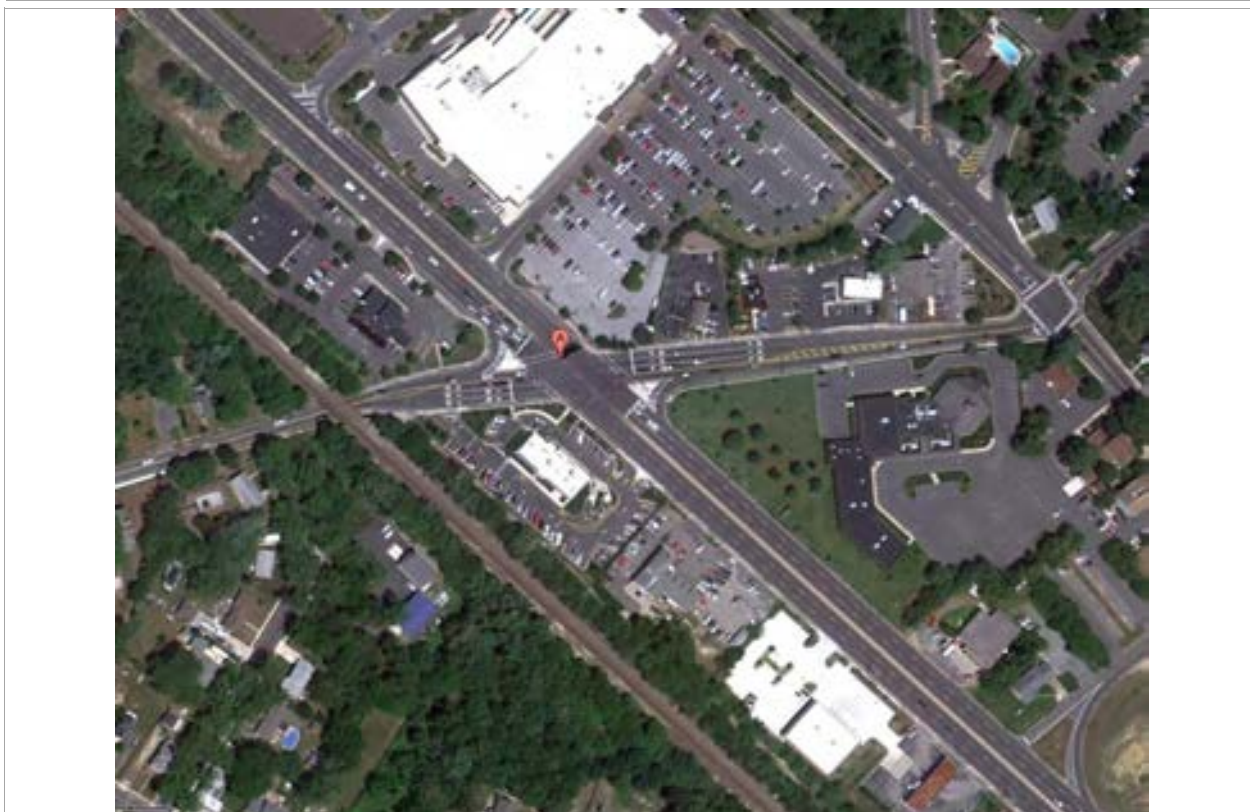
Figure 1. Overhead View of Site

There are overhead street lamps on the roadway.

The area surrounding Rt 30 is very commercial. At this intersection there is a McDonald's, a pharmacy, a bank and a grocery store

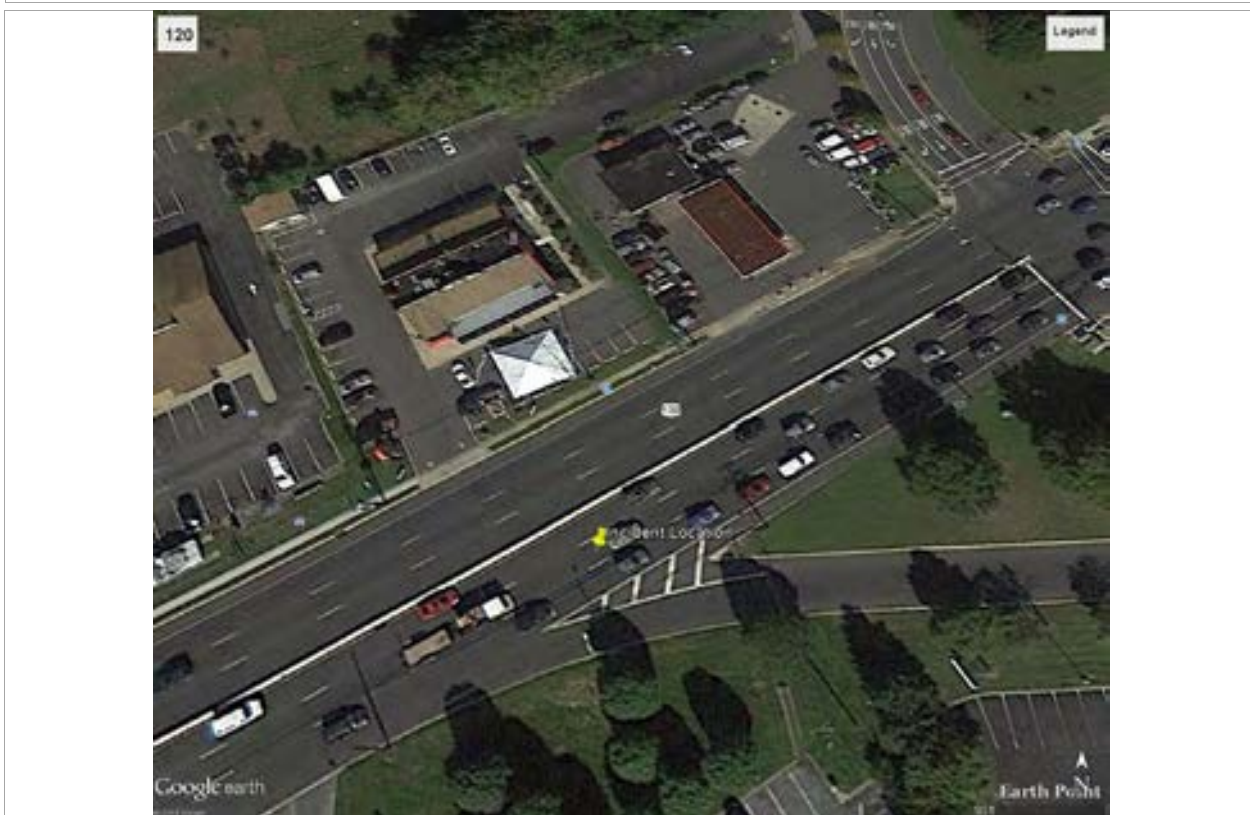
Figure 1. Overhead View of Site Map Link <http://goo.gl/maps/hgcgw>

To the east of the roadway are apartment buildings. Along Rt 30, there are multiple commercial buildings like restaurants and an auto body store.

There is a sidewalk along the southbound lane, but not next to the northbound lane.

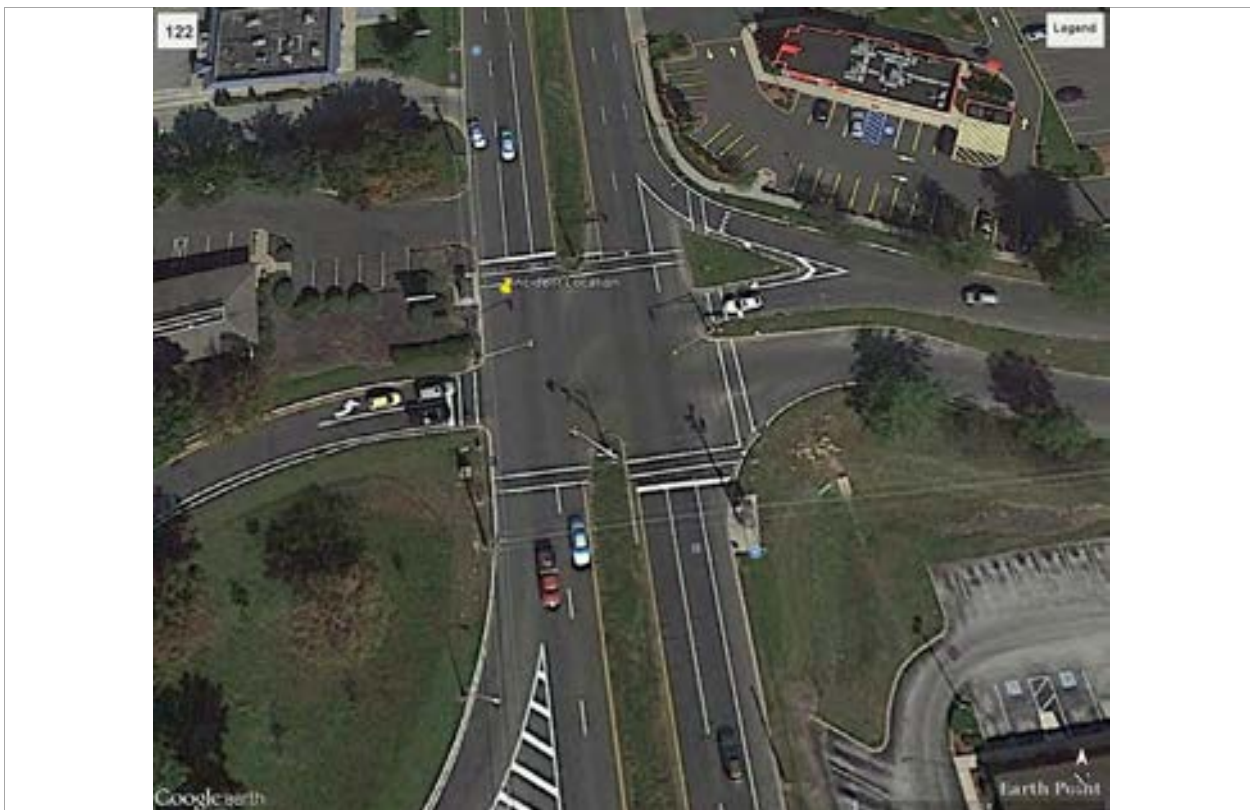
Figure 1. Overhead View of Site Map Link <https://goo.gl/maps/ymH9o>

The surrounding area is strip commercial, with many fast-food locations along the highway. Beyond that, it is suburban residential.

There are two streetlights near the intersection, but not directly over it.

NJ Transit bus stop sign is located 150 feet before shelter in what appears to be an old stop location.

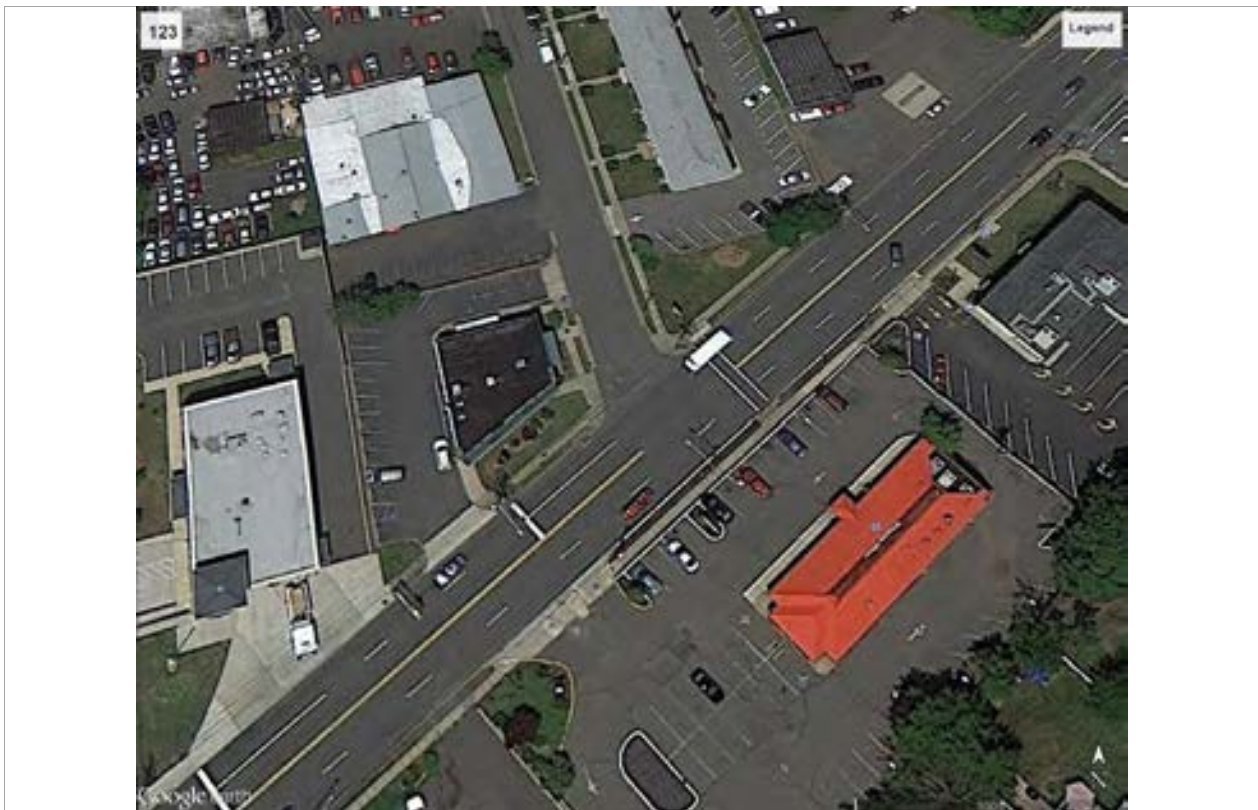
Figure 1. Overhead View of Site Map Link <http://goo.gl/maps/F0teW>

Casey Avenue is a very minor road with no line markings. It terminates at 27 from the north with a stop sign. There is a single transverse crosswalk across 27 on the east side of the intersection. There is no advance signage of the crosswalk. All streets have sidewalks, and there is no on street parking.

There are overhead streetlamps. The surrounding area seems to be commercial along the roadway, with residential buildings to the west. The east side of the intersection has a large Pizza Hut with surface parking.

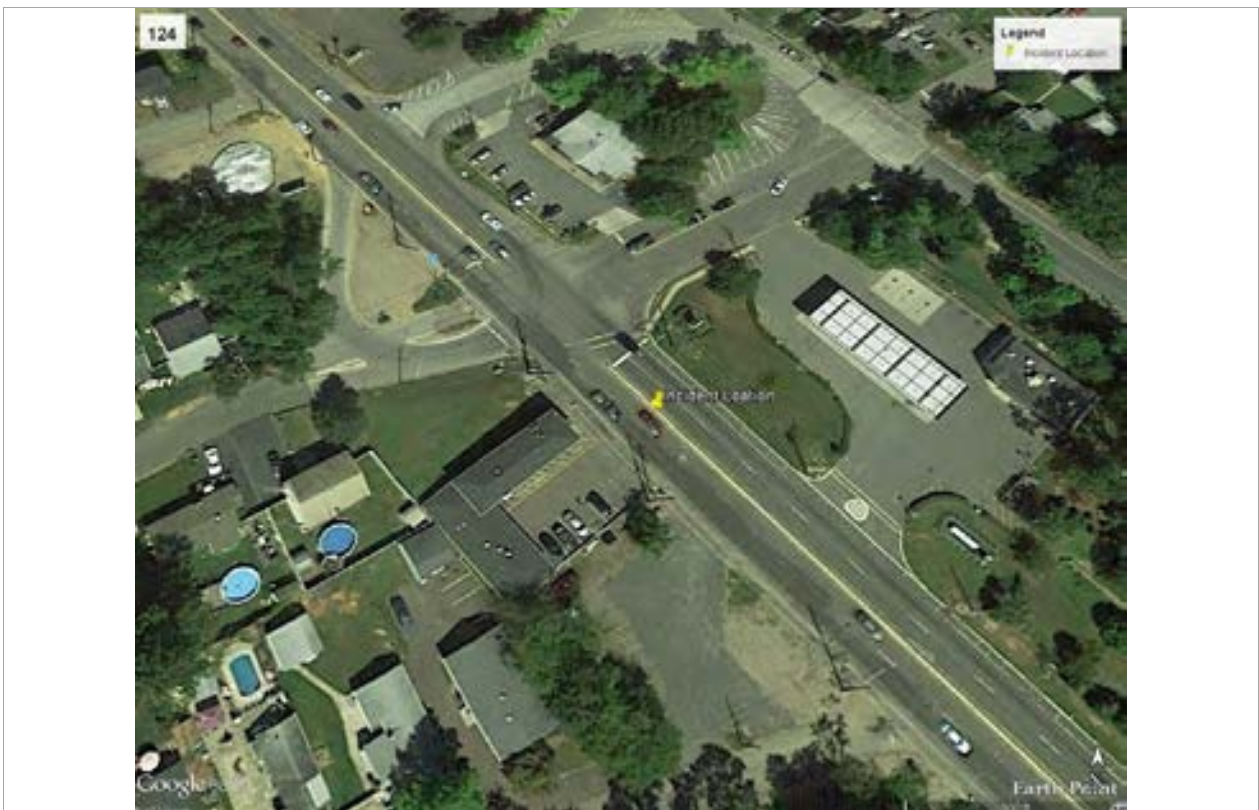
Figure 1. Overhead View of Site

There are overhead street lights. The condition of the infrastructure appears to be poor, with outdated traffic signals, uneven pavement, and faded lane markings.

There are residential communities on both sides of the road, but Rt. 35 has commercial buildings along it. There is a 7-11 at the northeast corner of the intersection.

Infrastructure contribute?	<input type="text" value="Yes: Lack of sidewalks and no pedestrian signals at intersection"/>								
Questions	<input type="text" value="Were the overhead street lights on?
Was traffic light green?
Where is a pedestrian supposed to cross on the north side of the street? If the pedestrian wanted to be on the north side of the intersection there is no way to get there (only crosswalk across 1 side of intersection)."/>								
Supplemental	<input .="" blank."="" but="" included="" is="" page="" second="" the="" type="text" value="The report stops mid-sentence and there is no information on the second page of the report. Diagram says 'Incomplete"/>

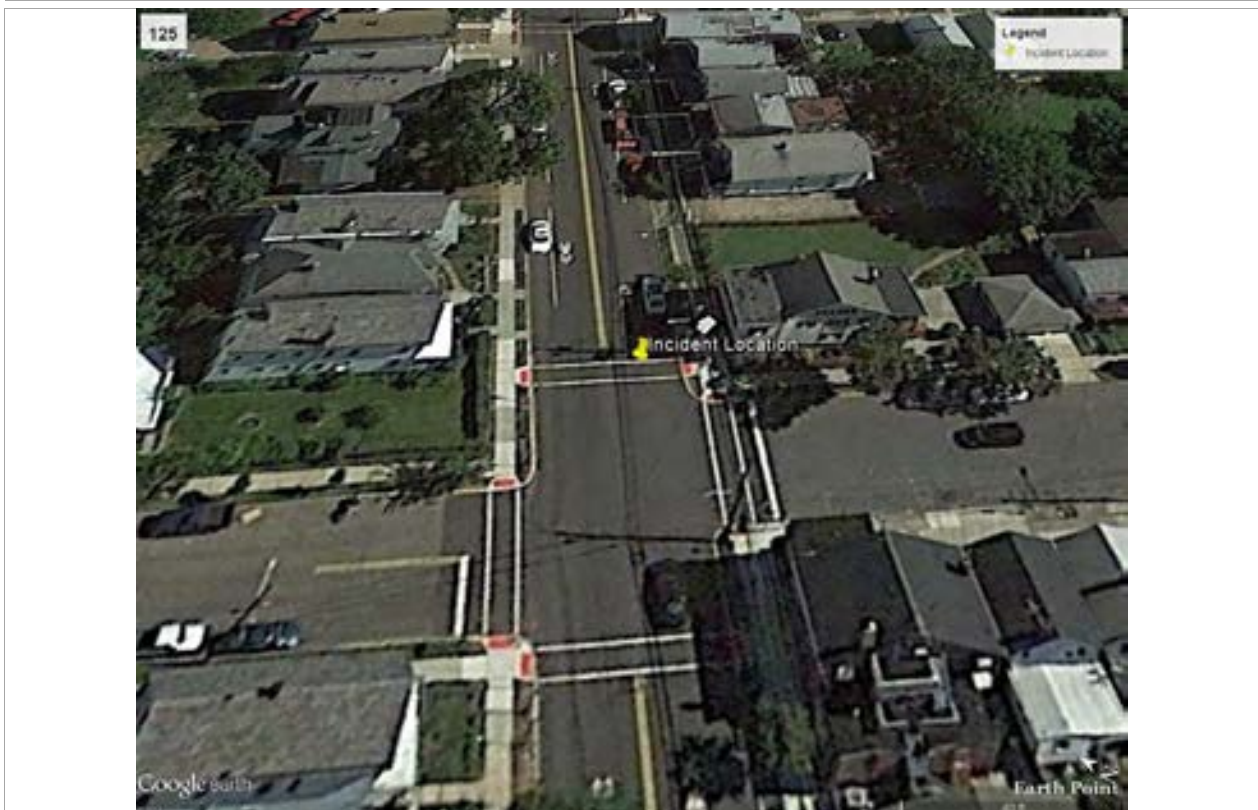
Figure 1. Overhead View of Site

There are sidewalks and streetlights in all directions.

The surrounding area is urban mixed use.. There are both residential and commercial buildings, some buildings contain both, including a small food market on the south corner.

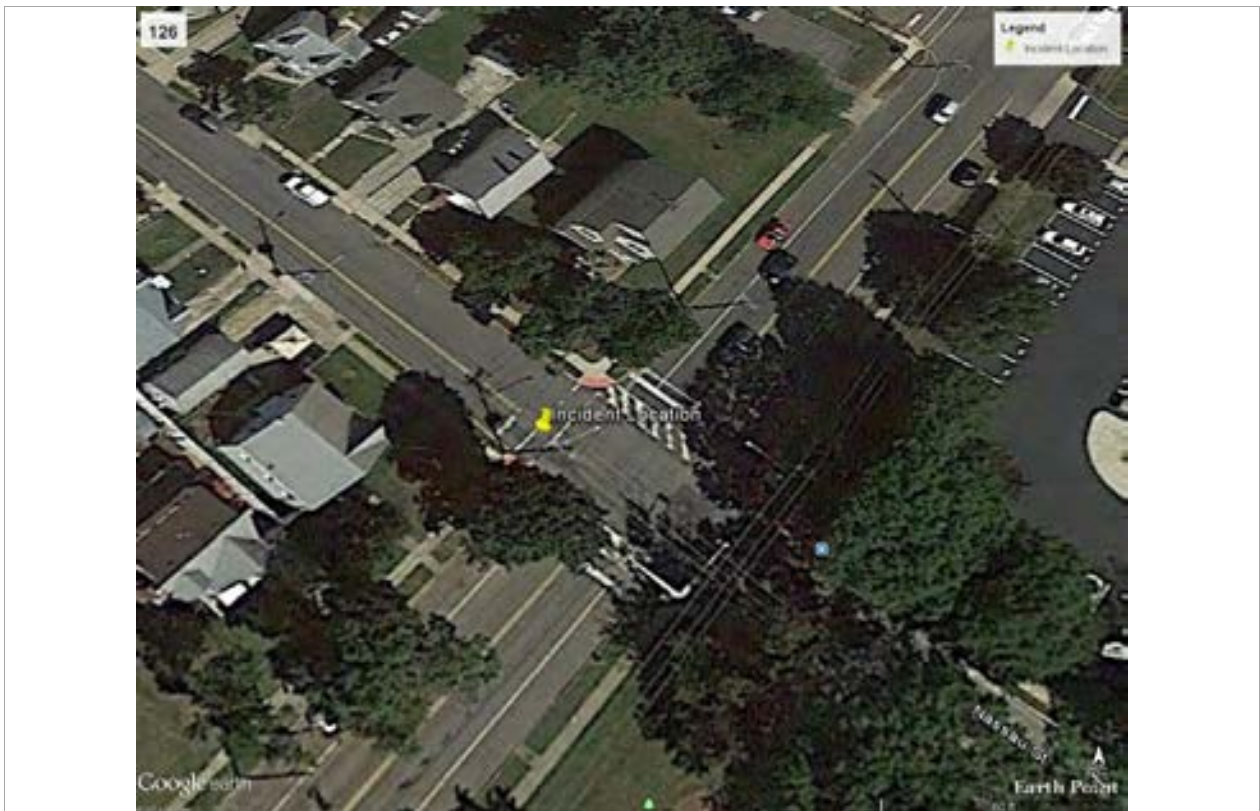
Figure 1. Overhead View of Site Map Link <http://goo.gl/maps/FX9yg>

Additional Infrastructure Nassau St and Remsen Ave are both 2-lane residential roadways. Both have double yellow lines separating lanes of traffic. Both have street parking.

The intersection has a traffic light for all 4 ways of traffic. There are pedestrian crossing signals. All sides have crosswalks, but they look poorly maintained. In streetview, they are all very faded transverse crosswalks. In the aerial photo, there is a striped (ladder) crosswalks across Remsen. It is unknown if they were painted after the crash.

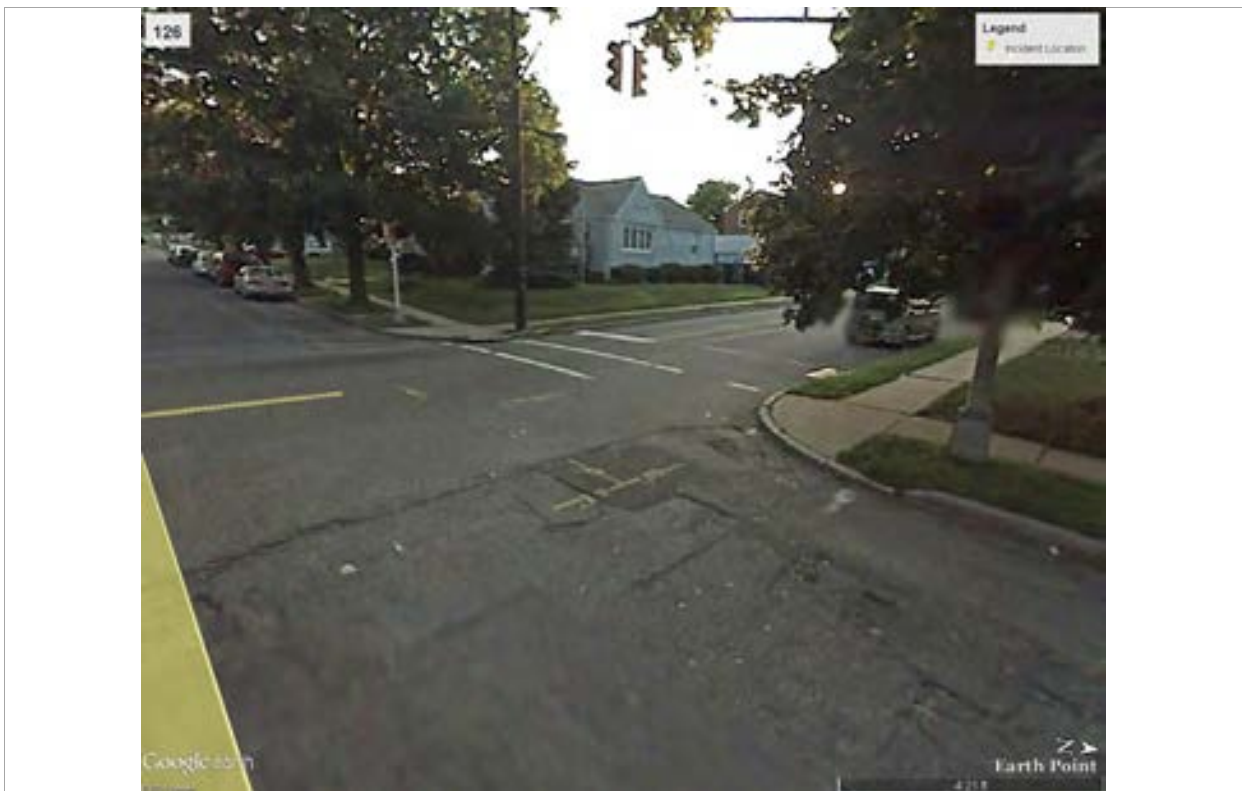
Figure 2. Street View of Site, Direction Driver was Going

Supplemental	<input type="text" value="Crosswalk markings look poorly maintained. No information in report and cannot find any articles online."/>

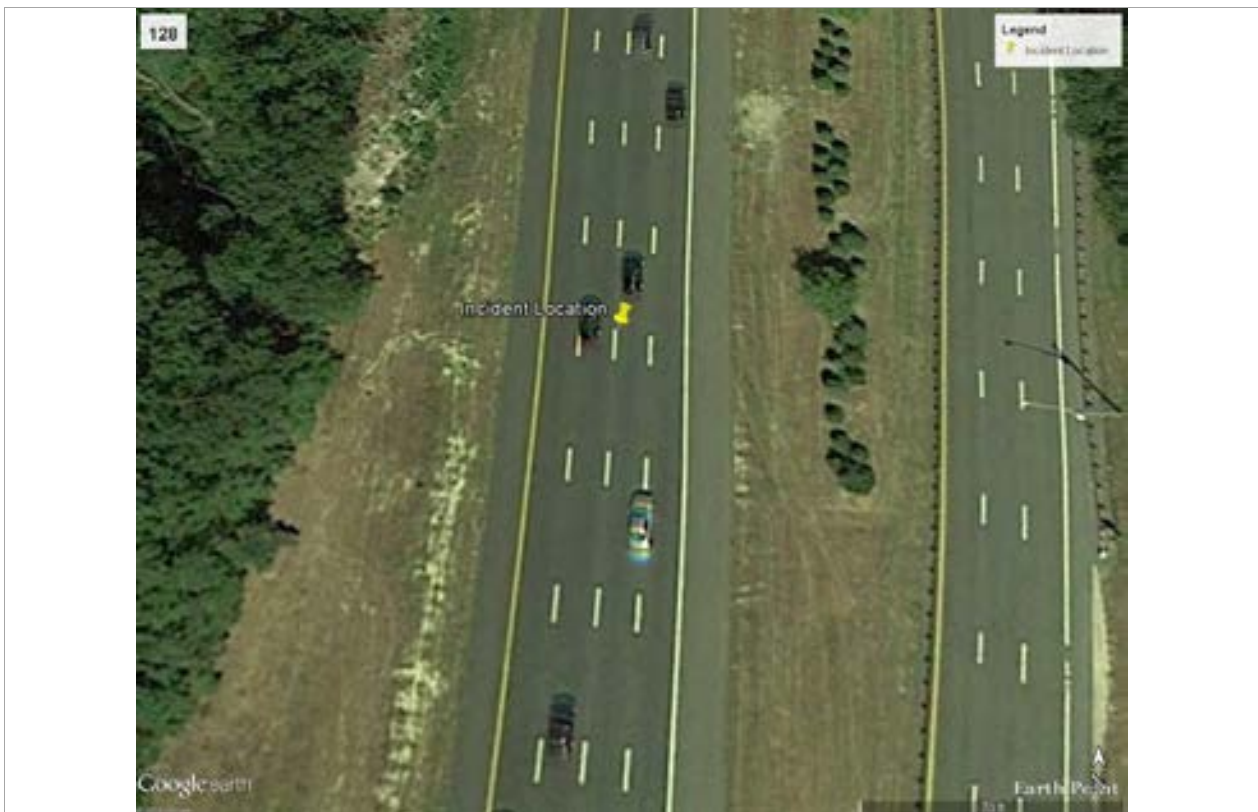
Figure 1. Overhead View of Site Map Link <https://goo.gl/maps/ISnI8>

Additional Infrastructure The Garden State Parkway is an 8 lane highway. There are 4 lanes traveling north and 4 lanes traveling south. At this particular part of the highway there is an exit/entrance to the highway. There are wooded areas between the lanes and on either side.

No sidewalks or crosswalks. This is a highway designated for motor vehicles and pedestrians are prohibited.

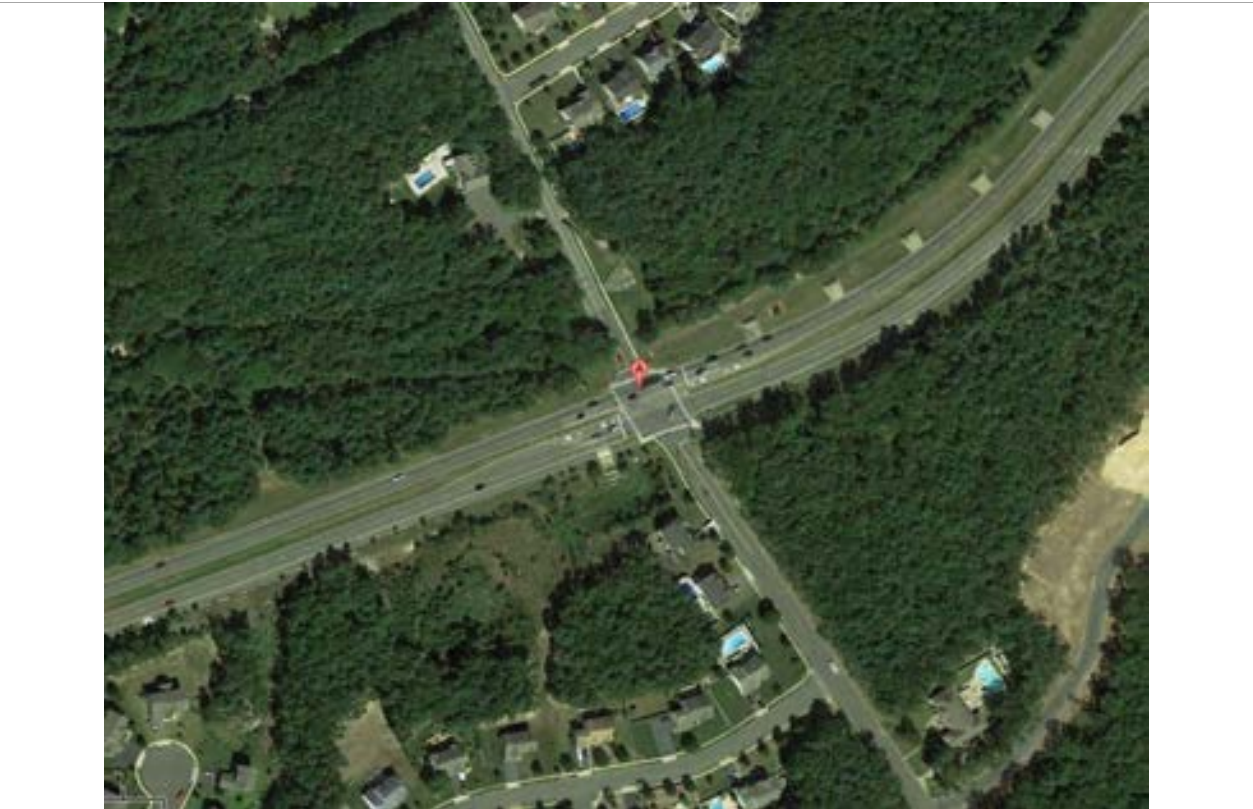
Figure 1. Overhead View of Site Map Link <https://goo.gl/maps/a17X>

The area surrounding the intersection is nothing but trees, but there are residential areas nearby that the pedestrian must have been walking to and from. There are no commercial locations in the area. In general, the area is very forested rural.

There is a single streetlight over the intersection.

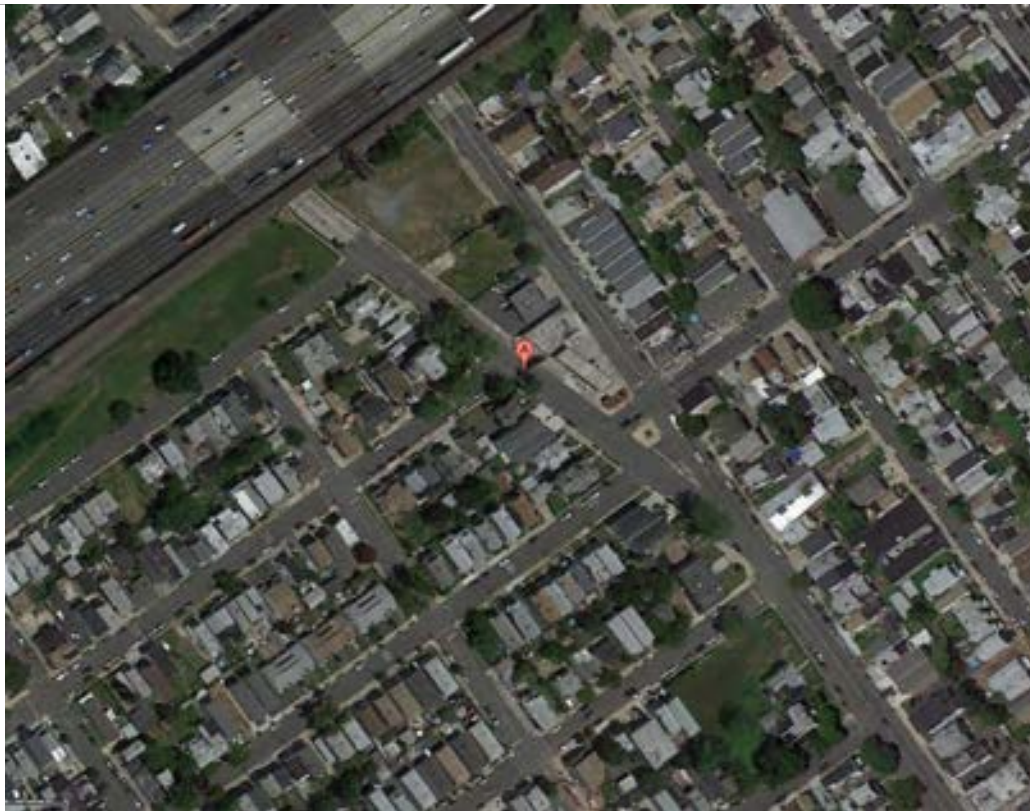
Figure 1. Overhead View of Site

There is no crosswalk crossing 1st Avenue, although there is currently a “stop for pedestrians” sign in the middle of the street. That may not have existed at the time of the crash and may have been added because of it. There is one streetlight over the intersection.

The east side of the intersection has a gas station with convenience store. The west side is all residential. To the north, 1st Avenue crosses under I-95 and a railroad track.

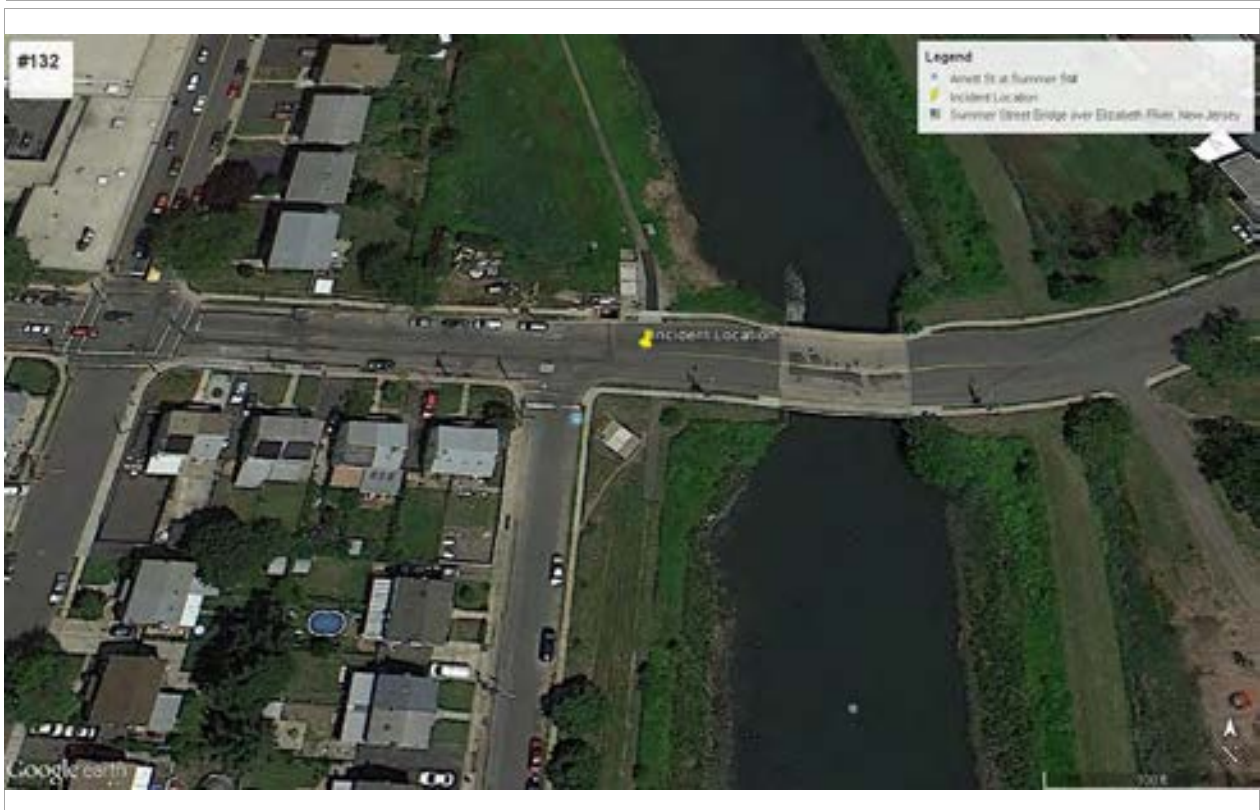
Figure 1. Overhead View of Site

The area is mostly residential. There is what appears to be a school one block to the west. Across the small river, to the east, is parkland with recreational fields and more homes.

There is a bus stop on the southeast corner.
