Appendix A

Individual Summaries of all 2012 New Jersey Pedestrian Fatalities

New Jersey Bicycle and Pedestrian Resource Center

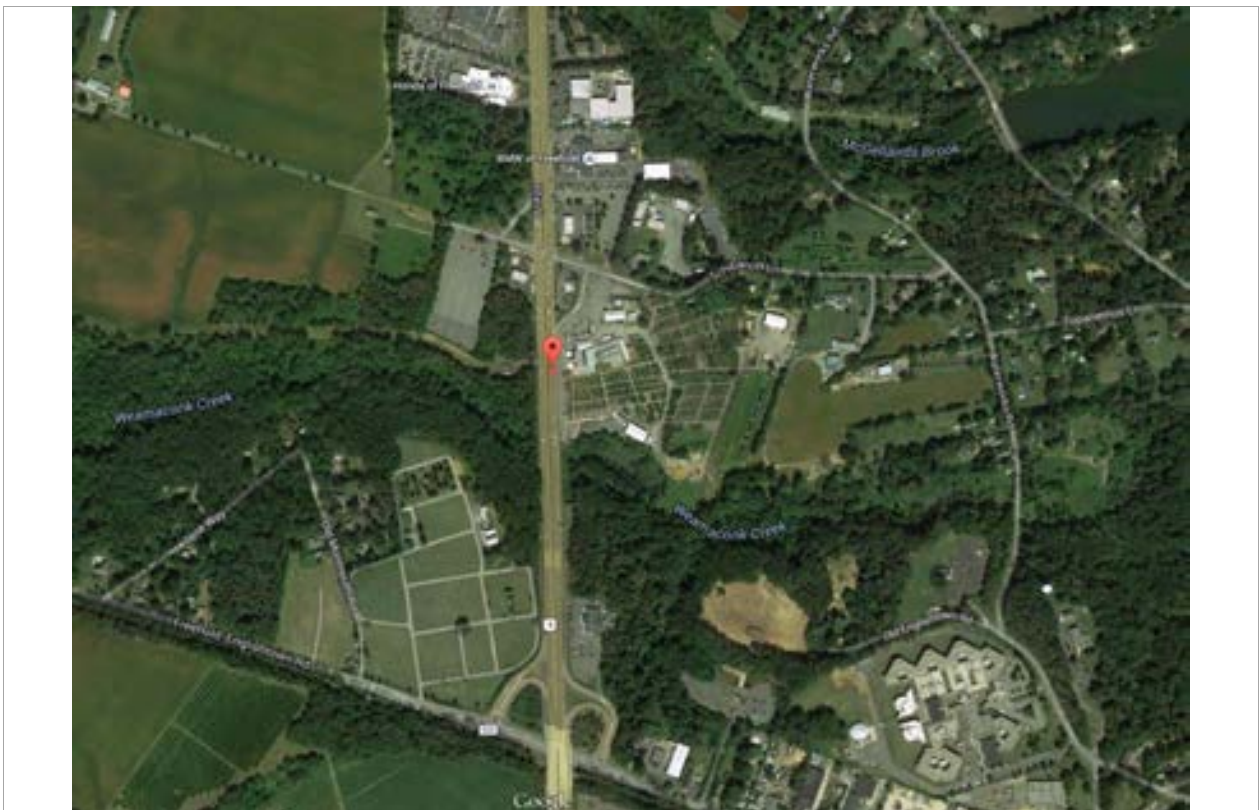
Figure 1. Overhead View of Site

There are no street lights illuminating the area of the collision on either the northbound or southbound side. The nearest street light is located at the entrance to the ramp of Rt 9 north onto Schibanoff Lane, approx 400 feet from the point of impact. Directly east of the collision area is the parking lot of Brock Farms Garden Center. It is illuminated with several low level globe type street lights. It provides minimal secondary lighting to the collision area. Directly west of the collision area is wooded and a NJ Natural Gas Transmission station is located inside the wooded area. No secondary lighting is provided. The weather at the time of the collision was clear and approx. 45 degrees.

Area is very rural.

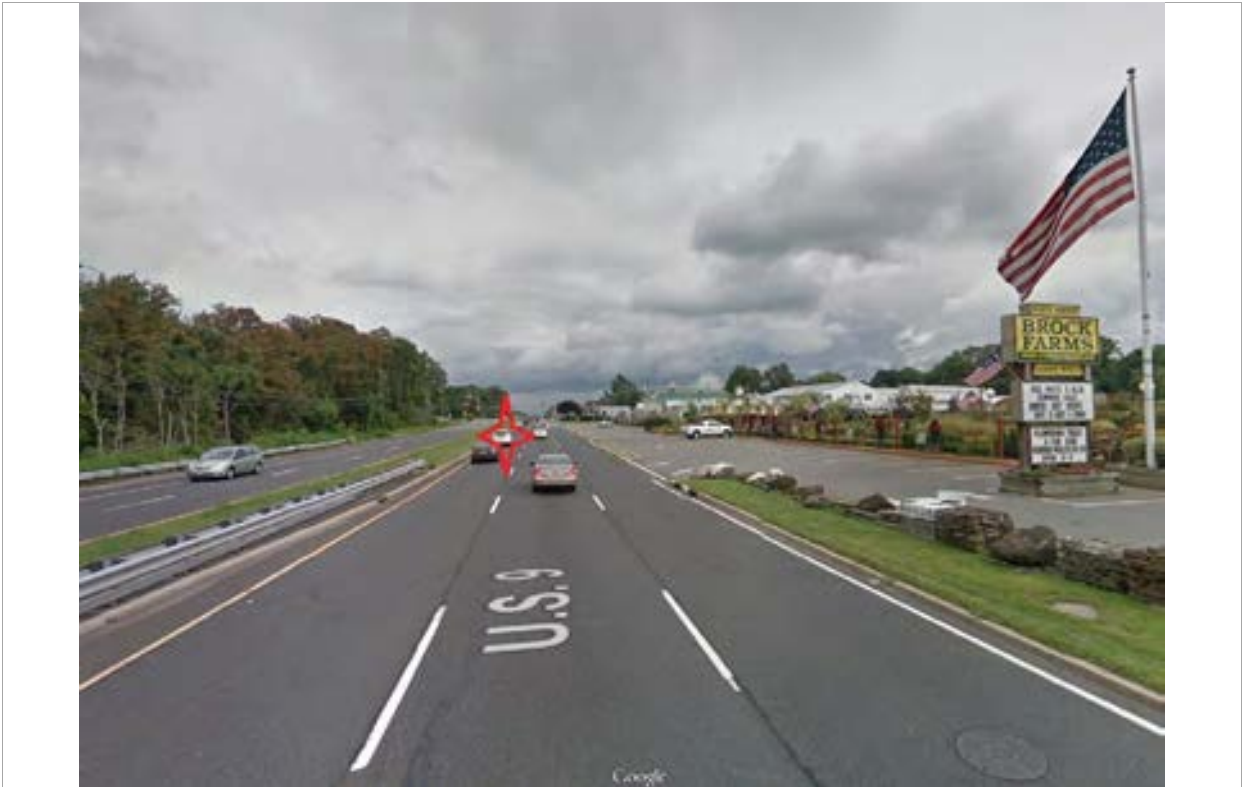
Figure 2. Street View of Site, Direction Driver was Going

The pedestrian crossed when the traffic signal was green and was struck. It was dark outside and the pedestrian was wearing dark clothing. There no streetlights over the crosswalks. Arena Drive is wide (4 lanes) and has a high speed limit in a residential neighborhood. Road should have a road-diet.

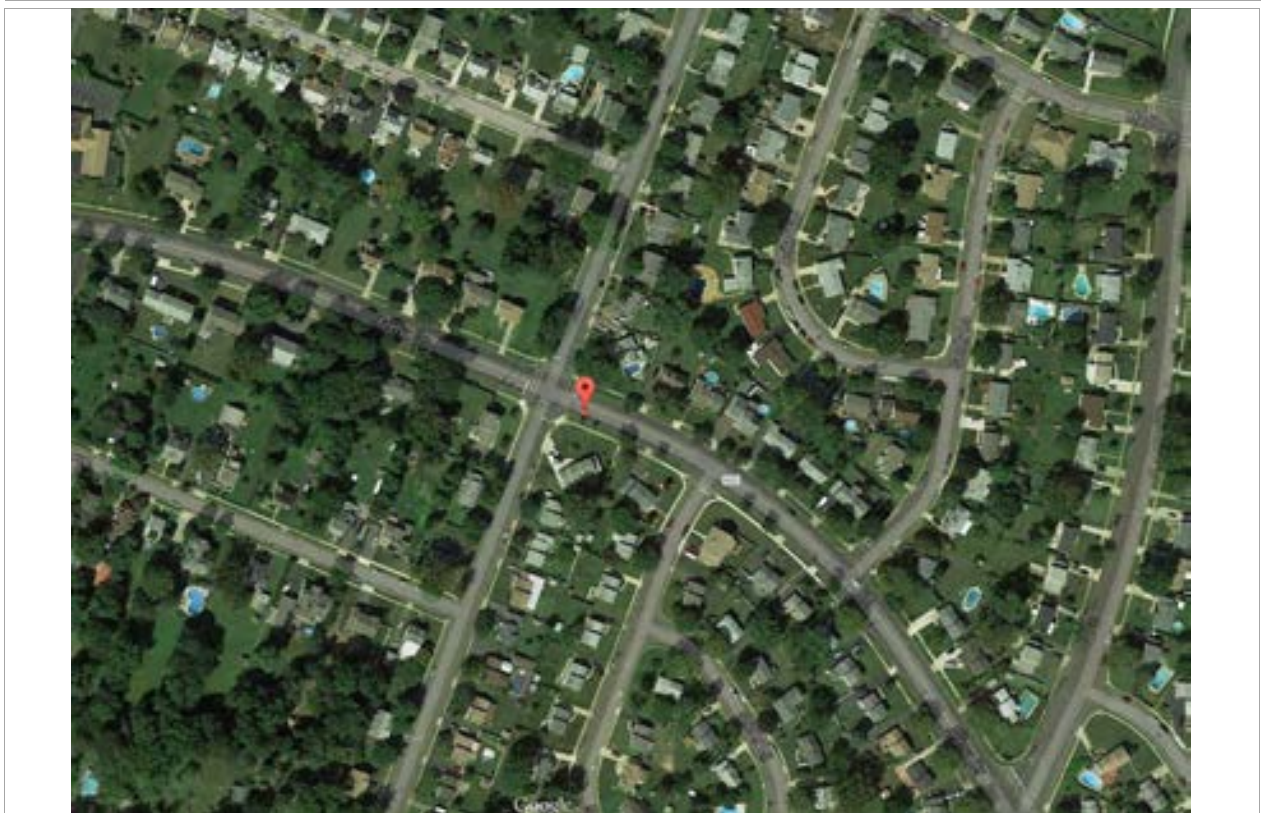
Figure 1. Overhead View of Site [Map Link https://goo.gl/maps/kPP00](https://goo.gl/maps/kPP00)

There are some overhead street lamps, but not at the particular corner of the intersection. The area surrounding the intersection is completely suburban residential. There are grass lawns all along the roadway.

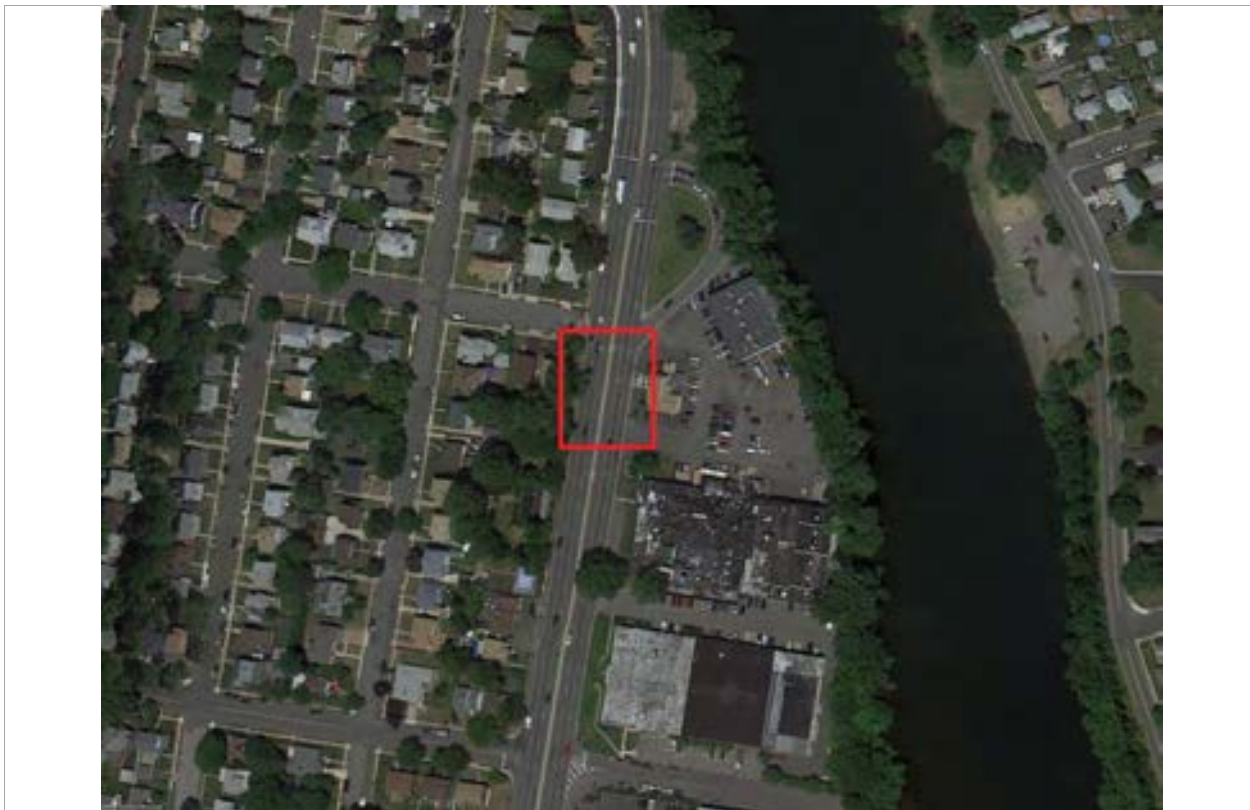
Figure 1. Overhead View of Site

On the west side is a residential neighborhood with detached single family homes.

There are streetlights on both sides of the street but they are not tightly spaced

Infrastructure contribute?	<input type="text" value="Partially. Infrastructure is completely unsuitable for pedestrians, as it appears to be impossible to cross the avenue at any point. The road is also designed for very high speeds. However, the pedestrian was wrestling in the roadway."/>								
Questions	<p>1) Why were pedestrians wrestling in roadway?</p> <p>2) Was driver charged for hit and run?</p> <p>3) How does one get to businesses on foot?</p>								
Supplemental	<input type="text" value="This is an amendment to the initial report, which is missing. Do not have access to pedestrian address or exact crash location."/>

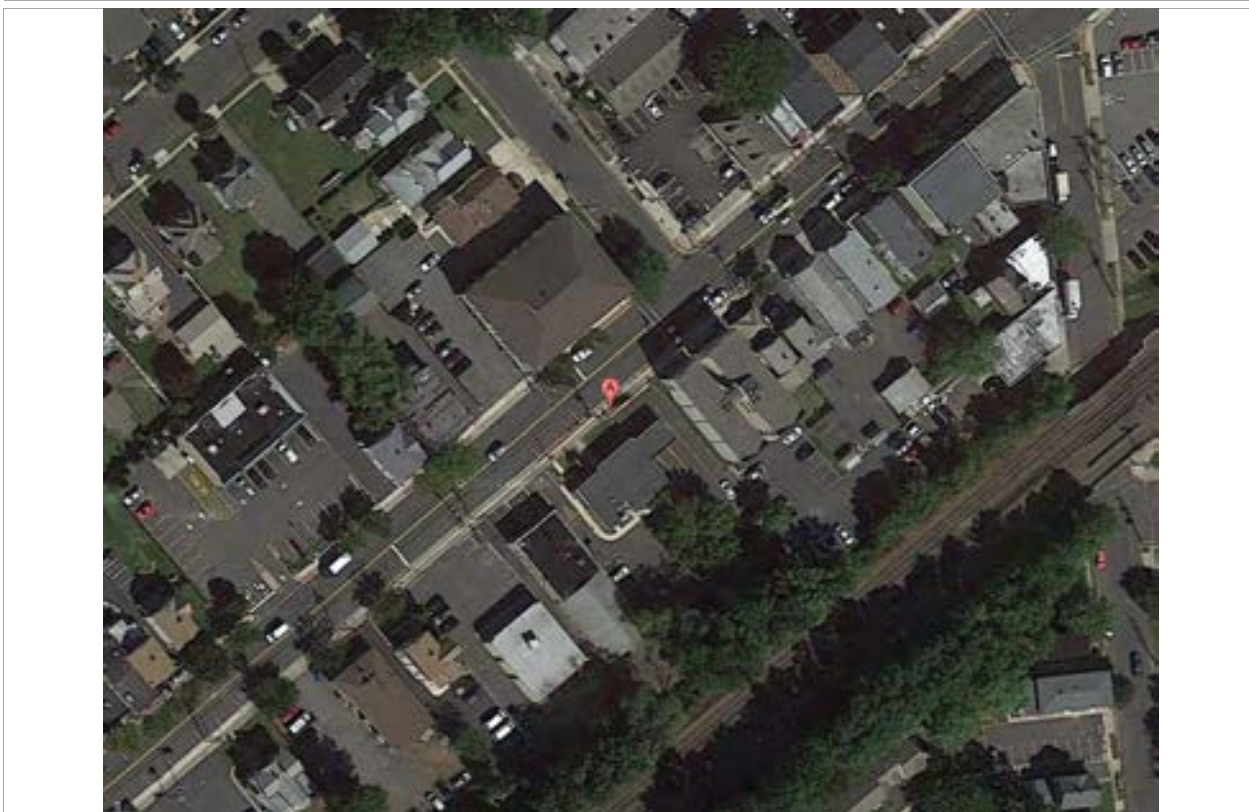
Figure 1. Overhead View of Site

Route 28 (North Avenue) is a two-lane bidirectional street in a densely settled commercial strip. The area appears to be very walkable, with many building (1-2 stories) built to the sidewalk. However, there is also a lot of auto-oriented business, including surface lots and the drive-thru bank.

The Dunellen Train Station is a block away, so the sidewalk is probably well used. Single-family detached residential neighborhoods are nearby

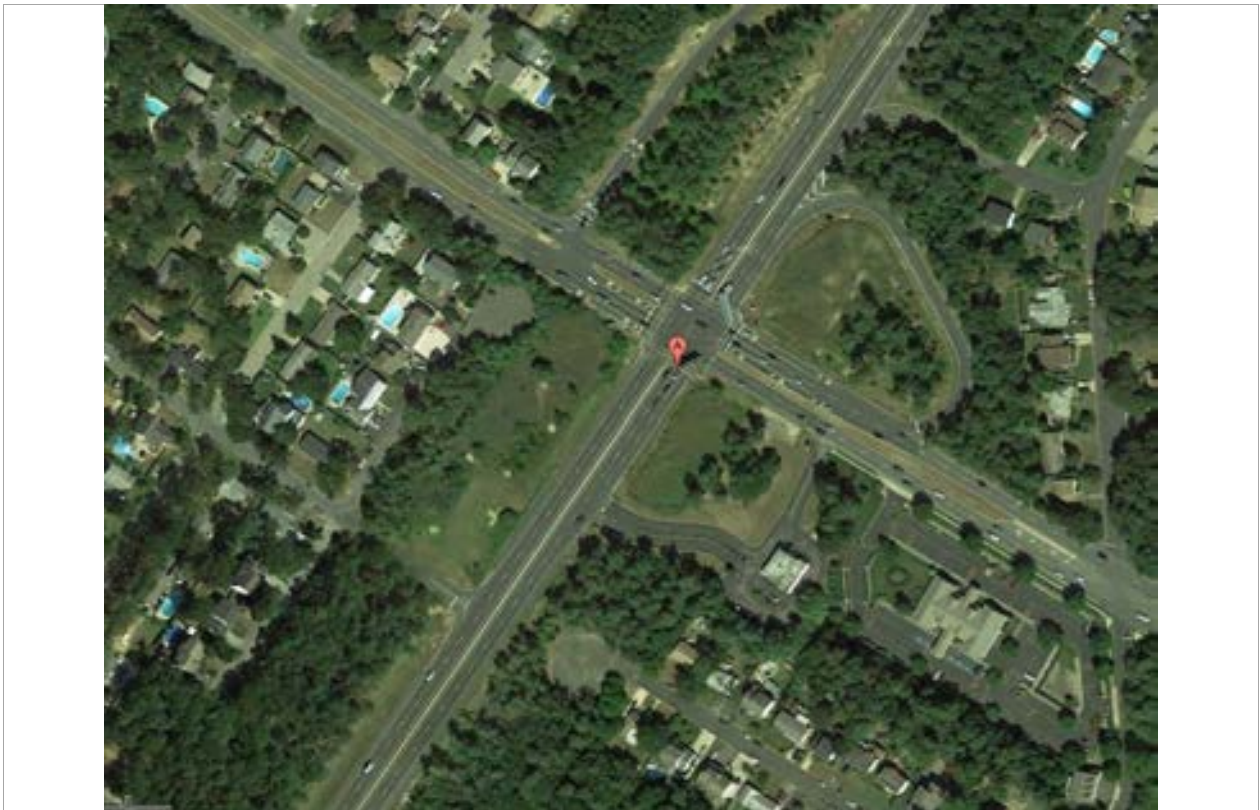
Figure 1. Overhead View of Site Map Link <http://goo.gl/maps/SsrUI>

The collision occurred just before the intersection with Burnt Tavern Road, which is signalized. That roadway is of a very similar design.

At the intersection, both roads widen to allow for turning lanes.

Streetlights are located with significant gaps, and none existed over the crash site.

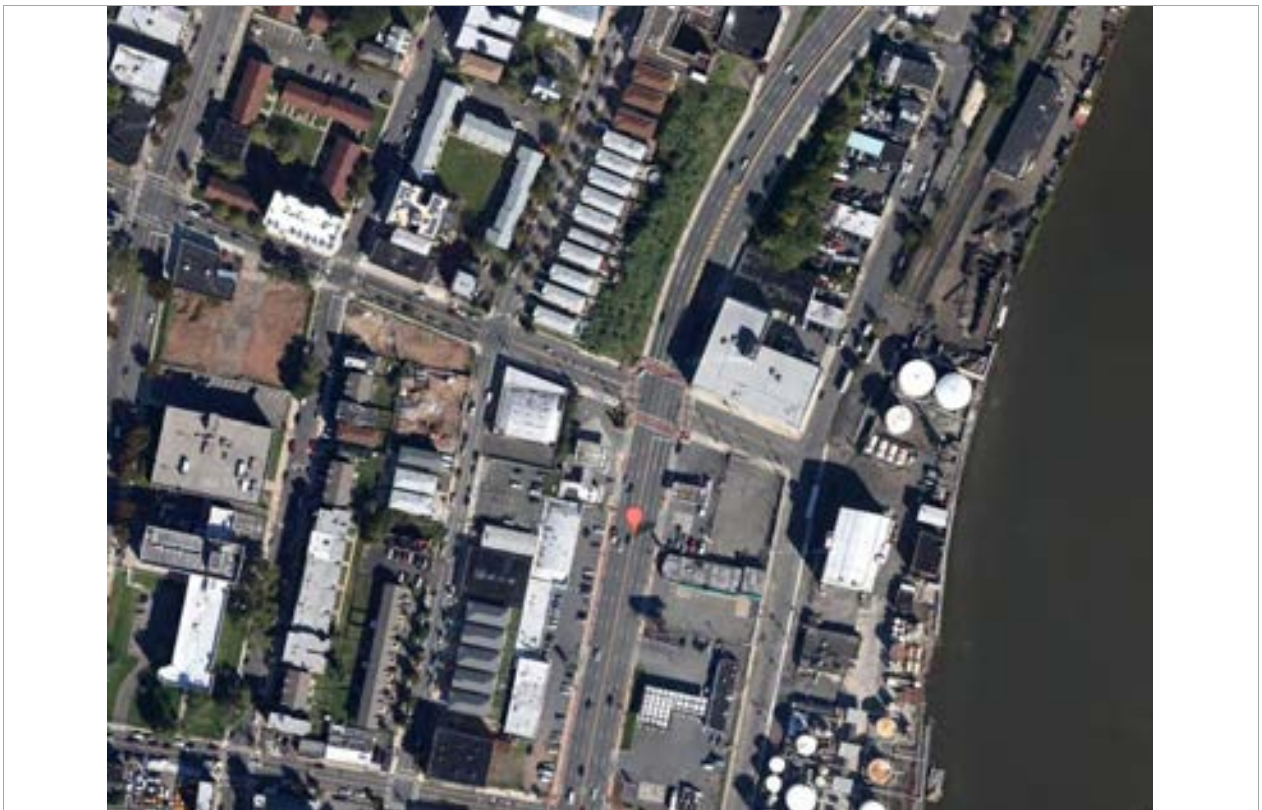
Figure 1. Overhead View of Site

Incident occurred approx 190 feet south of intersection. The next intersection south of collision does not have crosswalks across the highway.

This area seems to be outside of the main downtown Newark city. It is a commercial area with two gas stations at the intersection. There is also a strip mall with a laundromat, nail salon, sprint store and other food stores. There is a 7/11 across the street from the strip mall. Behind the strip mall to the west of the roadway are apartment buildings

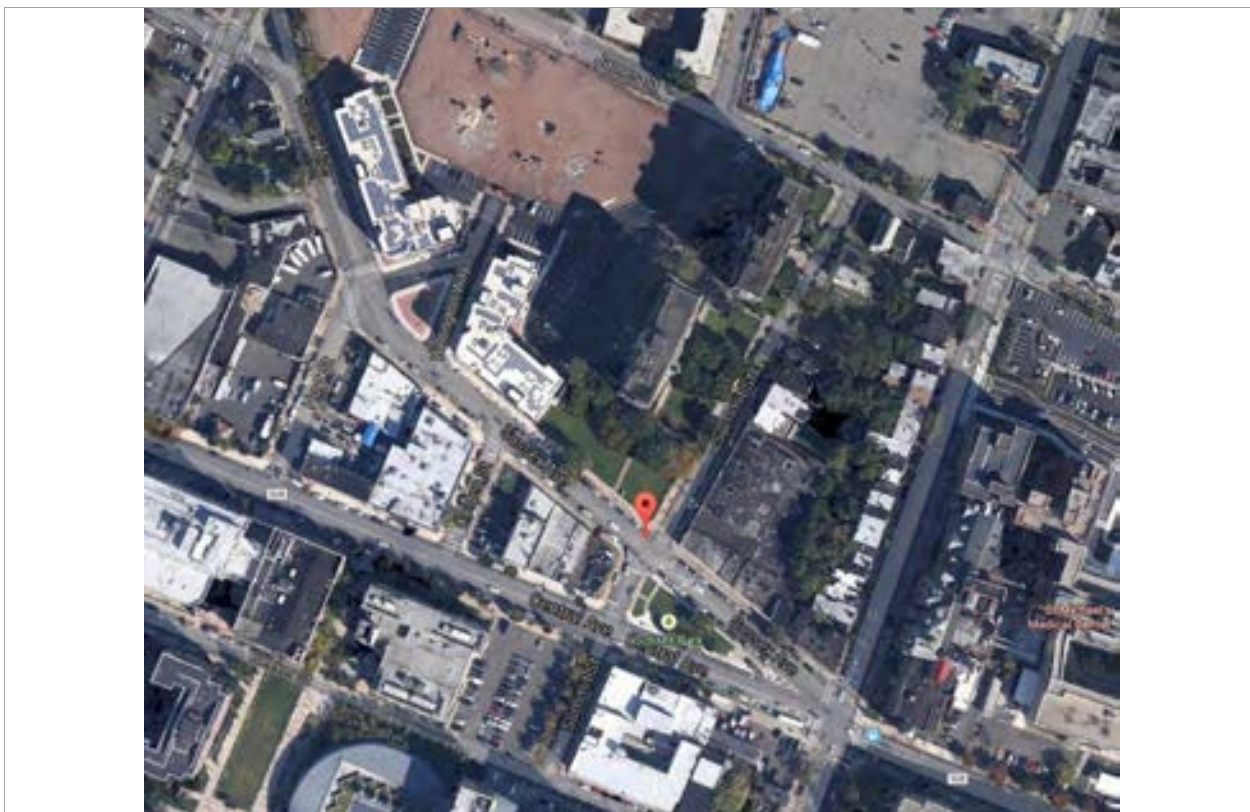
Figure 1. Overhead View of Site

There are sidewalks on all the area streets. At the intersection, Summit Street has a stop sign, however Sussex does not. There are marked transverse crosswalks across all sides of the intersection, but no pedestrian crossing signals.

This area looks a little desolate aside from the college campus. There are warehouses and vacant lots. There are a couple of apartment buildings. There is a medical center and a bus stop further down Sussex Avenue.

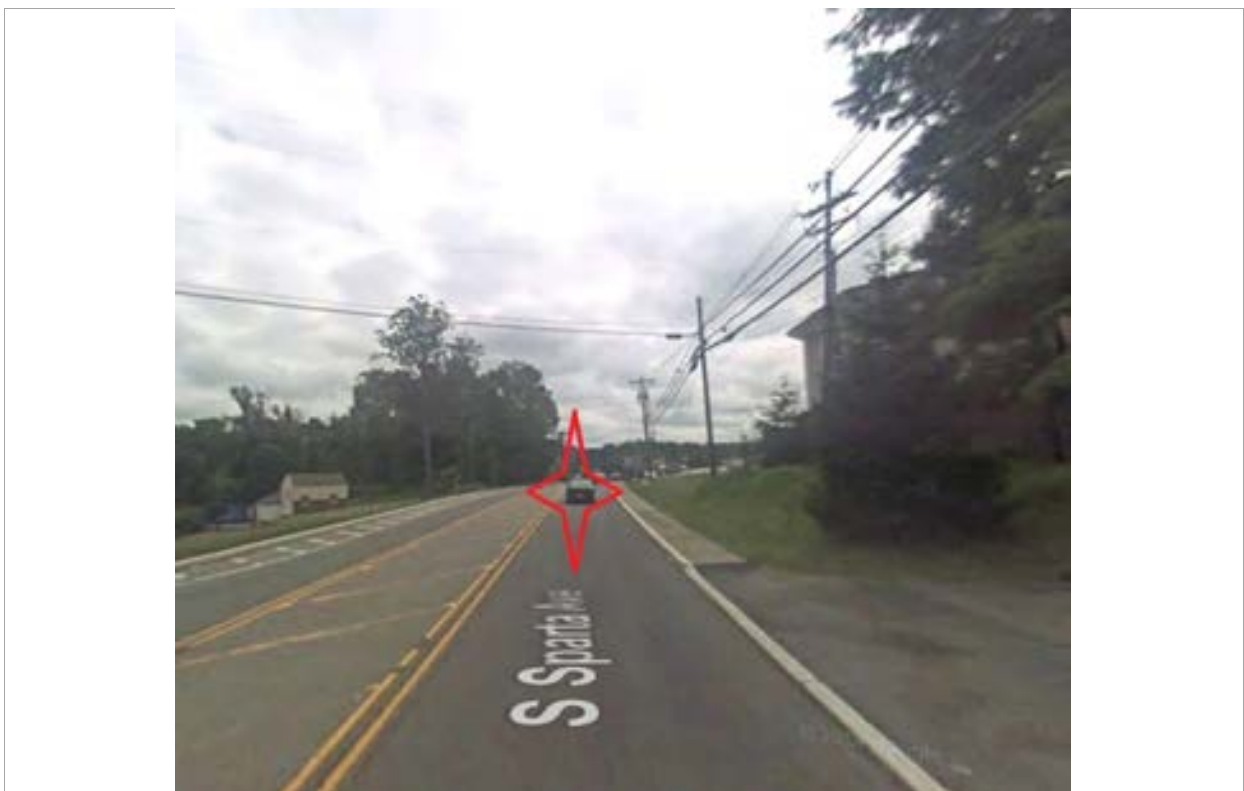
Figure 2. Street View of Site, Direction Driver was Going

Police Findings Vehicle #1 was traveling northbound on Sparta Avenue. The driver of vehicle #1 said that a pedestrian walked from the painted median into the northbound lane. The driver said that he braked heavily and attempted to avoid the pedestrian who was wearing dark clothing and moving slowly across the lane. The driver of vehicle #1 swerved left as he braked causing him to cross the double yellow line into the painted median before striking the pedestrian. The pedestrian was struck on the right side by the front passenger side of the mechanical dumpster arm. The right side of the pedestrian's body was impacted by the passenger side bumper.

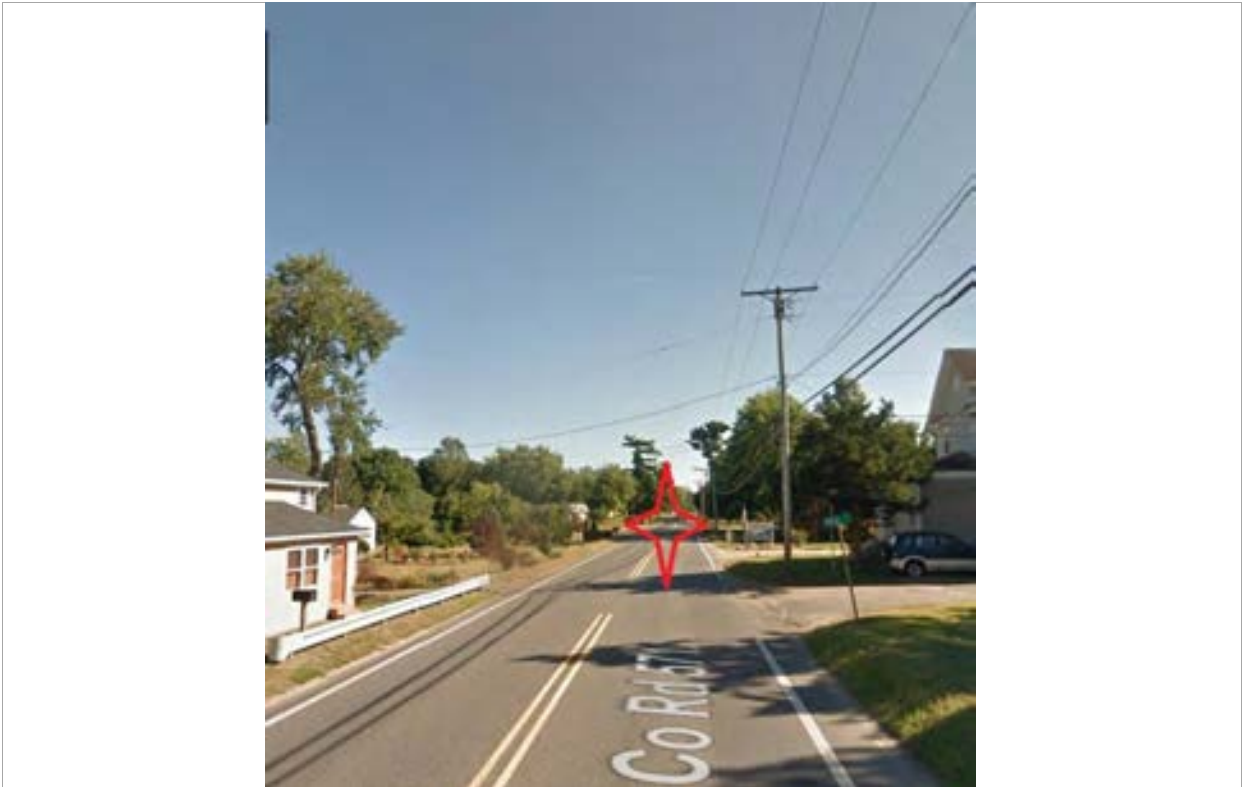
Figure 2. Street View of Site, Direction Driver was Going

Additional Infrastructure The roadway in the area of the crash is a two lane roadway, that heads generally in a north and south direction with one lane in each direction. The speed limit on the roadway is 40 mph which is clearly marked. The pavement on the roadway was in good condition. There are small shoulders. Properties on large lots directly front the roadway with their driveways and yards.

The lane markings were clearly visible, easily observed and each lane is clearly defined. The roadway is divided by a solid double yellow line (no passing) with white fog lines along the shoulder of the roadway, no sidewalks are provided. There are no streetlights.

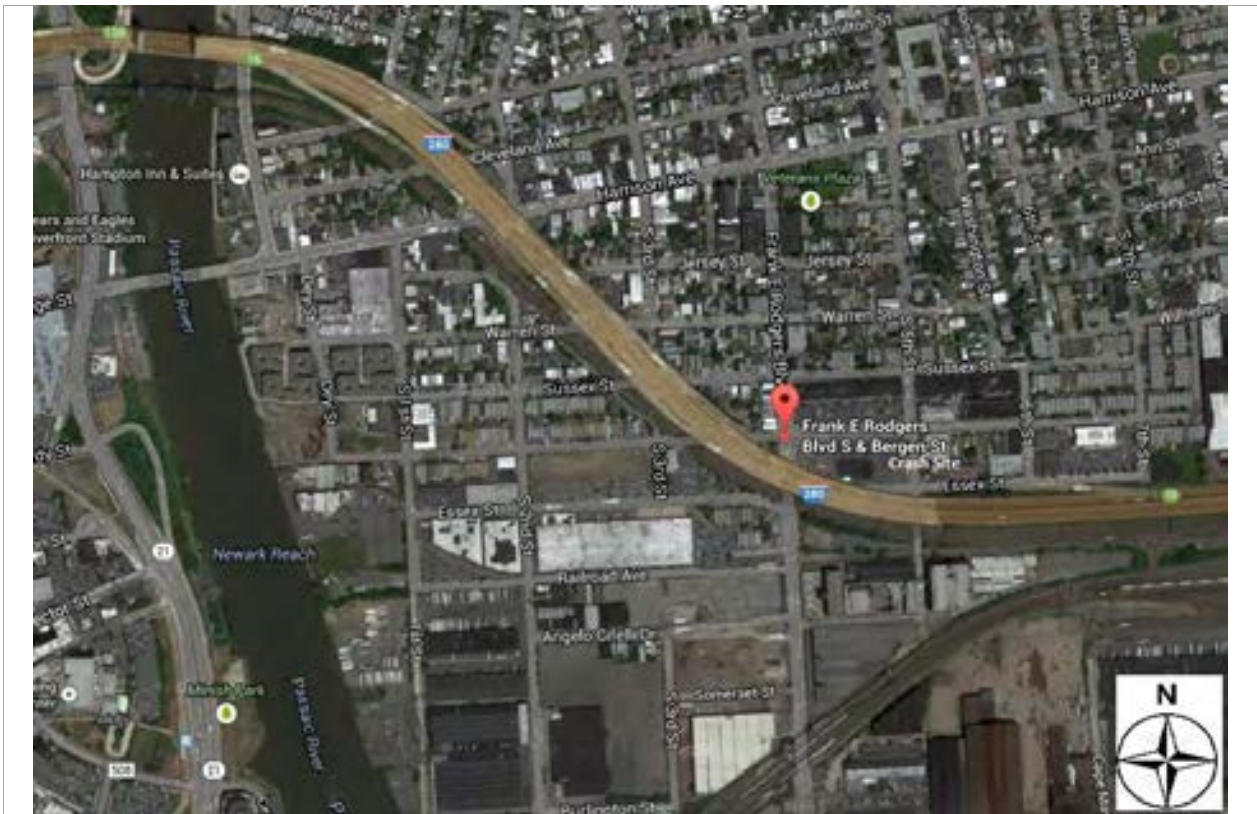
Figure 1. Overhead View of Site Map Link <https://goo.gl/maps/hHY9S>

Additional Infrastructure There are traffic signals and painted crosswalks in each direction. The paint appears to be fading somewhat on all four of the crosswalks, especially on the southern and western sides of the intersection. The southern crosswalk across Frank E Rogers Blvd. is almost complete erased. The next worst is the western crosswalk across Bergen Street, where the crash occurred. Both Frank E Rogers Blvd. and Bergen Street are two lane roads. There are painted turning instructions in the both lanes of Frank E Rogers Blvd. The paint in these appears to be in better shape than the crosswalks.

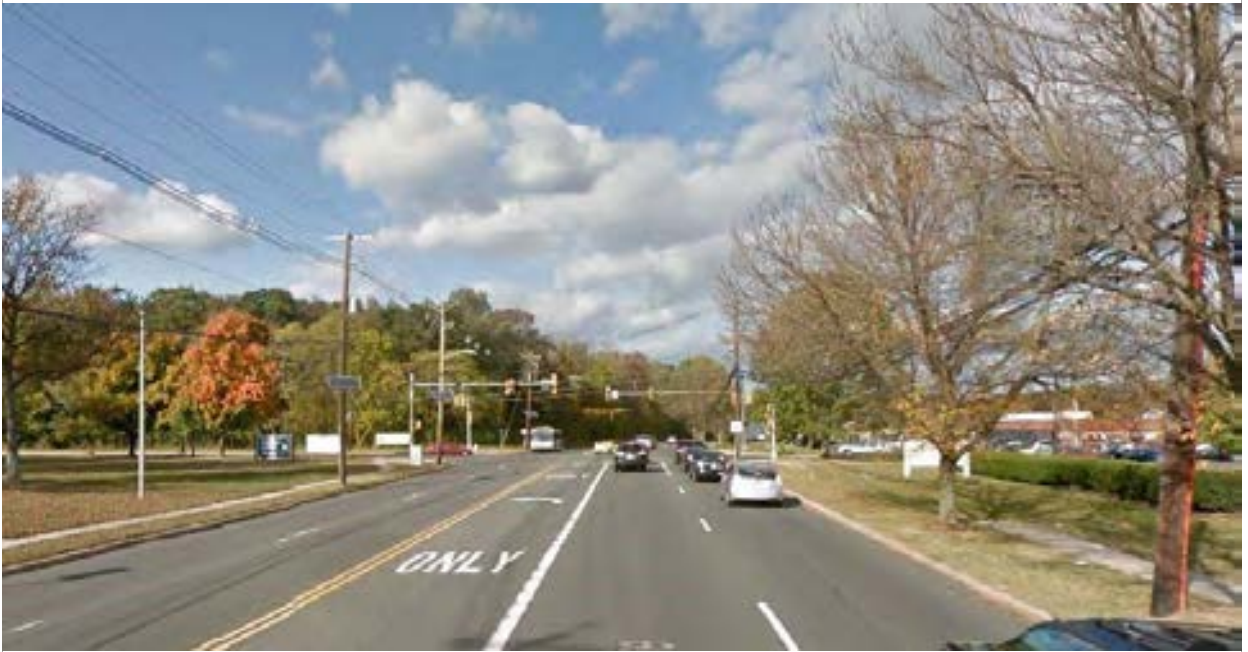
Figure 2. Street View of Site, Direction Driver was Going

The vehicle was traveling northbound in the right lane. The crash report is unclear what the pedestrian was doing in the right northbound lane of Whitehorse-Mercerville Road. Figure 1 shows the crash site using Street View imagery. Based on the crash diagram, the initial contact happened from roughly where a camera would be to take the image in Figure 1. To the immediate left is a white painted left turn arrow at the about the same location. The utility pole on the right should be Pole #75398HM. The SUV stopped shortly after the first tree on the right. The pedestrian's body came to rest at the side of the road between the second and third dashed white lines on the right.

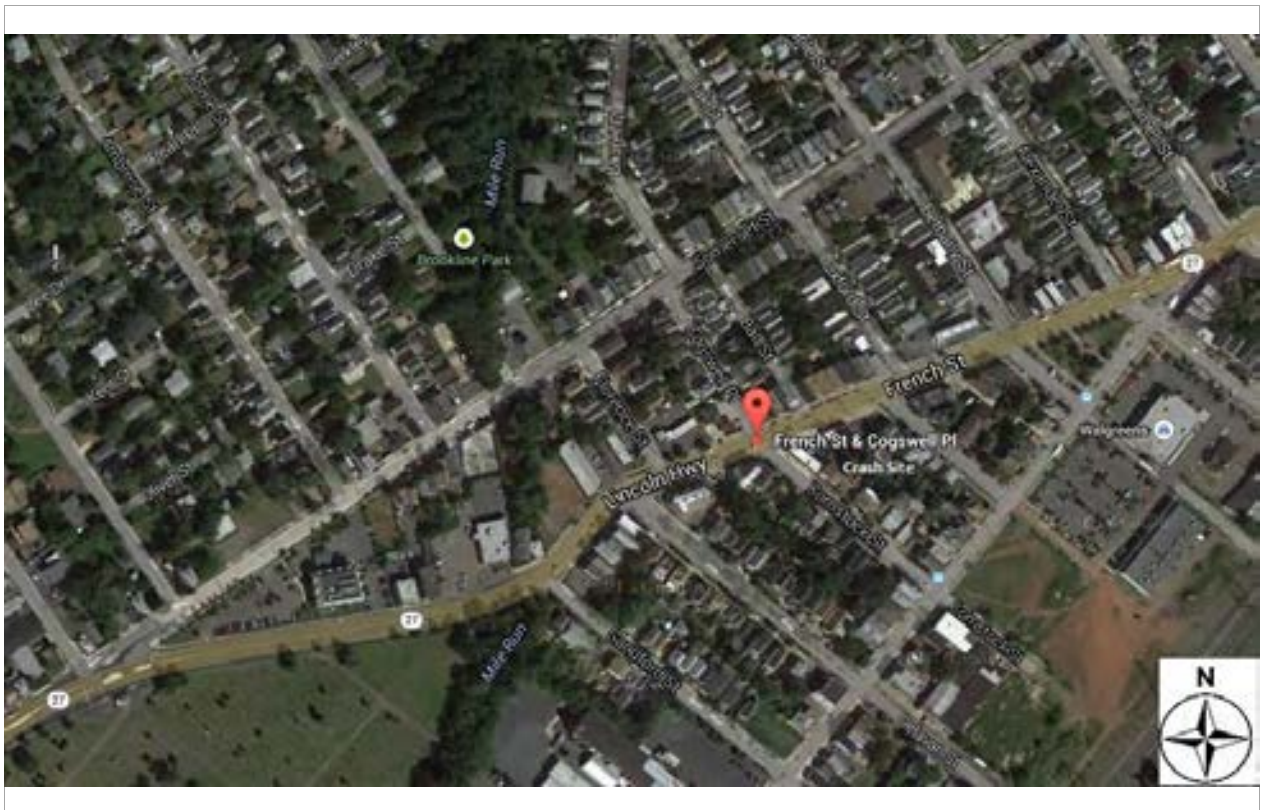
Figure 1. Overhead View of Site Map Link <https://goo.gl/maps/MtvuA>

The Google Maps satellite image shown in Figure 1 shows that French Street has minimal traffic controls. French Street traffic has the right of way unimpeded by stop signs, traffic signals, or crosswalks at the crash site. Cogswell Place on the northern side of the intersection has a crosswalk. However, there is one unmarked crosswalk across Comstock Street at the southern end of the intersection, and two more across French Street.

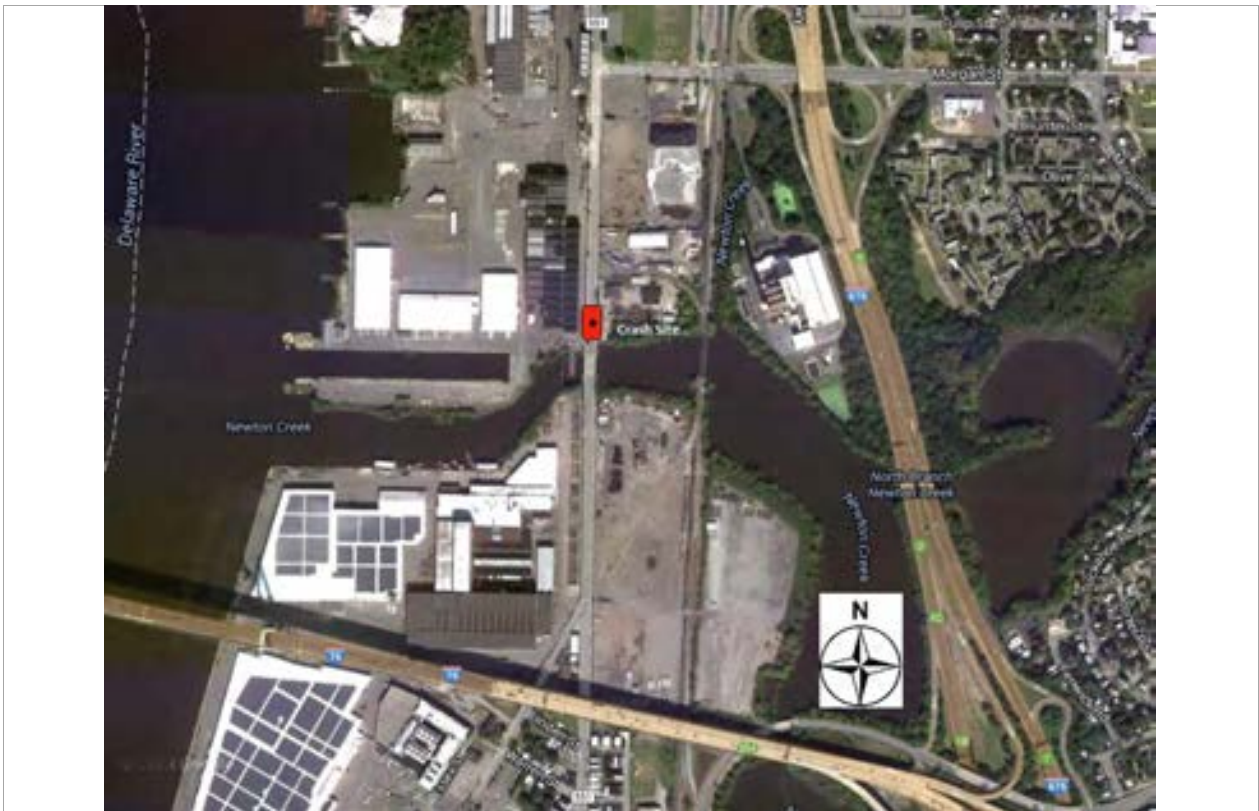
Figure 1. Overhead View of Site [Map Link https://goo.gl/maps/oDIDH](https://goo.gl/maps/oDIDH)

Additional Infrastructure The crash site is a single lane road on the approach to a bridge. The speed limit at this location is 25 mph. There are concrete sidewalks on either side of the roadway. It was dark with no streetlights at the time of the crash but the sky was clear and the road was dry. The road becomes inclined as it approaches the bridge because it must rise to meet the bridge surface.
